UNITED STATES
NUCLEAR REGULATORY COMMISSION
OFFICE OF NUCLEAR REACTOR REGULATION
WASHINGTON, D.C. 20555

November 26, 1993

**NRC INFORMATION NOTICE 93-89: POTENTIAL PROBLEMS WITH BWR LEVEL
INSTRUMENTATION BACKFILL MODIFICATIONS**

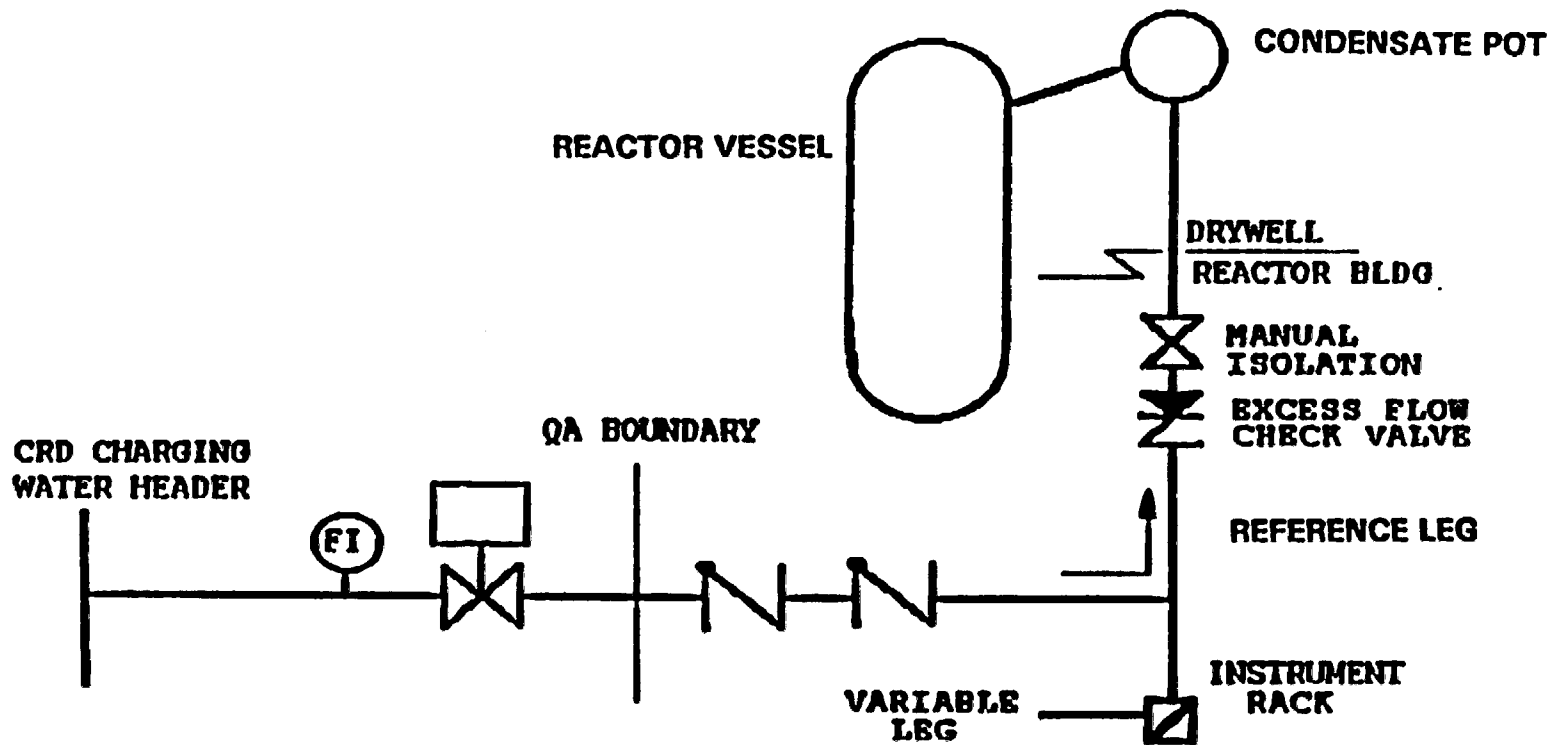
FIGURE 1 - SIMPLIFIED SKETCH OF BACKFILL MODIFICATION

It was postulated at Susquehanna that a manual isolation valve in one of the reference legs (see Figure 1) could be closed by operator error. Closure of this valve would result in pressurization of that reference leg to CRD system pressure and erroneous indication of low reactor water level and high reactor pressure on all instrumentation associated with that reference leg. The transient resulting from pressurization of the most limiting reference leg

includes reactor scram and opening of all safety relief valves (SRVs) due to the false high reactor pressure. The SRVs would remain open and depressurize the reactor until the valves are closed by operator action, or actual reactor pressure falls below approximately 446 kPa [50 psig] at which time the valves can no longer stay open. Reactor depressurization and loss of inventory through the SRVs, in combination with the false low water level signal on the affected reference leg, would result in closure of the main steam isolation valves, actuation of high-pressure and low-pressure emergency core cooling system (ECCS) and containment isolation. Low-pressure ECCS injection would commence after the low-pressure permissive is satisfied. This permissive would be satisfied in this scenario, allowing the low pressure ECCS injection valves to open, because only one of the pressure transmitters is affected and the logic would still be satisfied. A single failure could defeat this logic, however, preventing all low-pressure ECCS injection. The low-pressure permissive can be bypassed in the control room to open the injection valves for all four low pressure core spray (LPCS) pumps. The Susquehanna licensee has informed the NRC that it has physically disabled the manual isolation valves to prevent misoperation of these valves; in addition, the valves are not readily accessible as they are located 6.1 meters [20 feet] above the floor.

This event was recently analyzed for the LaSalle plant by Commonwealth Edison. The analysis indicates that the low-pressure permissive for opening the low-pressure ECCS injection valve would be defeated for the LaSalle design due to the false high pressure signal, thus preventing ECCS injection from the affected division. If a single failure is assumed in the relay for the low-pressure permissive on the other division, no low-pressure ECCS injection would be available. Because the induced plant transient is potentially so severe, LaSalle has designed its backfill modification to make the injection point for the backfill system on the reactor side of the manual isolation valve and excess flow check valve, thereby precluding the potential for pressurization of the reference leg through the backfill system.

Commonwealth Edison took a different design approach for its Dresden and Quad Cities plants. The backfill system design for Dresden and Quad Cities injects into the reference leg on the instrument rack side of the manual isolation valve and excess flow check valve. Additional administrative controls were developed to ensure that the isolation valve would not be inadvertently closed. The licensee analyzed the inadvertent closure of the manual isolation valve for the Dresden and Quad Cities plants and concluded that, while multiple SRVs would open, the resultant plant transient could be mitigated by appropriate operator actions. Without operator actions, the low-pressure ECCS would be available for event mitigation; however, a single failure in the instrumentation system could defeat the low-pressure permissive for opening the low-pressure ECCS injection valves and result in no low-pressure ECCS being available for this transient. The licensee also determined that this design presented an unreviewed safety question because it would increase the probability of a previously analyzed accident, and submitted an application to amend its license pursuant to 10 CFR 50.90. The NRC is currently reviewing the licensee submittal.
