UNITED STATES  
NUCLEAR REGULATORY COMMISSION  
OFFICE OF NUCLEAR REACTOR REGULATION  
WASHINGTON, D.C. 20555

November 26, 1993

**NRC INFORMATION NOTICE 93-89: POTENTIAL PROBLEMS WITH BWR LEVEL  
INSTRUMENTATION BACKFILL MODIFICATIONS**

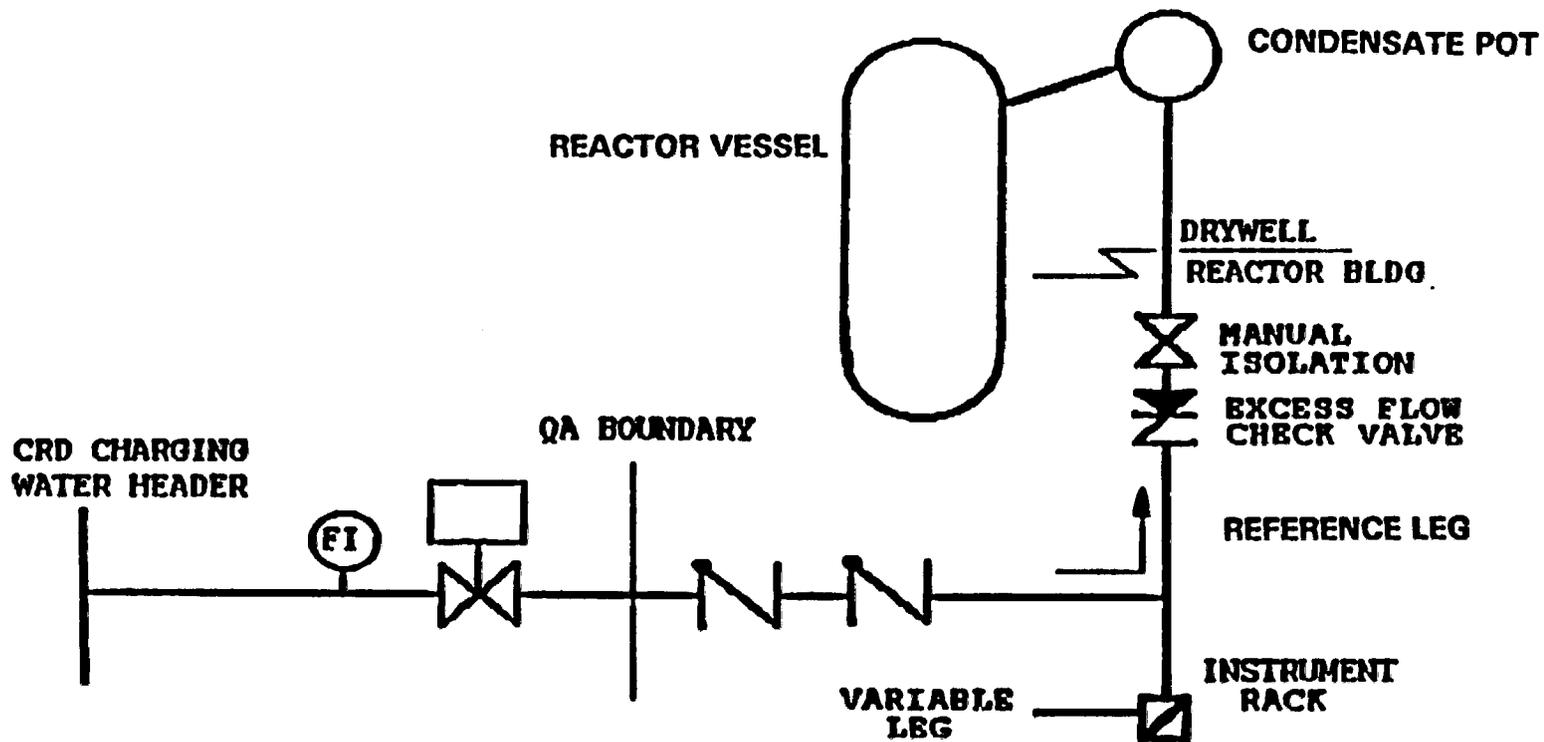
**FIGURE 1 - SIMPLIFIED SKETCH OF BACKFILL MODIFICATION**

It was postulated at Susquehanna that a manual isolation valve in one of the reference legs (see Figure 1) could be closed by operator error. Closure of this valve would result in pressurization of that reference leg to CRD system pressure and erroneous indication of low reactor water level and high reactor pressure on all instrumentation associated with that reference leg. The transient resulting from pressurization of the most limiting reference leg

includes reactor scram and opening of all safety relief valves (SRVs) due to the false high reactor pressure. The SRVs would remain open and depressurize the reactor until the valves are closed by operator action, or actual reactor pressure falls below approximately 446 kPa [50 psig] at which time the valves can no longer stay open. Reactor depressurization and loss of inventory through the SRVs, in combination with the false low water level signal on the affected reference leg, would result in closure of the main steam isolation valves, actuation of high-pressure and low-pressure emergency core cooling system (ECCS) and containment isolation. Low-pressure ECCS injection would commence after the low-pressure permissive is satisfied. This permissive would be satisfied in this scenario, allowing the low pressure ECCS injection valves to open, because only one of the pressure transmitters is affected and the logic would still be satisfied. A single failure could defeat this logic, however, preventing all low-pressure ECCS injection. The low-pressure permissive can be bypassed in the control room to open the injection valves for all four low pressure core spray (LPCS) pumps. The Susquehanna licensee has informed the NRC that it has physically disabled the manual isolation valves to prevent misoperation of these valves; in addition, the valves are not readily accessible as they are located 6.1 meters [20 feet] above the floor.

This event was recently analyzed for the LaSalle plant by Commonwealth Edison. The analysis indicates that the low-pressure permissive for opening the low-pressure ECCS injection valve would be defeated for the LaSalle design due to the false high pressure signal, thus preventing ECCS injection from the affected division. If a single failure is assumed in the relay for the low-pressure permissive on the other division, no low-pressure ECCS injection would be available. Because the induced plant transient is potentially so severe, LaSalle has designed its backfill modification to make the injection point for the backfill system on the reactor side of the manual isolation valve and excess flow check valve, thereby precluding the potential for pressurization of the reference leg through the backfill system.

Commonwealth Edison took a different design approach for its Dresden and Quad Cities plants. The backfill system design for Dresden and Quad Cities injects into the reference leg on the instrument rack side of the manual isolation valve and excess flow check valve. Additional administrative controls were developed to ensure that the isolation valve would not be inadvertently closed. The licensee analyzed the inadvertent closure of the manual isolation valve for the Dresden and Quad Cities plants and concluded that, while multiple SRVs would open, the resultant plant transient could be mitigated by appropriate operator actions. Without operator actions, the low-pressure ECCS would be available for event mitigation; however, a single failure in the instrumentation system could defeat the low-pressure permissive for opening the low-pressure ECCS injection valves and result in no low-pressure ECCS being available for this transient. The licensee also determined that this design presented an unreviewed safety question because it would increase the probability of a previously analyzed accident, and submitted an application to amend its license pursuant to 10 CFR 50.90. The NRC is currently reviewing the licensee submittal.
