# UNITED STATES NUCLEAR REGULATORY COMMISSION OFFICE OF NUCLEAR REACTOR REGULATION WASHINGTON, D.C. 20555

NRC INFORMATION NOTICE 93-84:

DETERMINATION OF WESTINGHOUSE REACTOR COOLANT PUMP SEAL FAILURE

2. Excerpt from Westinghouse Technical Bulletin, NSD-TB-93-01-RO, "Revised Procedures for RCP Shutdown with No. 1 Seal Leakage Outside Operating Limits"

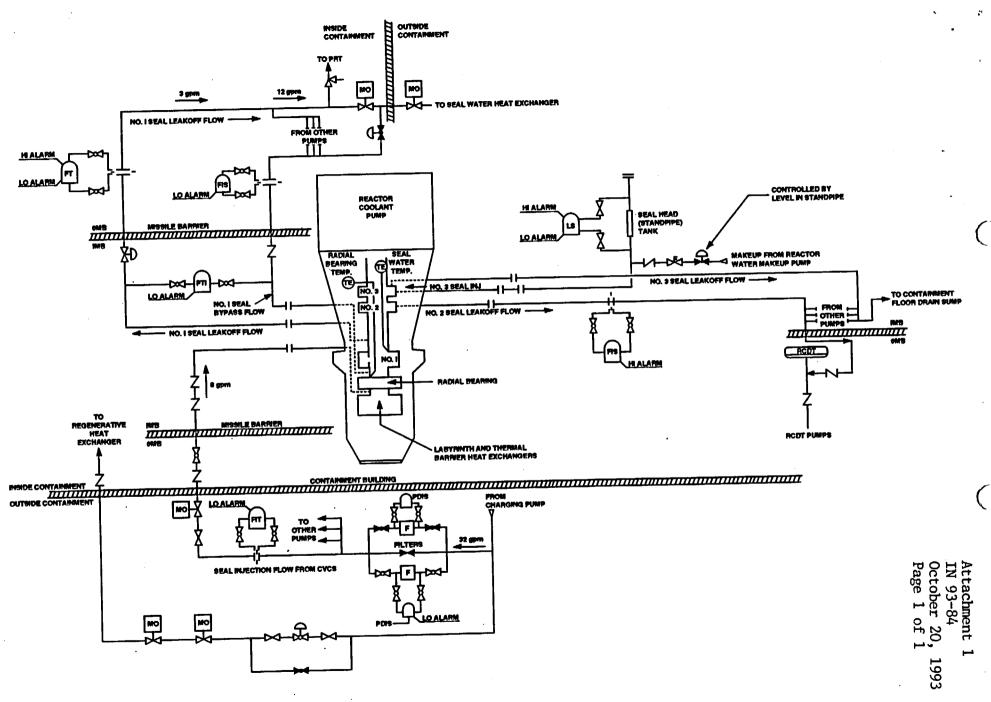
1. Simplified Braidwood Seal Water Injection and Leakoff Flow Diagram

Westinghouse supplied the Braidwood Station RCPs, incorporating a three-stage seal series arrangement to limit coolant flow up the pump shaft. The No. 1 seal, the main seal of the pump, is a controlled-leakage, film riding face seal. The No. 2 and No. 3 seals are rubbing face seals. During normal operation, an injection flow of nominally 30.3 liters [8 gallons] per minute enters the pump below the No. 1 seal (see Attachment 1). Here the flow splits. A portion (approximately 18.9 liters [5 gallons] per minute) flows down through the thermal barrier heat exchanger and enters the reactor coolant system. In this manner, the primary coolant is prevented from entering the radial bearing and seal section of the pump unit. The remainder (11.4 liters [3 gallons] per minute) (controlled leakage) passes through the pump radial bearing and enters the No. 1 seal. Above the No. 1 seal, most of the flow leaves the pump through the No. 1 seal leakoff line and returns to the chemical and volume control system. Minor flow passes through the No. 2 seal and its leakoff line to the reactor coolant drain tank. A back flush injection of 0.8 liters [0.21 gallons] per hour from a head tank flows into the No. 3 seal between its "double dam" seal area. At this point, half of the flow passes through one side of the seal and out the No. 2 seal leakoff line while the remaining flow passes through the other side and out the No. 3 seal leakoff line. This arrangement ensures essentially zero leakage of reactor coolant from the pump.

During normal operation, the No. 1 seal is subject to full reactor coolant system pressure. When the injection flow passes through the No. 1 seal, it produces a pressure drop of approximately 15.41 MPa [2235 psi]. The No. 2 seal has the capability to withstand full operating pressure, and its major function is to act as a backup in case the No. 1 seal fails. If the No. 1 seal fails, leakage through the No. 2 seal increases. The No. 2 seal high leak flow alarm actuates at 3.8 liters [1 gallon] per minute.

The inadequacies in the operating procedure stem from the limitations of the instrumentation used to monitor the leakage. The relevant No. 1 seal instrumentation limits maximum readings to 22.7 liters [6 gallons] per minute. Although the No. 2 seal high leak flow alarm was set at 3.8 liters [1 gallon] per minute, very high No. 1 seal leak rates, more than 113.6 liters [30 gallons] per minute, are needed for the No. 2 seal to reach this flow rate. Thus, the No. 1 seal could have substantial leakage (e.g., 22.7-113.6 liters [6-30 gallons] per minute) even though the No. 2 seal high leak flow alarm was not actuated. In the mean time, the RCP seal system might be severely damaged if loss of injection were to occur or the No. 1 seal leak rates were more than 30.3 liters [8 gallons] per minute. Therefore, monitoring for high No. 2 seal leakage is not a reliable method of determining whether the No. 1 seal has failed.
