UNITED STATES
NUCLEAR REGULATORY COMMISSION
OFFICE OF NUCLEAR REACTOR REGULATION
WASHINGTON, D.C. 20555

July 9, 1993

NRC INFORMATION NOTICE 93-51: REPETITIVE OVERSPEED TRIPPING OF TURBINE-DRIVEN
AUXILIARY FEEDWATER PUMPS

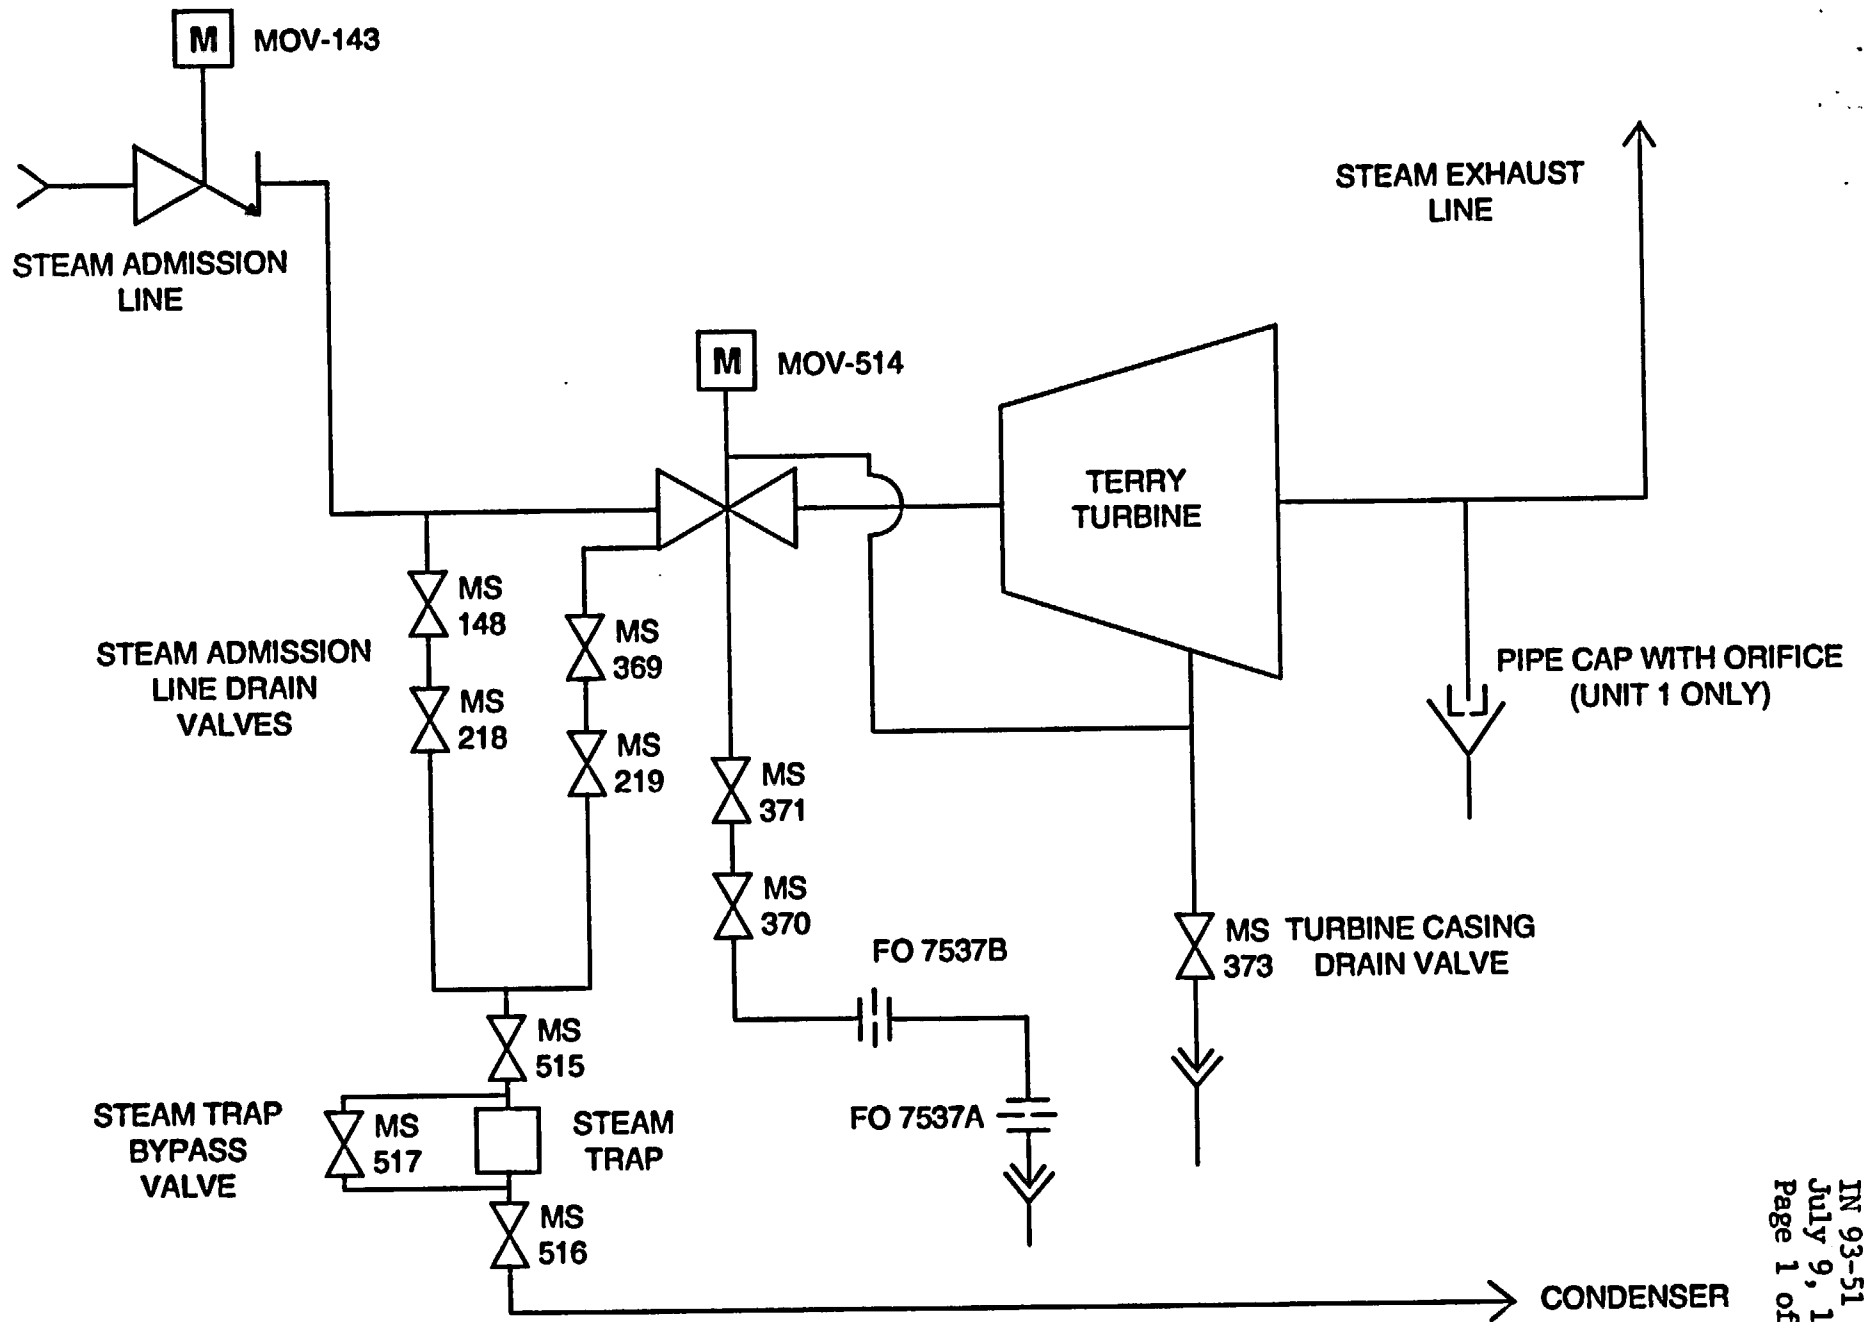
FIGURE 1
TDAFWP STEAM SUPPLY AND EXHAUST SYSTEM (UNMODIFIED)

The licensee determined that the root cause of the February 3, 1993, Unit 2 TDAFWP overspeed trip was an incorrect valve lineup in conjunction with an inoperable or degraded steam trap. The valves and the steam trap are located in the drain line from the steam admission line. (See Figure 1.) The TDAFWP overspeed trip was caused by excessive condensate buildup in the steam supply line upstream of the trip/throttle valve (MOV-514 in Figure 1). The excessive condensate had accumulated because the steam trap bypass valve, MS-517, was incorrectly positioned (closed) and the steam trap had degraded to such an extent that it was no longer capable of passing condensate to the condenser.
