UNITED STATES  
NUCLEAR REGULATORY COMMISSION  
OFFICE OF NUCLEAR REACTOR REGULATION  
WASHINGTON, D.C. 20555

June 9, 1993

NRC INFORMATION NOTICE 93-42: FAILURE OF ANTI-ROTATION KEYS IN MOTOR-OPERATED VALVES MANUFACTURED BY VELAN

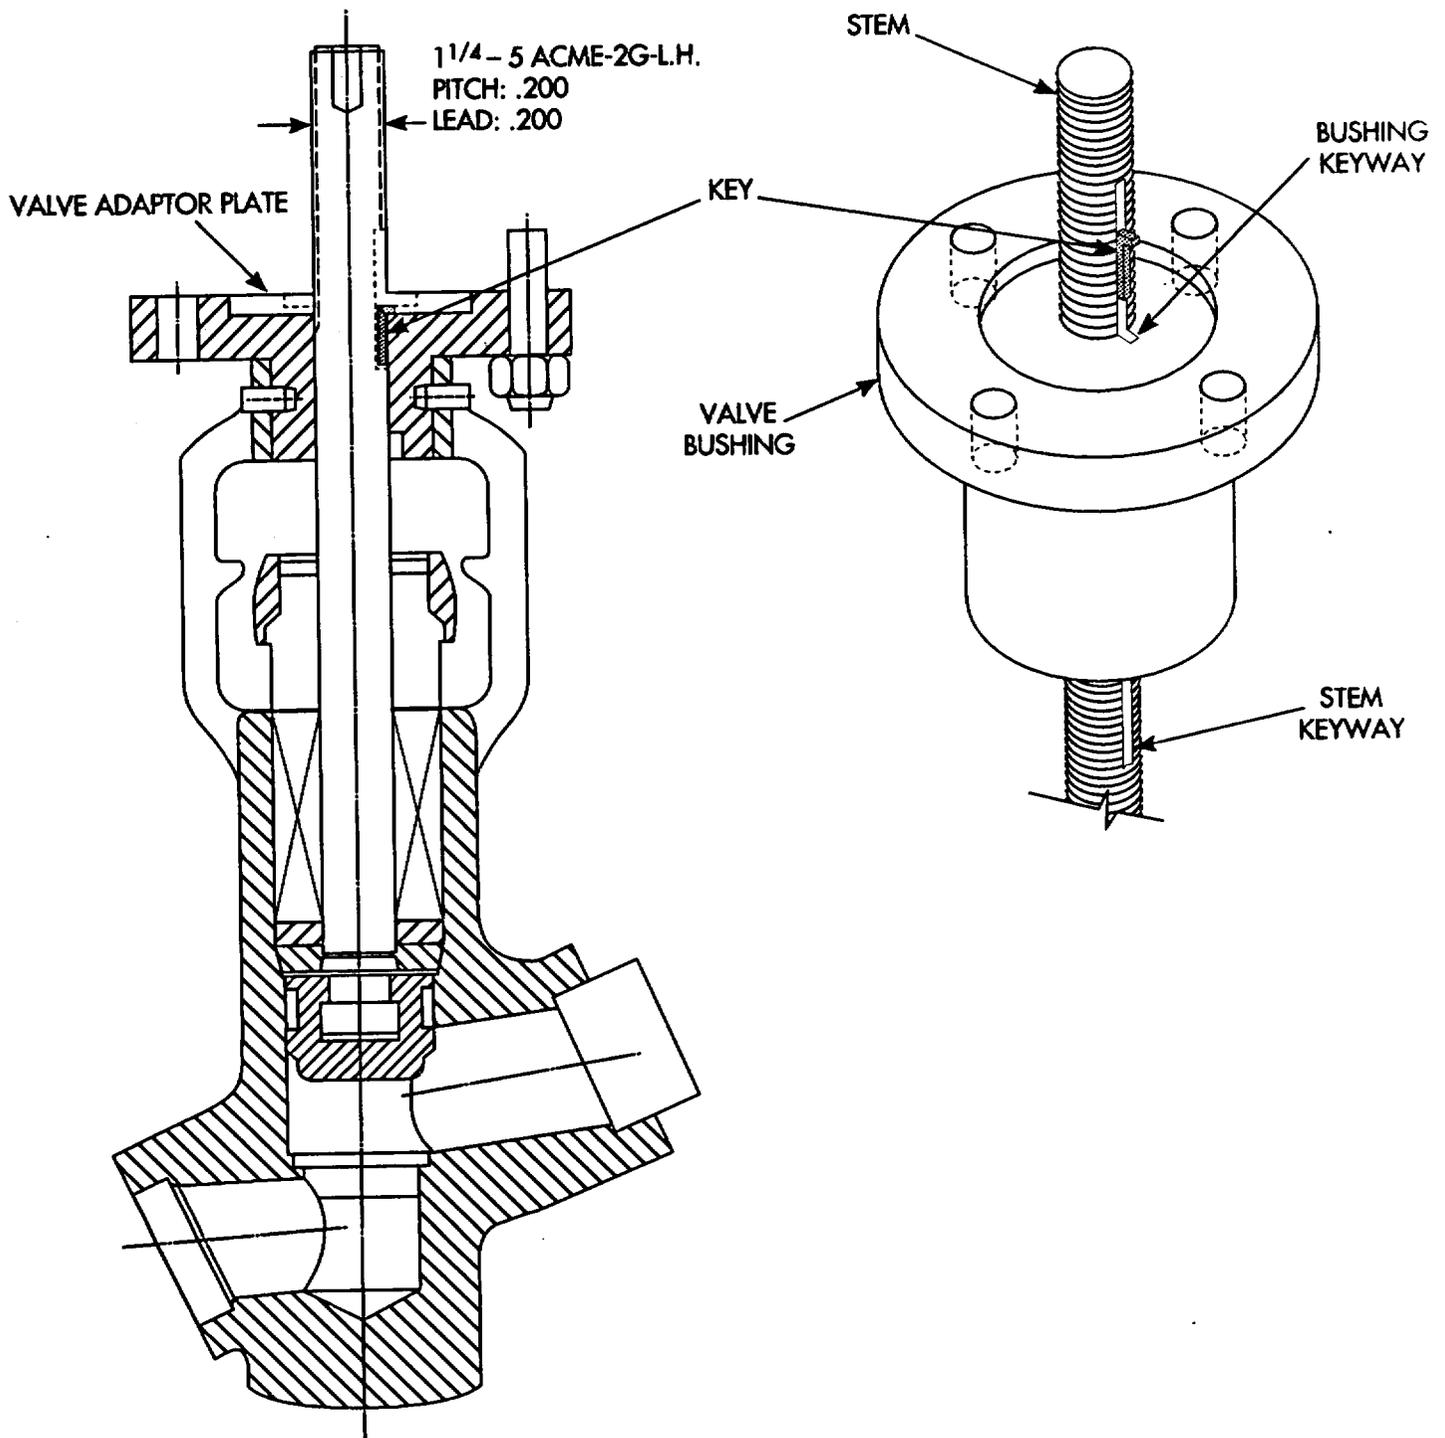
# VELAN VALVE AND ANTI-ROTATION KEY

On March 28, 1993, Wisconsin Public Service Corporation, the licensee for Kewaunee Nuclear Power Plant, reported that during motor-operated valve (MOV) dynamic testing on March 27, 1993, one of two redundant safety injection recirculation valves to the refueling water storage tank failed to close completely. Investigation revealed that the anti-rotation device, an L-shaped key between the valve stem and the yoke bushing (Attachment 1), had broken. The shorter part of the broken L-shaped key had apparently worked its way toward the valve stem and had jammed the valve stem, preventing closing. The valve that failed was a 2-inch bonnetless globe valve manufactured by Velan Valve Corp. The licensee inspected all nine similar motor-operated valves and found that six had broken anti-rotation keys. The inspections were visual and did not require disassembly of the motor-operated valve. Failures usually can be observed on normally closed valves, since the broken long leg of the L-shaped key slides down partially and becomes visible below the yoke bushing.

According to the licensee, the keys failed in a brittle manner. The fractures began on either side of the key at the sharp radius of the inside corner of the L-shaped key and propagated into the body of the key. Machining of the sharp inside corner of the L-shaped key may have contributed to the failure of the anti-rotation keys by producing high stresses in the corner of the keys. It is likely that the rotational action of the valve stem impacted on both sides of the key, exceeding the impact strength of the material at the sharp radius of the key.

Based on the incident at Kewaunee Nuclear Plant we recommend that keys be inspected for possible wear which could result in failure. Consideration should also be given to replacing keys at your earliest possible convenience with new keys. These new keys are supplied in material meeting AISI 4140. This material replaces the 440C grade which several project drawings call up.
