UNITED STATES
NUCLEAR REGULATORY COMMISSION
OFFICE OF NUCLEAR REACTOR REGULATION
WASHINGTON, D.C. 20555

NRC INFORMATION NOTICE 93-42: FAILURE OF ANTI-ROTATION KEYS IN MOTOR-OPERATED VALVES MANUFACTURED BY VELAN

- SERVICE BULLETIN -	#SB-106

SUBJECT: GLOBE VALVE STEM ANTIROTATION KEY

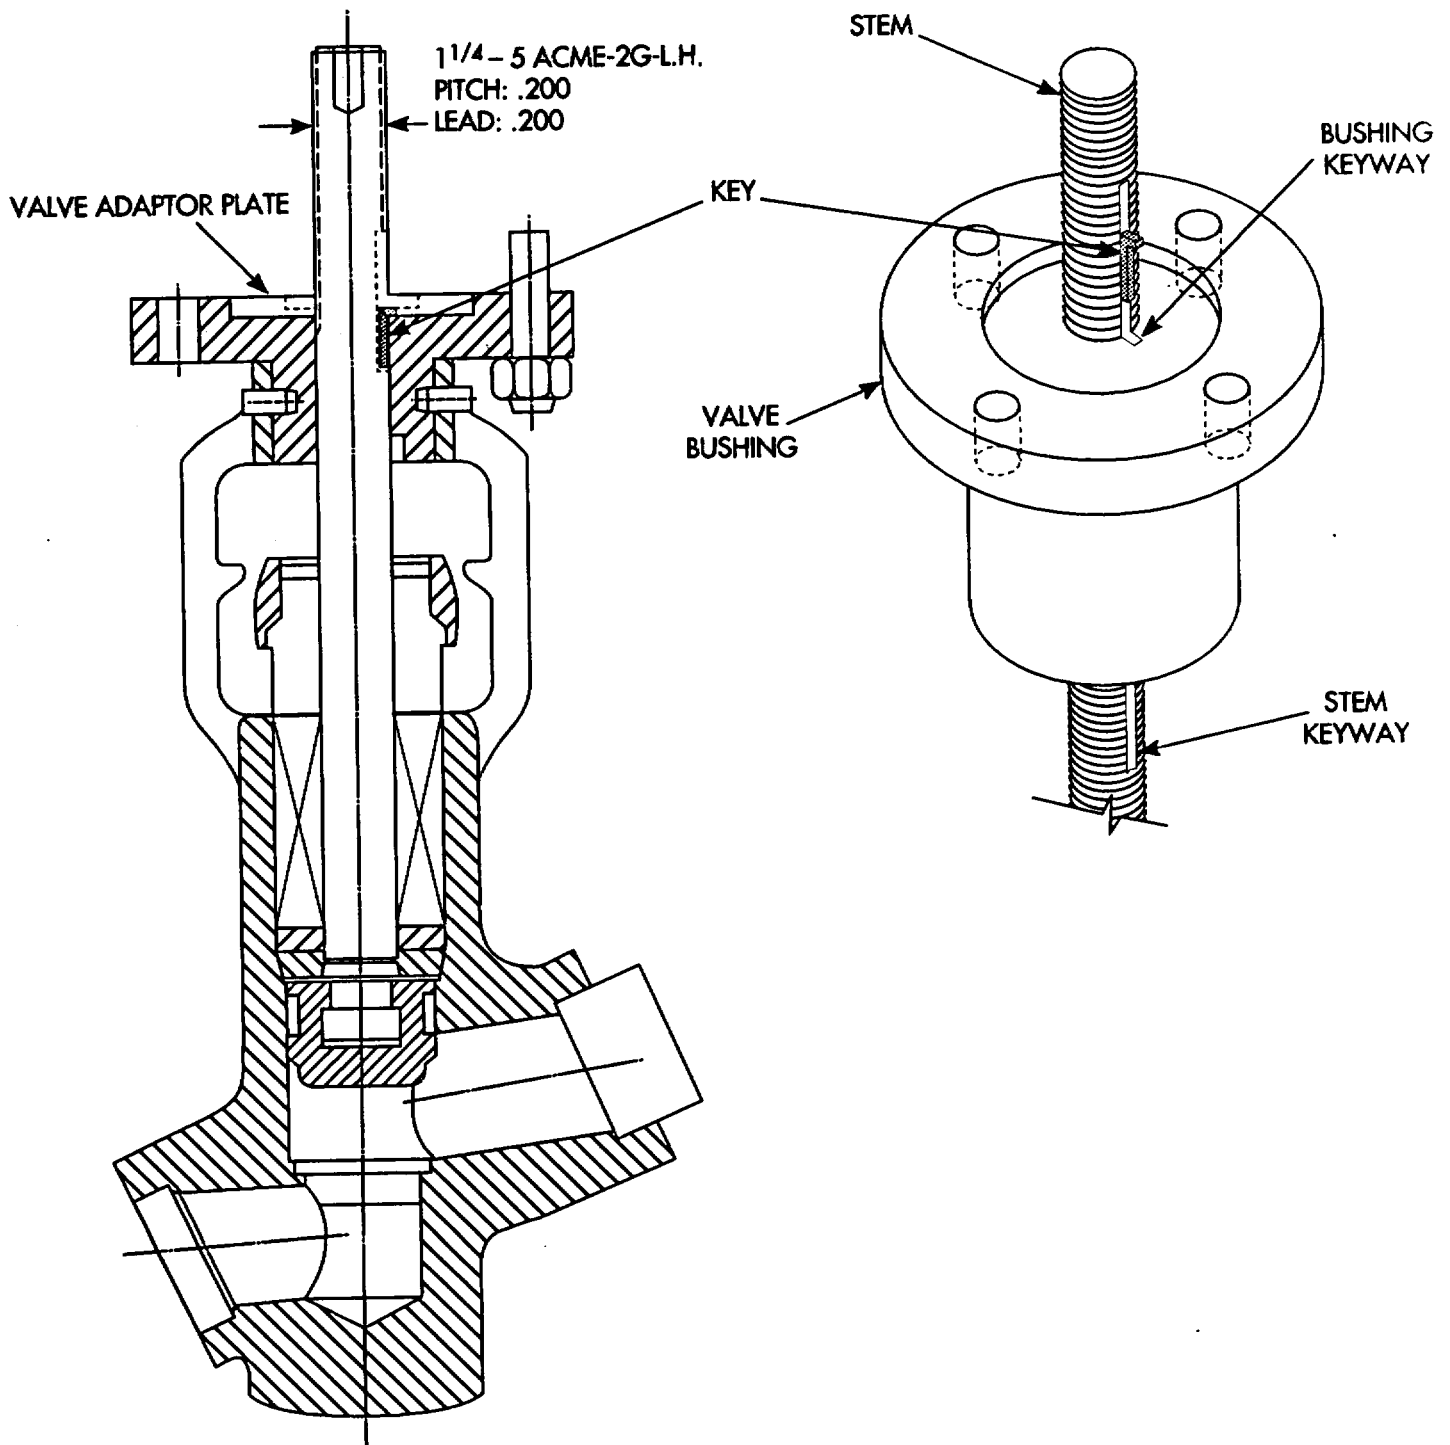
VELAN VALVE AND ANTI-ROTATION KEY

On March 28, 1993, Wisconsin Public Service Corporation, the licensee for Kewaunee Nuclear Power Plant, reported that during motor-operated valve (MOV) dynamic testing on March 27, 1993, one of two redundant safety injection recirculation valves to the refueling water storage tank failed to close completely. Investigation revealed that the anti-rotation device, an L-shaped key between the valve stem and the yoke bushing (Attachment 1), had broken. The shorter part of the broken L-shaped key had apparently worked its way toward the valve stem and had jammed the valve stem, preventing closing. The valve that failed was a 2-inch bonnetless globe valve manufactured by Velan Valve Corp. The licensee inspected all nine similar motor-operated valves and found that six had broken anti-rotation keys. The inspections were visual and did not require disassembly of the motor-operated valve. Failures usually can be observed on normally closed valves, since the broken long leg of the L-shaped key slides down partially and becomes visible below the yoke bushing.

According to the licensee, the keys failed in a brittle manner. The fractures began on either side of the key at the sharp radius of the inside corner of the L-shaped key and propagated into the body of the key. Machining of the sharp inside corner of the L-shaped key may have contributed to the failure of the anti-rotation keys by producing high stresses in the corner of the keys. It is likely that the rotational action of the valve stem impacted on both sides of the key, exceeding the impact strength of the material at the sharp radius of the key.

Based on the incident at Kewaunee Nuclear Plant we recommend that keys be inspected for possible wear which could result in failure. Consideration should also be given to replacing keys at your earliest possible convenience with new keys. These new keys are supplied in material meeting AISI 4140. This material replaces the 440C grade which several project drawings call up.
