UNITED STATES
NUCLEAR REGULATORY COMMISSION
OFFICE OF NUCLEAR REACTOR REGULATION
WASHINGTON, D.C. 20555

April 9, 1993

NRC INFORMATION NOTICE 93-28: FAILURE TO CONSIDER LOSS OF DC BUS IN THE EMERGENCY CORE COOLING SYSTEM EVALUATION MAY LEAD TO NONCONSERVATIVE ANALYSIS

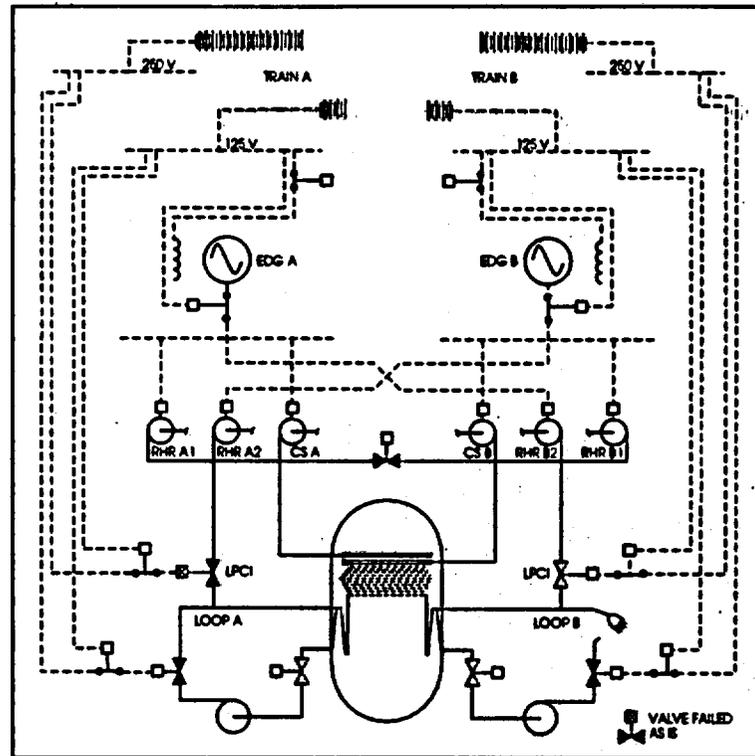
In the previous ECCS analysis, as shown in Figure 1, the licensee assumed a guillotine break in one recirculation loop and failure of the LPCI injection valve for the other recirculation loop. If this event were to occur, coolant from RHR pumps B1 and B2 would not reach the reactor vessel because the coolant would flow out through the broken recirculation loop, and RHR pumps A1 and A2 would not pump coolant to the reactor vessel because of the failure of the LPCI injection valve to open. However, it was concluded that both core spray pumps would pump coolant to the reactor vessel and the temperature of fuel cladding would increase but remain less than the regulatory limit.

Figure 1: Low pressure ECCS trains showing break in recirculation loop B with loss of offsite power and failure of the 'A' LPCI injection valve.

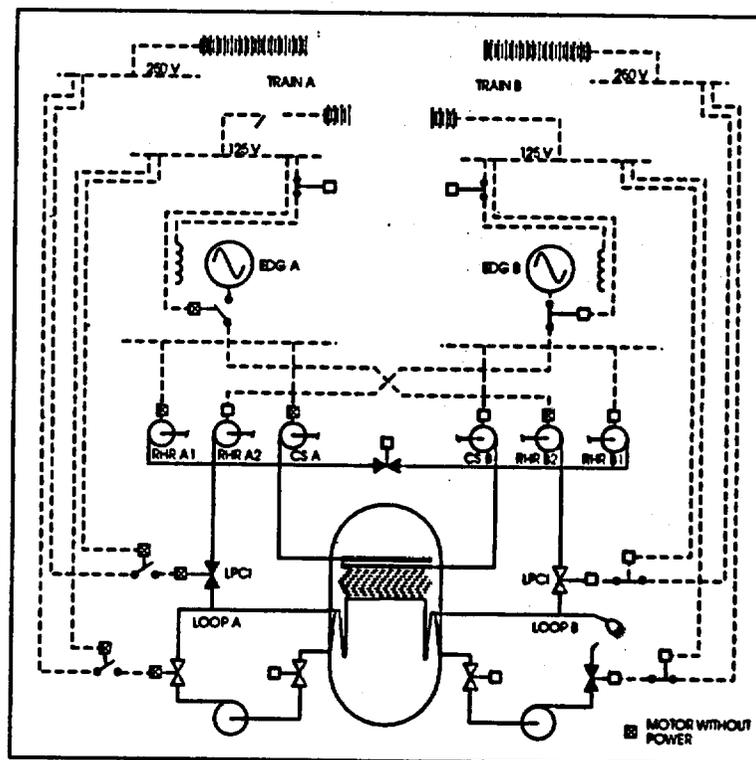
The licensee has now determined that the worst single failure would be the failure of one of the two 125-Vdc buses. As shown in Figure 2, failure of the 125-Vdc bus for train A would prevent closure of the output breaker for EDG A. Motors for RHR pumps A1 and B2 and core spray pump A would not receive emergency power and would not supply coolant to the reactor vessel. Likewise, the LPCI injection valve for recirculation loop A would fail to open and RHR pump A2, which receives power from EDG B, would be unable to pump coolant to the reactor vessel. If the break were in recirculation loop B, then RHR pump B1 would pump coolant to the broken loop, leaving only core spray pump B to pump coolant to the reactor vessel, which is insufficient to perform the intended ECCS function. To avoid the possibility that the temperature of the fuel cladding might exceed the regulatory limit, the licensee reduced the reactor power level pending completion of modifications to correct the problem. The licensee took this action based on analyses by the General Electric Company.

Figure 2: Break in recirculation loop B with loss of offsite power and one 125-Vdc bus.

Although the combined probability of occurrence of a guillotine rupture, loss of offsite power, and failure of the 125-Vdc bus for the ECCS train serving the intact recirculation loop is very low, the licensee has modified the control power for the LPCI injection valves and recirculation pump discharge valves so that they are powered from the 250-Vdc buses, while leaving the 125-Vdc control power for the EDG output breakers unchanged.
