UNITED STATES
NUCLEAR REGULATORY COMMISSION
OFFICE OF NUCLEAR REACTOR REGULATION
WASHINGTON, D.C. 20555

NRC INFORMATION NOTICE 93-28: FAILURE TO CONSIDER LOSS OF DC BUS IN THE EMERGENCY CORE COOLING SYSTEM EVALUATION MAY LEAD TO NONCONSERVATIVE ANALYSIS

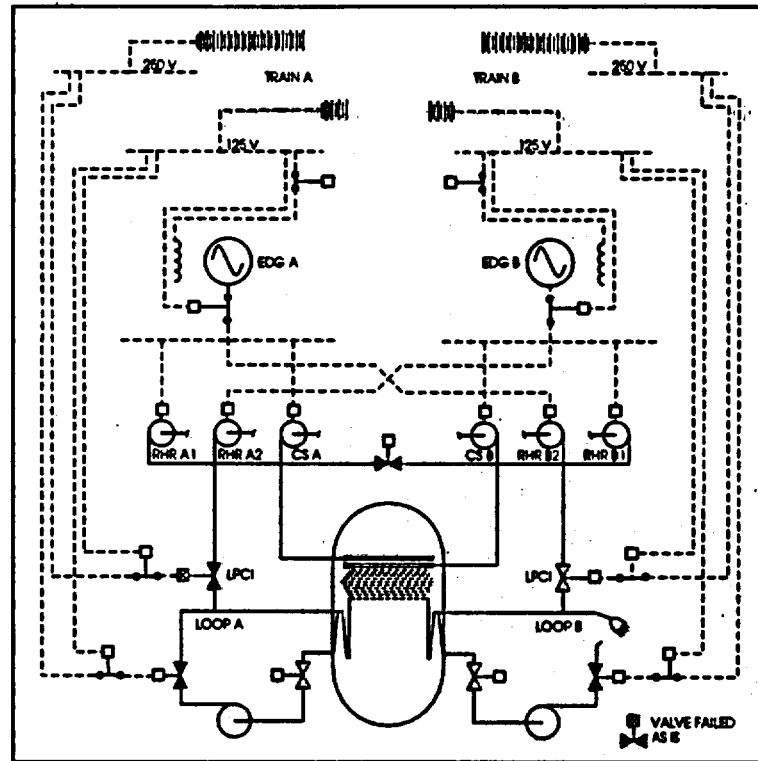
In the previous ECCS analysis, as shown in Figure 1, the licensee assumed a guillotine break in one recirculation loop and failure of the LPCI injection valve for the other recirculation loop. If this event were to occur, coolant from RHR pumps B1 and B2 would not reach the reactor vessel because the coolant would flow out through the broken recirculation loop, and RHR pumps A1 and A2 would not pump coolant to the reactor vessel because of the failure of the LPCI injection valve to open. However, it was concluded that both core spray pumps would pump coolant to the reactor vessel and the temperature of fuel cladding would increase but remain less than the regulatory limit.

Figure 1: Low pressure ECCS trains showing break in recirculation loop B with loss of offsite power and failure of the 'A' LPCI injection valve.

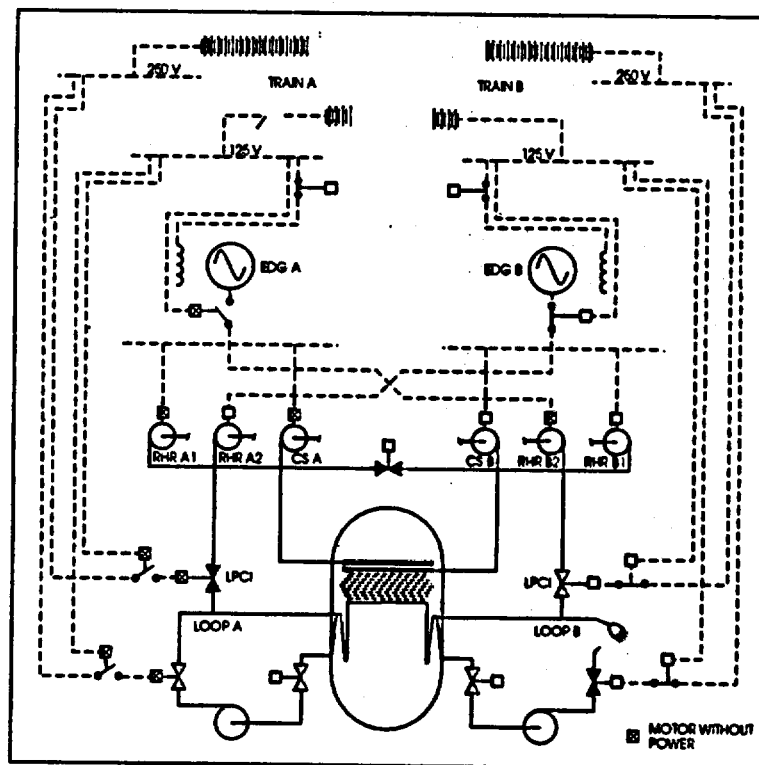
The licensee has now determined that the worst single failure would be the failure of one of the two 125-Vdc buses. As shown in Figure 2, failure of the 125-Vdc bus for train A would prevent closure of the output breaker for EDG A. Motors for RHR pumps A1 and B2 and core spray pump A would not receive emergency power and would not supply coolant to the reactor vessel. Likewise, the LPCI injection valve for recirculation loop A would fail to open and RHR pump A2, which receives power from EDG B, would be unable to pump coolant to the reactor vessel. If the break were in recirculation loop B, then RHR pump B1 would pump coolant to the broken loop, leaving only core spray pump B to pump coolant to the reactor vessel, which is insufficient to perform the intended ECCS function. To avoid the possibility that the temperature of the fuel cladding might exceed the regulatory limit, the licensee reduced the reactor power level pending completion of modifications to correct the problem. The licensee took this action based on analyses by the General Electric Company.

Figure 2: Break in recirculation loop B with loss of offsite power and one 125-Vdc bus.

Although the combined probability of occurrence of a guillotine rupture, loss of offsite power, and failure of the 125-Vdc bus for the ECCS train serving the intact recirculation loop is very low, the licensee has modified the control power for the LPCI injection valves and recirculation pump discharge valves so that they are powered from the 250-Vdc buses, while leaving the 125-Vdc control power for the EDG output breakers unchanged.
