UNITED STATES
NUCLEAR REGULATORY COMMISSION
OFFICE OF NUCLEAR REACTOR REGULATION
WASHINGTON, D.C. 20555

May 25, 1993

NRC INFORMATION NOTICE 93-39: RADIATION BEAMS FROM POWER REACTOR
BIOLOGICAL SHIELDS

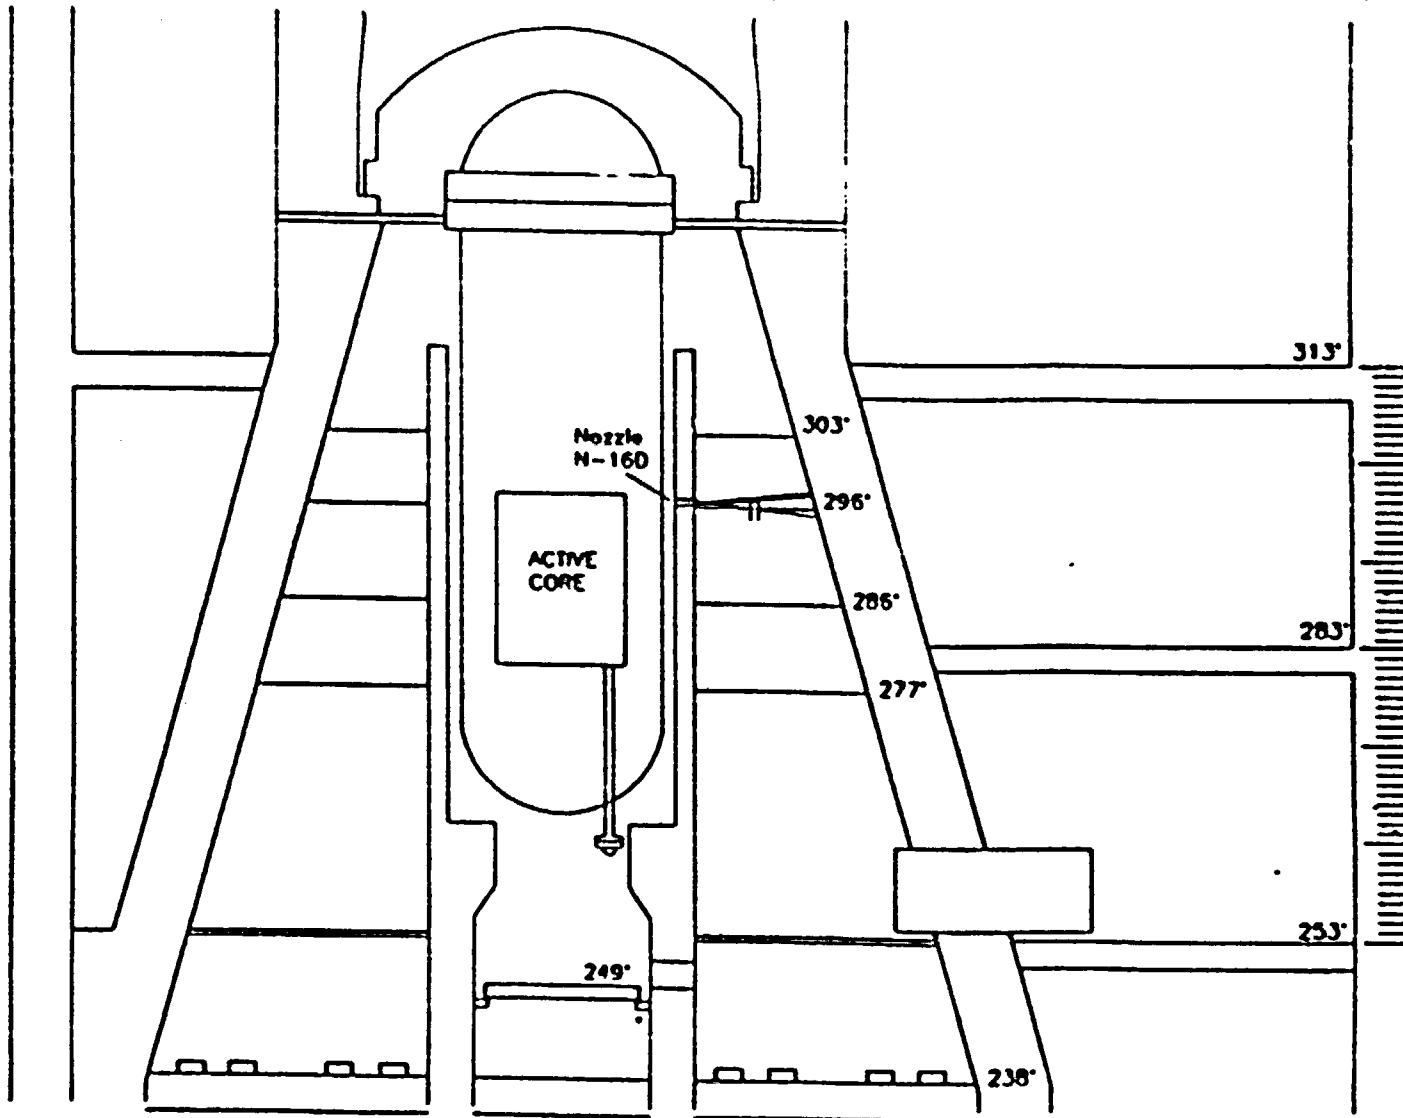
Figure 1: Limerick Generating Station Unit 1 Drywell

During startup of the Philadelphia Electric Company (the licensee) Limerick Generating Station, Unit 1, on July 7, 1992, operators could not properly operate a main steamline sample-flow isolation valve (HV-041-1F084) from the control room. Members of the licensee Operations Group determined that the valve was an inboard primary containment isolation valve and generated an action request to troubleshoot the valve. The valve is on the 303-foot elevation of the drywell (at an azimuth of 280 degrees). The electrical junction box for the valve is on the 296-foot elevation at about the same azimuth in the drywell and is directly across from the reactor water-level instrument-line penetration in the biological shield.

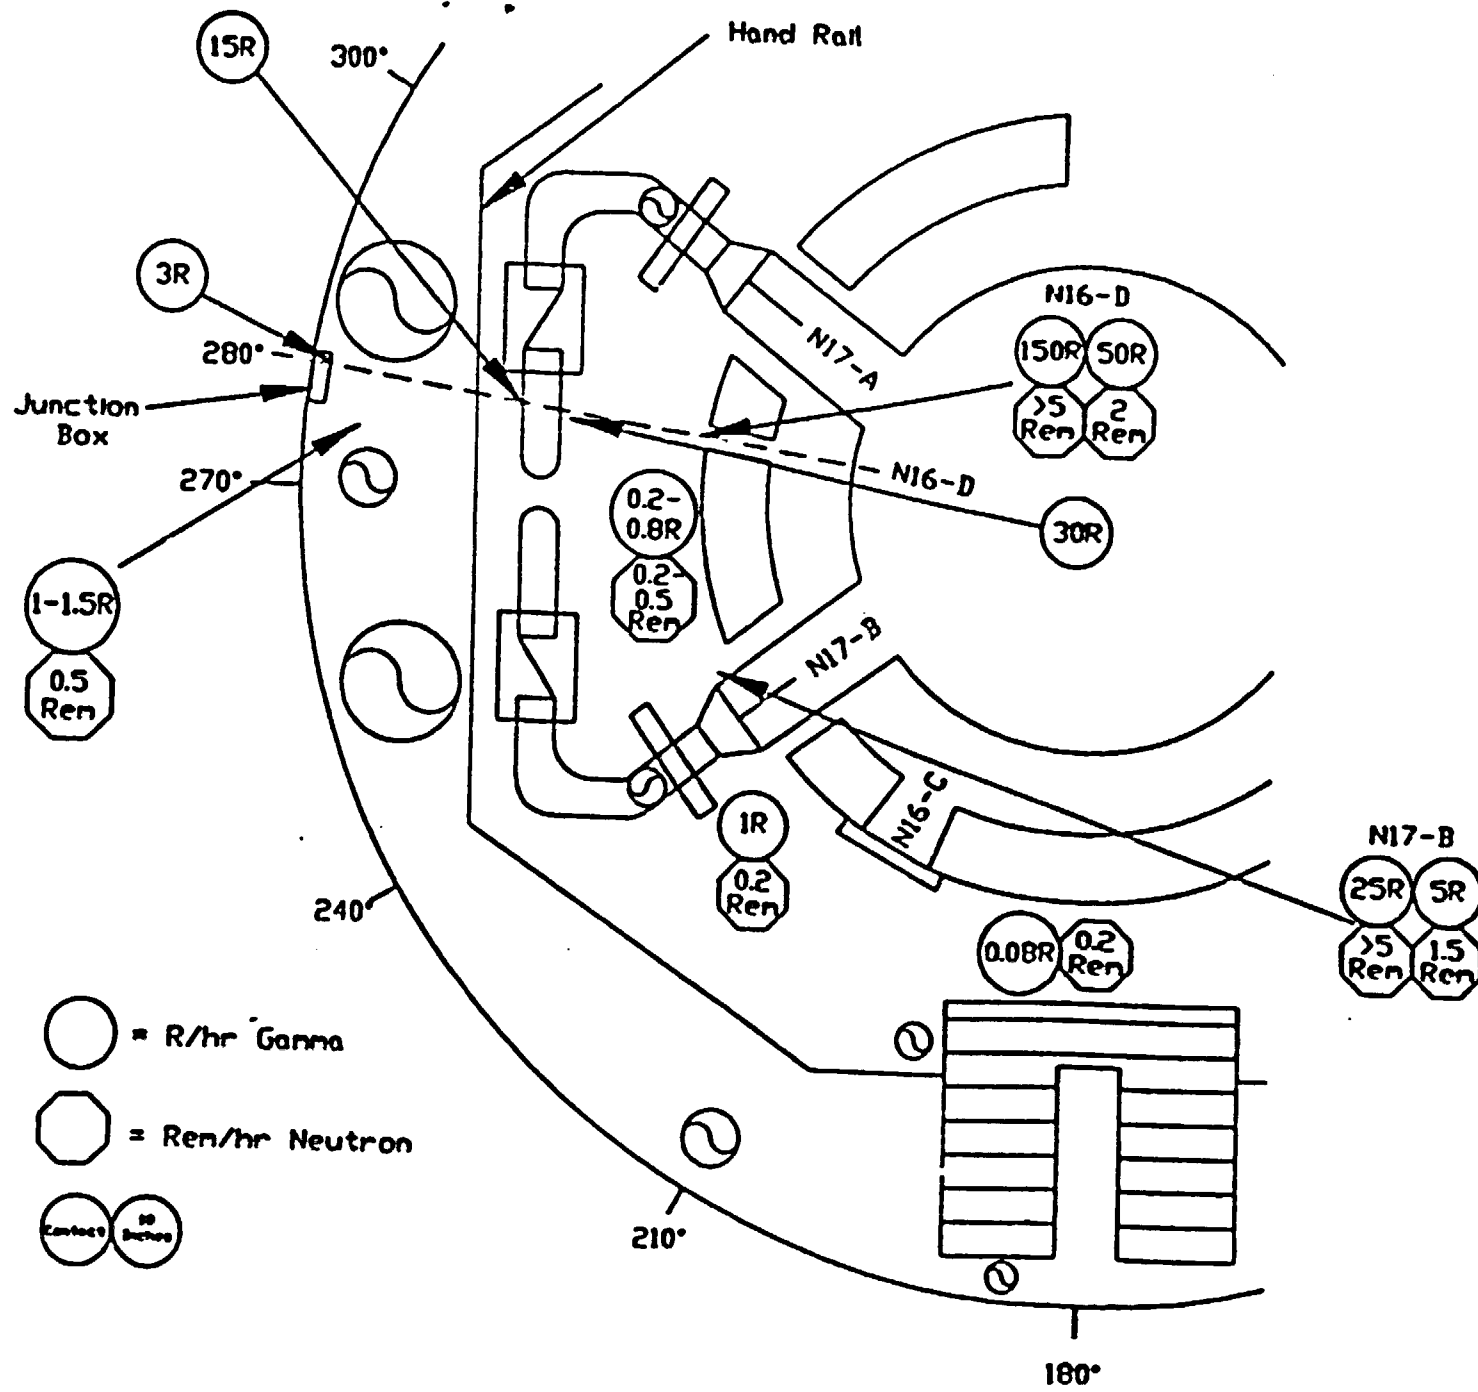
Figure 2: Limerick Generating Station Unit 1 Drywell
296' Elevation Survey Data

During the fifth entry, on July 9, 1992, the work crew, accompanied by a radiological controls technician, entered the 296-foot elevation and worked in sight of penetration N16-D. While working, one worker's dosimeter alarmed; apparently, the beam struck the dosimeter. The RCT conducted a radiation survey, detected the beam, and immediately evacuated the work area.

The licensee detailed survey found, at the extremity of the work area, radiation levels of about 30 mSv per hour [3 rem per hour] (gamma); and, at the point where the beam emerged from the penetration, levels of about 1500 mSv per hour [150 rem per hour] (gamma) and greater than 50 mSv per hour [5 rem per hour] (neutron). Radiation dose rates in the work area, readily accessible to personnel, and attributable to the beam, ranged from about 30 to about 250 mSv per hour [about 3 to about 25 rem per hour] (gamma) while the maximum general area radiation dose rates were 10 mSv per hour [1 rem per hour] (gamma) and 5 mSv per hour [500 millirem per hour] (neutron). These last maximum general area dose rates were used as the basis for radiation work permit requirements for work in the area. Figures 1, 2, and 3 show the location of the penetration, the approximate path of the beam, and the work location on the 296-foot elevation of the Unit 1 drywell. After the licensee detected the beam and reviewed the situation, a sixth work crew entered the 296-foot elevation to restore electrical connections to the isolation valve while remaining out of the path of the beam.

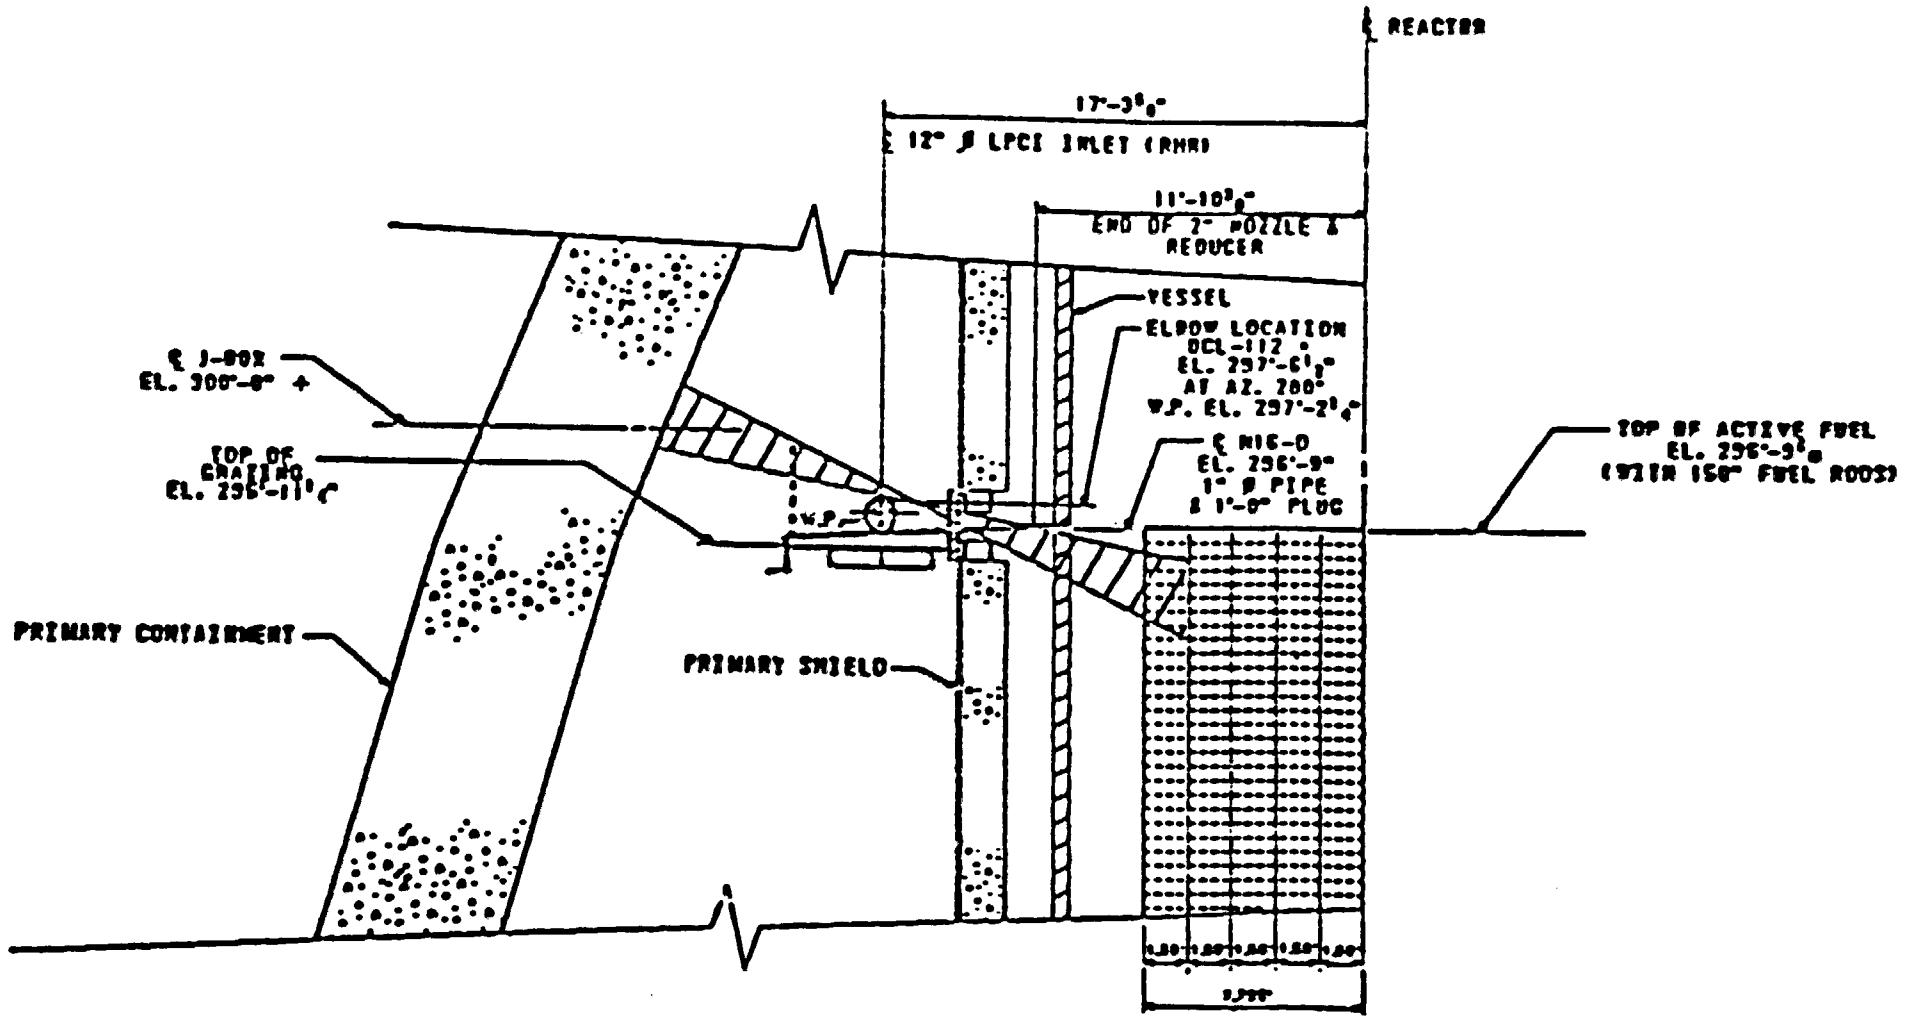
Figure 3: Limerick Generating Station Unit 1 Drywell
Section Along Azimuth 280°

7. Had the ISEG evaluate the event during which it found that:
 - the beam should have been anticipated,
 - the beam probably resulted from the unique geometric arrangement of the low-pressure coolant injection (LPCI) piping, the shield penetration, and the core peak axial power location, and that

- moving the rods downward to increase reactor power caused the location of peak axial power to move downward in the core, increasing the angle of the beam upward and causing the beam to pass over the top of a LPCI line, located in front of the penetration, and into the work area (see Figure 3). (Although operators changed the reactor power level between entries, power level changes were controlled so that no changes occurred while personnel were in the drywell.)

11. The licensee planned to complete the following long-term corrective actions:
 - Prepare a special procedure for drywell entries at power.
 - Require a higher level of station management approval for work in the drywell at power.

- Improve shielding, access control, or both, for high-radiation areas resulting from radiation beams.
 - Include review of this event in the training of health physics, operations, and radiation workers.
