UNITED STATES
NUCLEAR REGULATORY COMMISSION
OFFICE OF NUCLEAR REACTOR REGULATION
WASHINGTON, D.C. 20555

May 25, 1993

NRC INFORMATION NOTICE 93-39: RADIATION BEAMS FROM POWER REACTOR
BIOLOGICAL SHIELDS

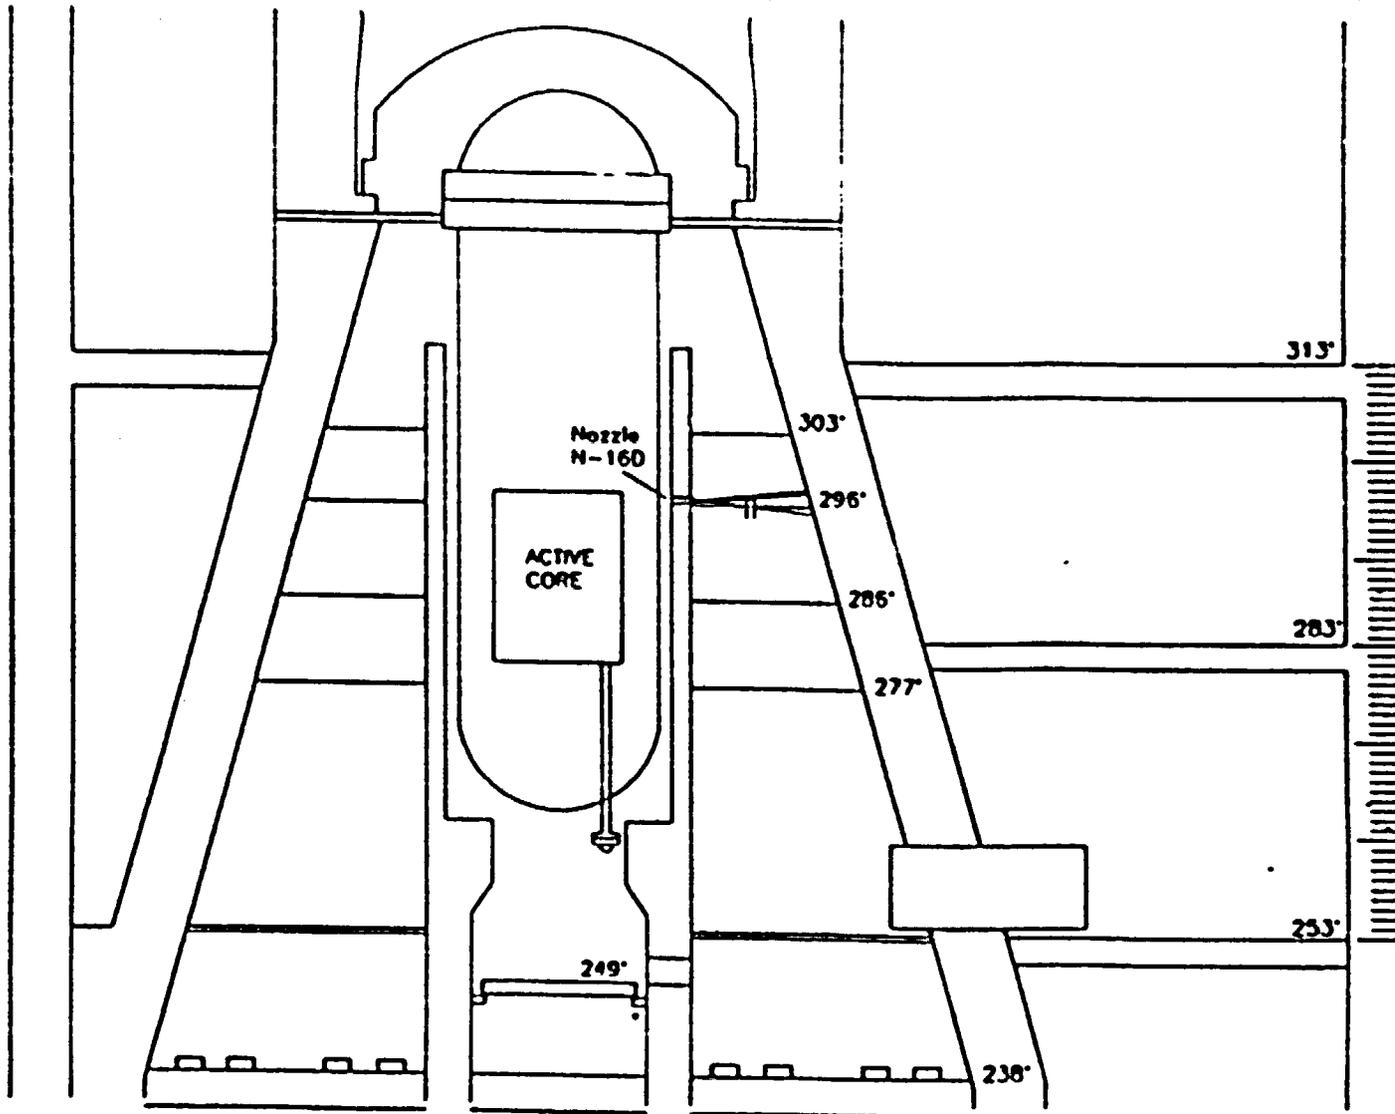
Figure 1: Limerick Generating Station Unit 1 Drywell

During startup of the Philadelphia Electric Company (the licensee) Limerick Generating Station, Unit 1, on July 7, 1992, operators could not properly operate a main steamline sample-flow isolation valve (HV-041-1F084) from the control room. Members of the licensee Operations Group determined that the valve was an inboard primary containment isolation valve and generated an action request to troubleshoot the valve. The valve is on the 303-foot elevation of the drywell (at an azimuth of 280 degrees). The electrical junction box for the valve is on the 296-foot elevation at about the same azimuth in the drywell and is directly across from the reactor water-level instrument-line penetration in the biological shield.

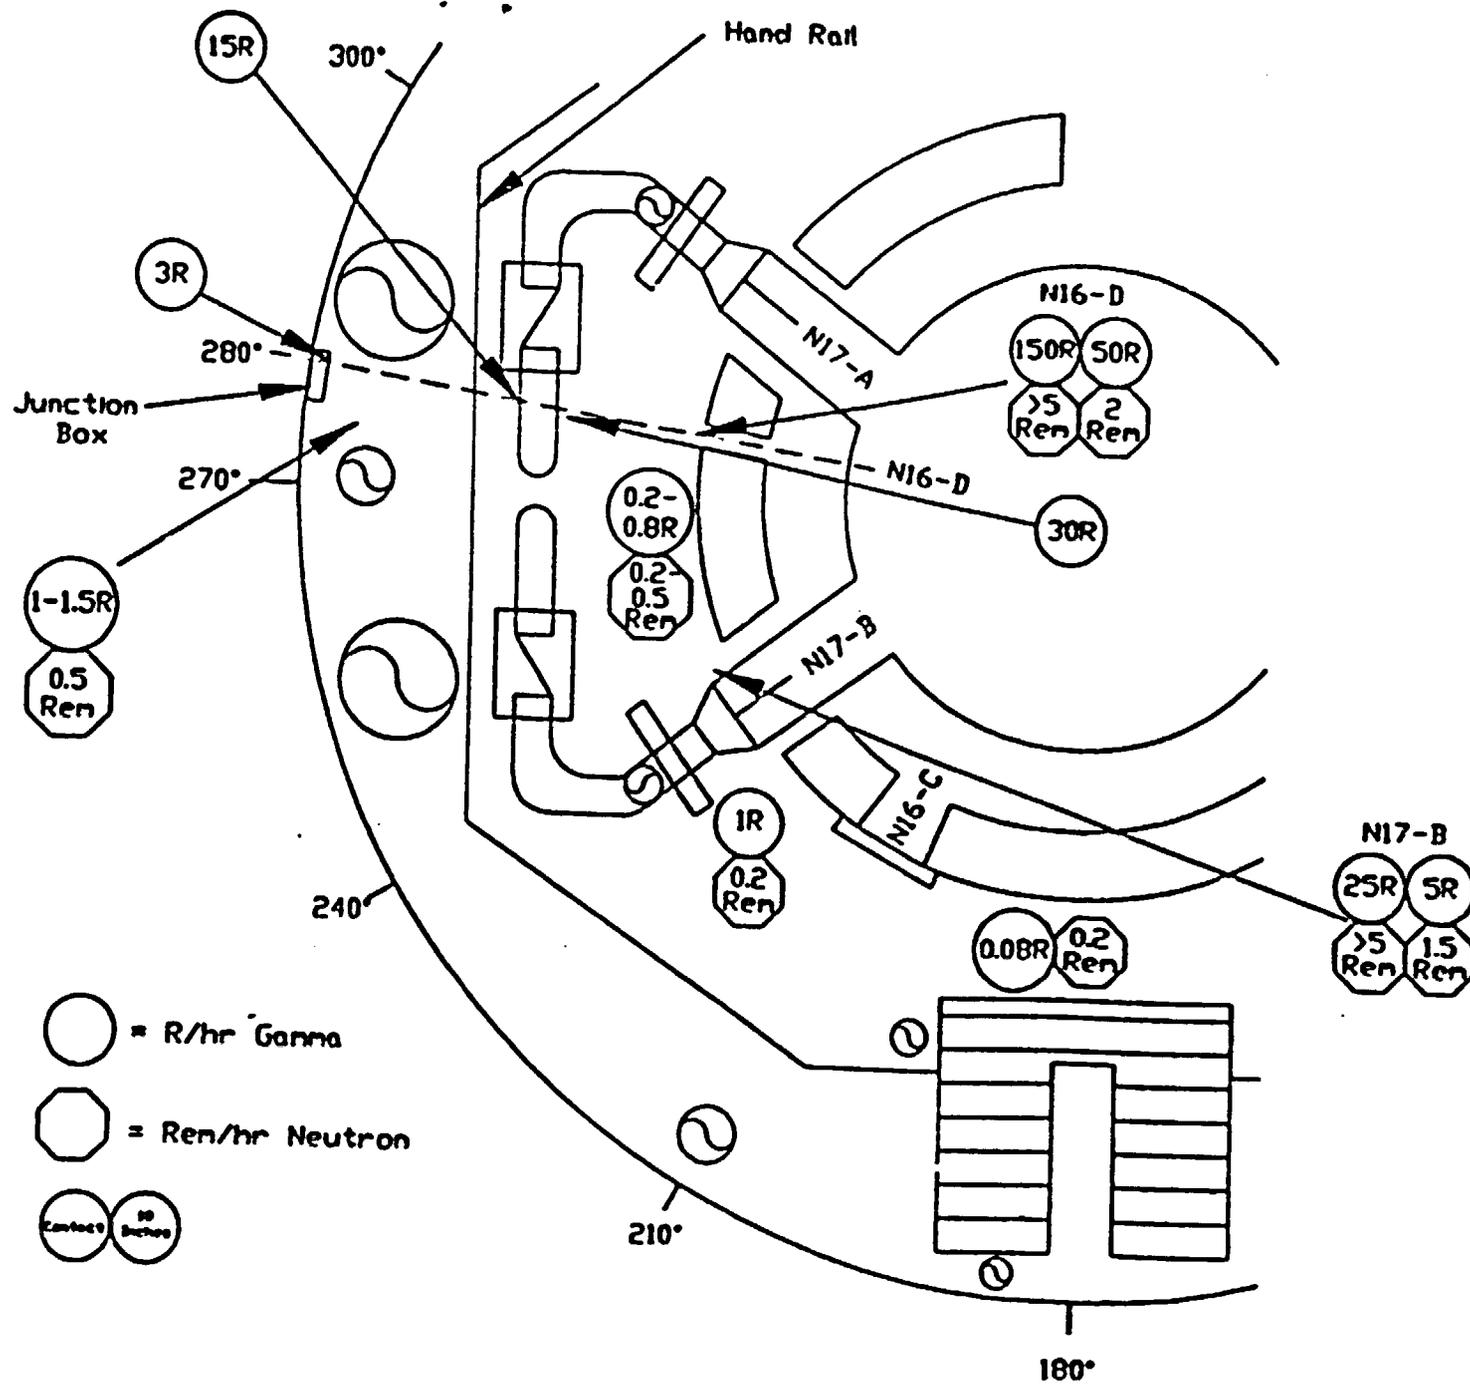
Figure 2: Limerick Generating Station Unit 1 Drywell
 296' Elevation Survey Data

During the fifth entry, on July 9, 1992, the work crew, accompanied by a radiological controls technician, entered the 296-foot elevation and worked in sight of penetration N16-D. While working, one worker's dosimeter alarmed; apparently, the beam struck the dosimeter. The RCT conducted a radiation survey, detected the beam, and immediately evacuated the work area.

The licensee detailed survey found, at the extremity of the work area, radiation levels of about 30 mSv per hour [3 rem per hour] (gamma); and, at the point where the beam emerged from the penetration, levels of about 1500 mSv per hour [150 rem per hour] (gamma) and greater than 50 mSv per hour [5 rem per hour] (neutron). Radiation dose rates in the work area, readily accessible to personnel, and attributable to the beam, ranged from about 30 to about 250 mSv per hour [about 3 to about 25 rem per hour] (gamma) while the maximum general area radiation dose rates were 10 mSv per hour [1 rem per hour] (gamma) and 5 mSv per hour [500 millirem per hour] (neutron). These last maximum general area dose rates were used as the basis for radiation work permit requirements for work in the area. Figures 1, 2, and 3 show the location of the penetration, the approximate path of the beam, and the work location on the 296-foot elevation of the Unit 1 drywell. After the licensee detected the beam and reviewed the situation, a sixth work crew entered the 296-foot elevation to restore electrical connections to the isolation valve while remaining out of the path of the beam.

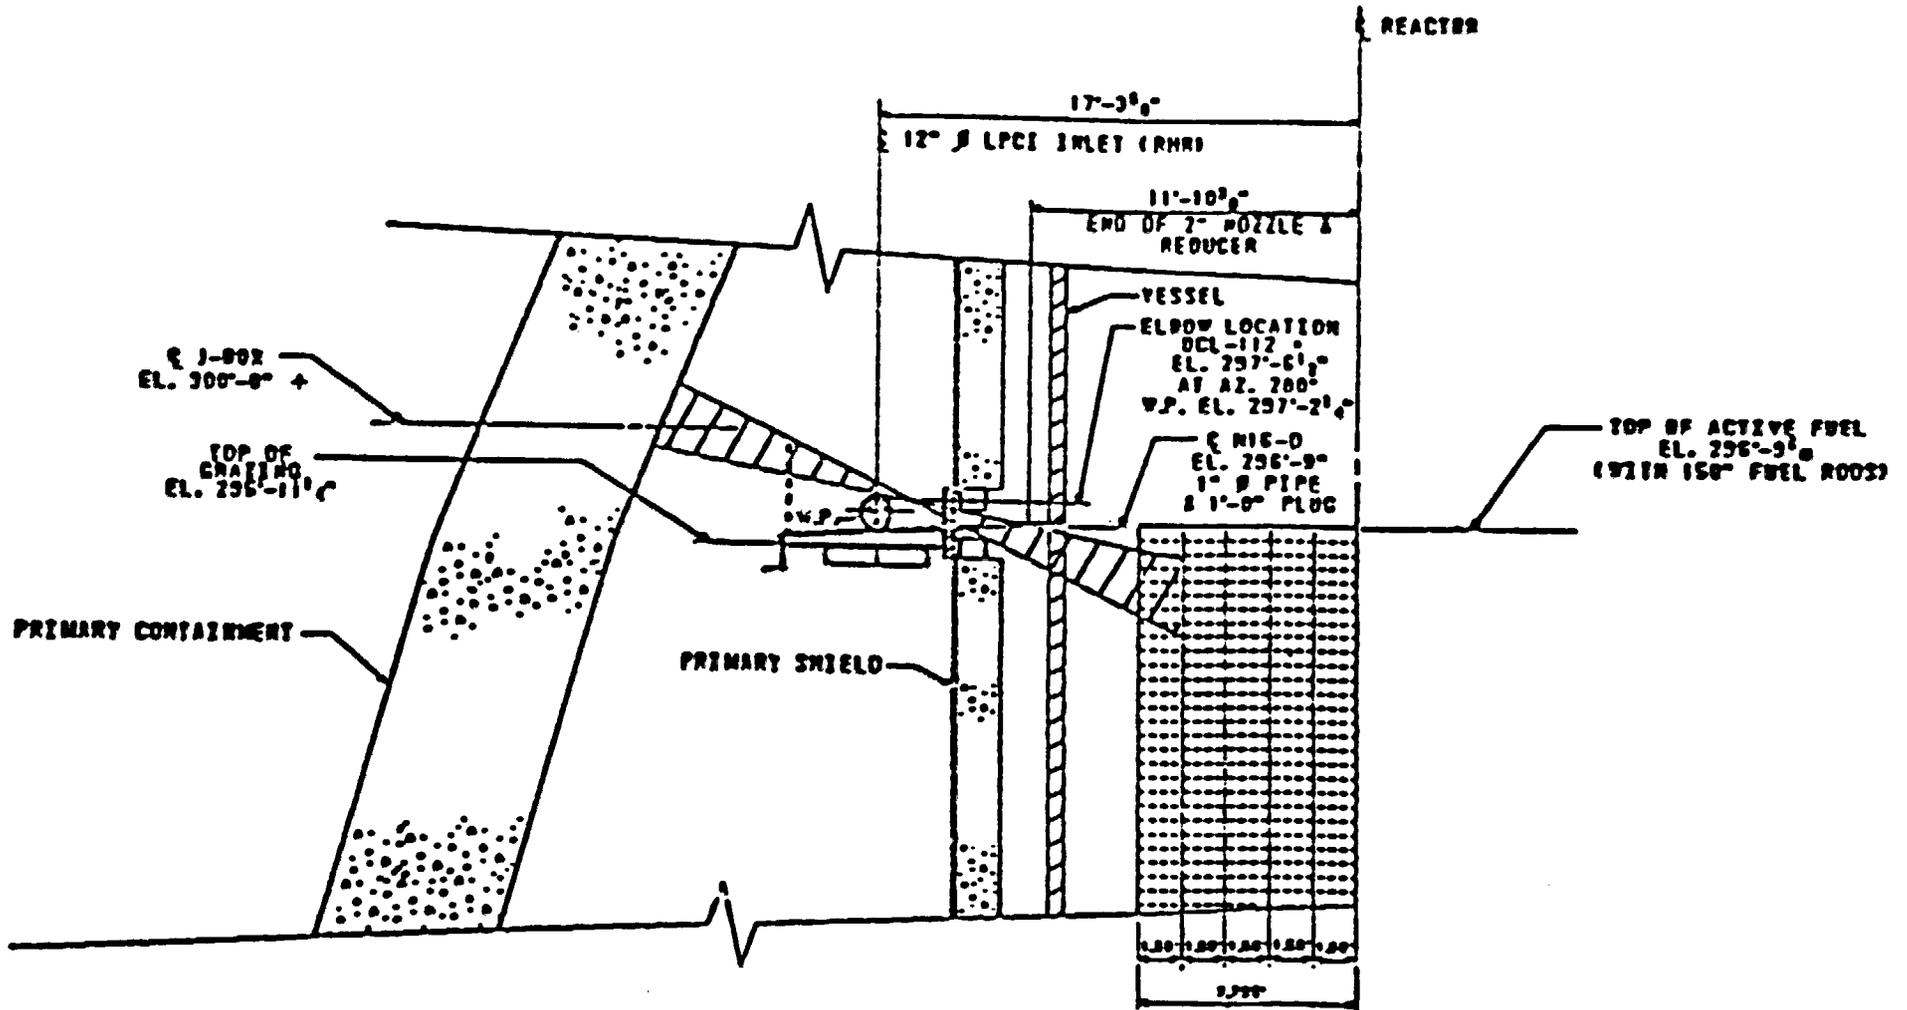
Figure 3: Limerick Generating Station Unit 1 Drywell
Section Along Azimuth 280°

7. Had the ISEG evaluate the event during which it found that:
 - the beam should have been anticipated,
 - the beam probably resulted from the unique geometric arrangement of the low-pressure coolant injection (LPCI) piping, the shield penetration, and the core peak axial power location, and that

- moving the rods downward to increase reactor power caused the location of peak axial power to move downward in the core, increasing the angle of the beam upward and causing the beam to pass over the top of a LPCI line, located in front of the penetration, and into the work area (see Figure 3). (Although operators changed the reactor power level between entries, power level changes were controlled so that no changes occurred while personnel were in the drywell.)

11. The licensee planned to complete the following long-term corrective actions:
 - Prepare a special procedure for drywell entries at power.
 - Require a higher level of station management approval for work in the drywell at power.

- Improve shielding, access control, or both, for high-radiation areas resulting from radiation beams.
 - Include review of this event in the training of health physics, operations, and radiation workers.
