UNITED STATES
NUCLEAR REGULATORY COMMISSION
OFFICE OF NUCLEAR REACTOR REGULATION
WASHINGTON, D.C. 20555

February 11, 1993

NRC INFORMATION NOTICE 93-12: OFF-GASSING IN AUXILIARY FEEDWATER
SYSTEM RAW WATER SOURCES

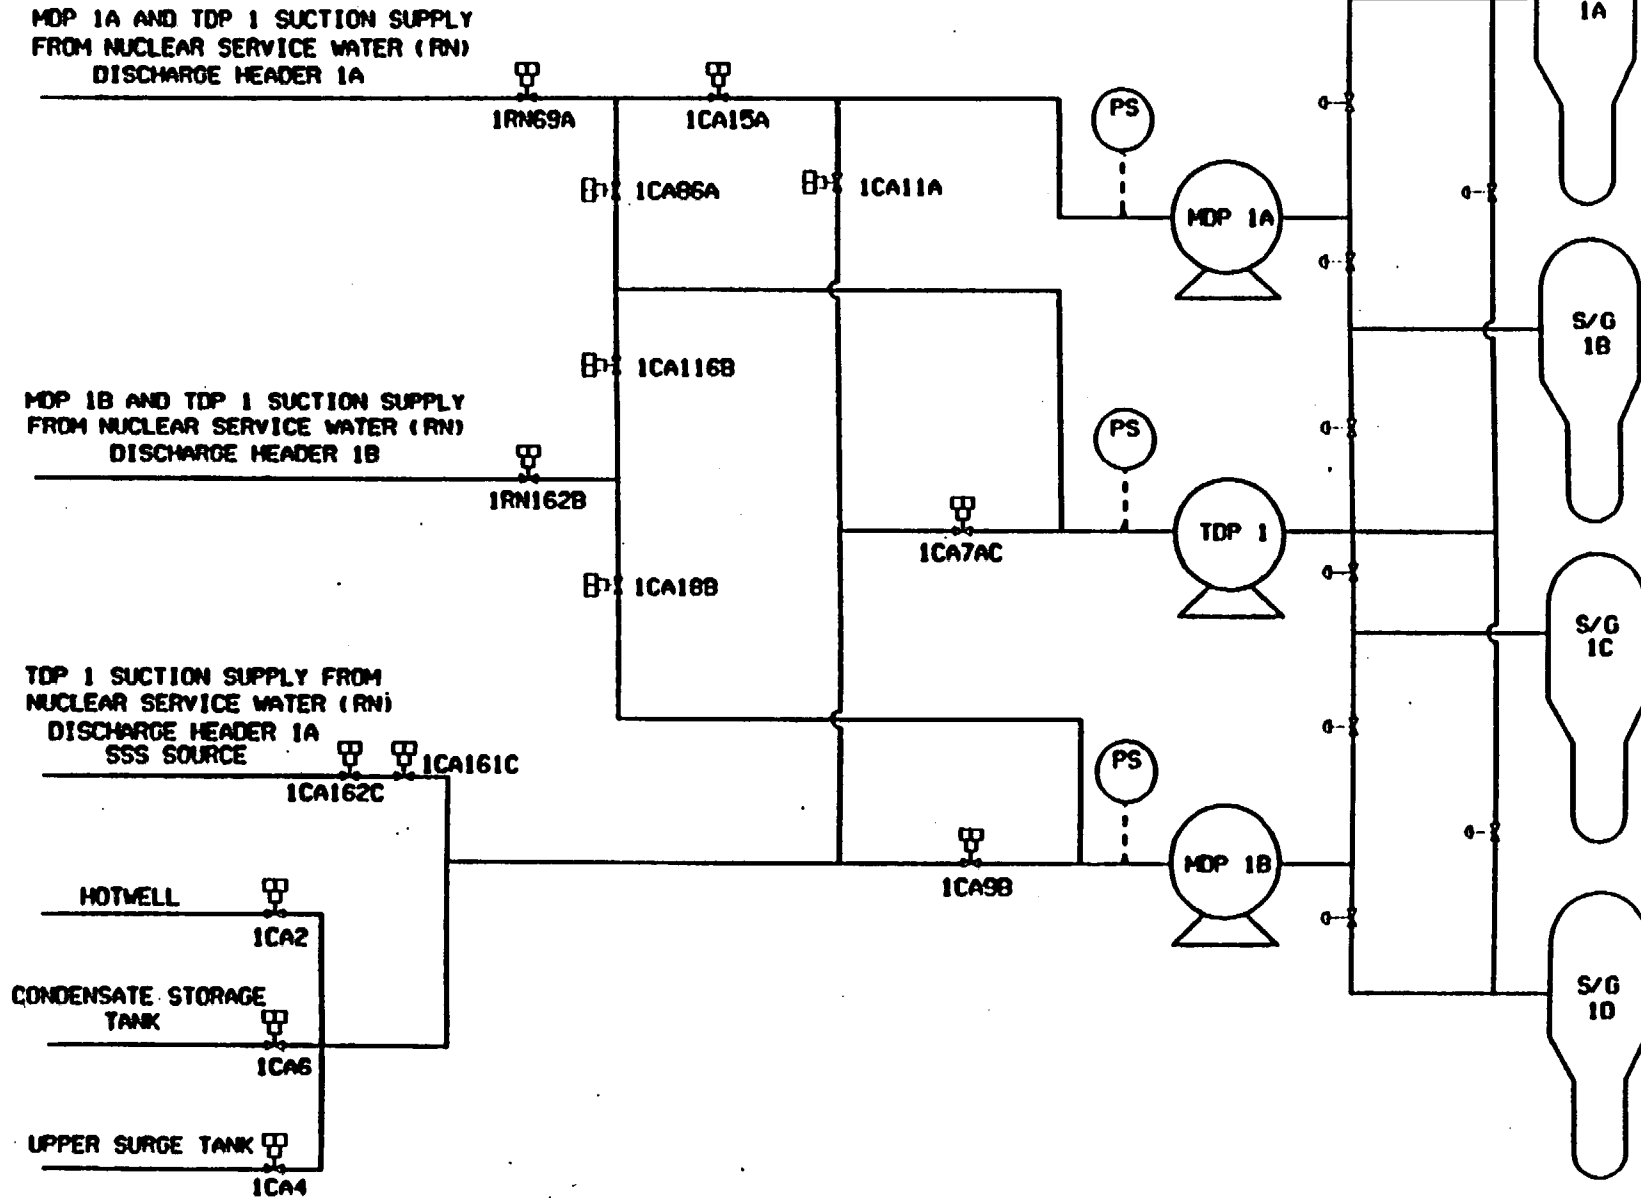
Figure 1

The licensee discovered two different sources of air in the nuclear service water system that could have potentially affected the operability of the auxiliary feedwater system. On March 27, McGuire personnel discovered air at a high point in the Unit 1 standby shutdown system line upstream of the isolation valves that separate the nuclear service water and the auxiliary feedwater systems (Valves 1CA161C and 1CA162C, Figure 2). McGuire personnel repeatedly vented this line over the following days, but air continued to be produced at the high point. After thoroughly searching for air inleakage and performing a detailed engineering and chemical evaluation of the system, McGuire staff concluded that the air was produced by off-gassing of the heated raw lake water. As a result of this discovery, the licensee searched for and found the second source of air at high points in the "A" train of the nuclear service water discharge header (Detail A-A, Figure 2). Under certain operating conditions, these additional sources of air could have affected the "A" auxiliary feedwater pumps and the turbine-driven auxiliary feedwater pumps on both units.

**MCGUIRE NUCLEAR STATION
AUXILIARY FEEDWATER SYSTEM
UNIT 1**

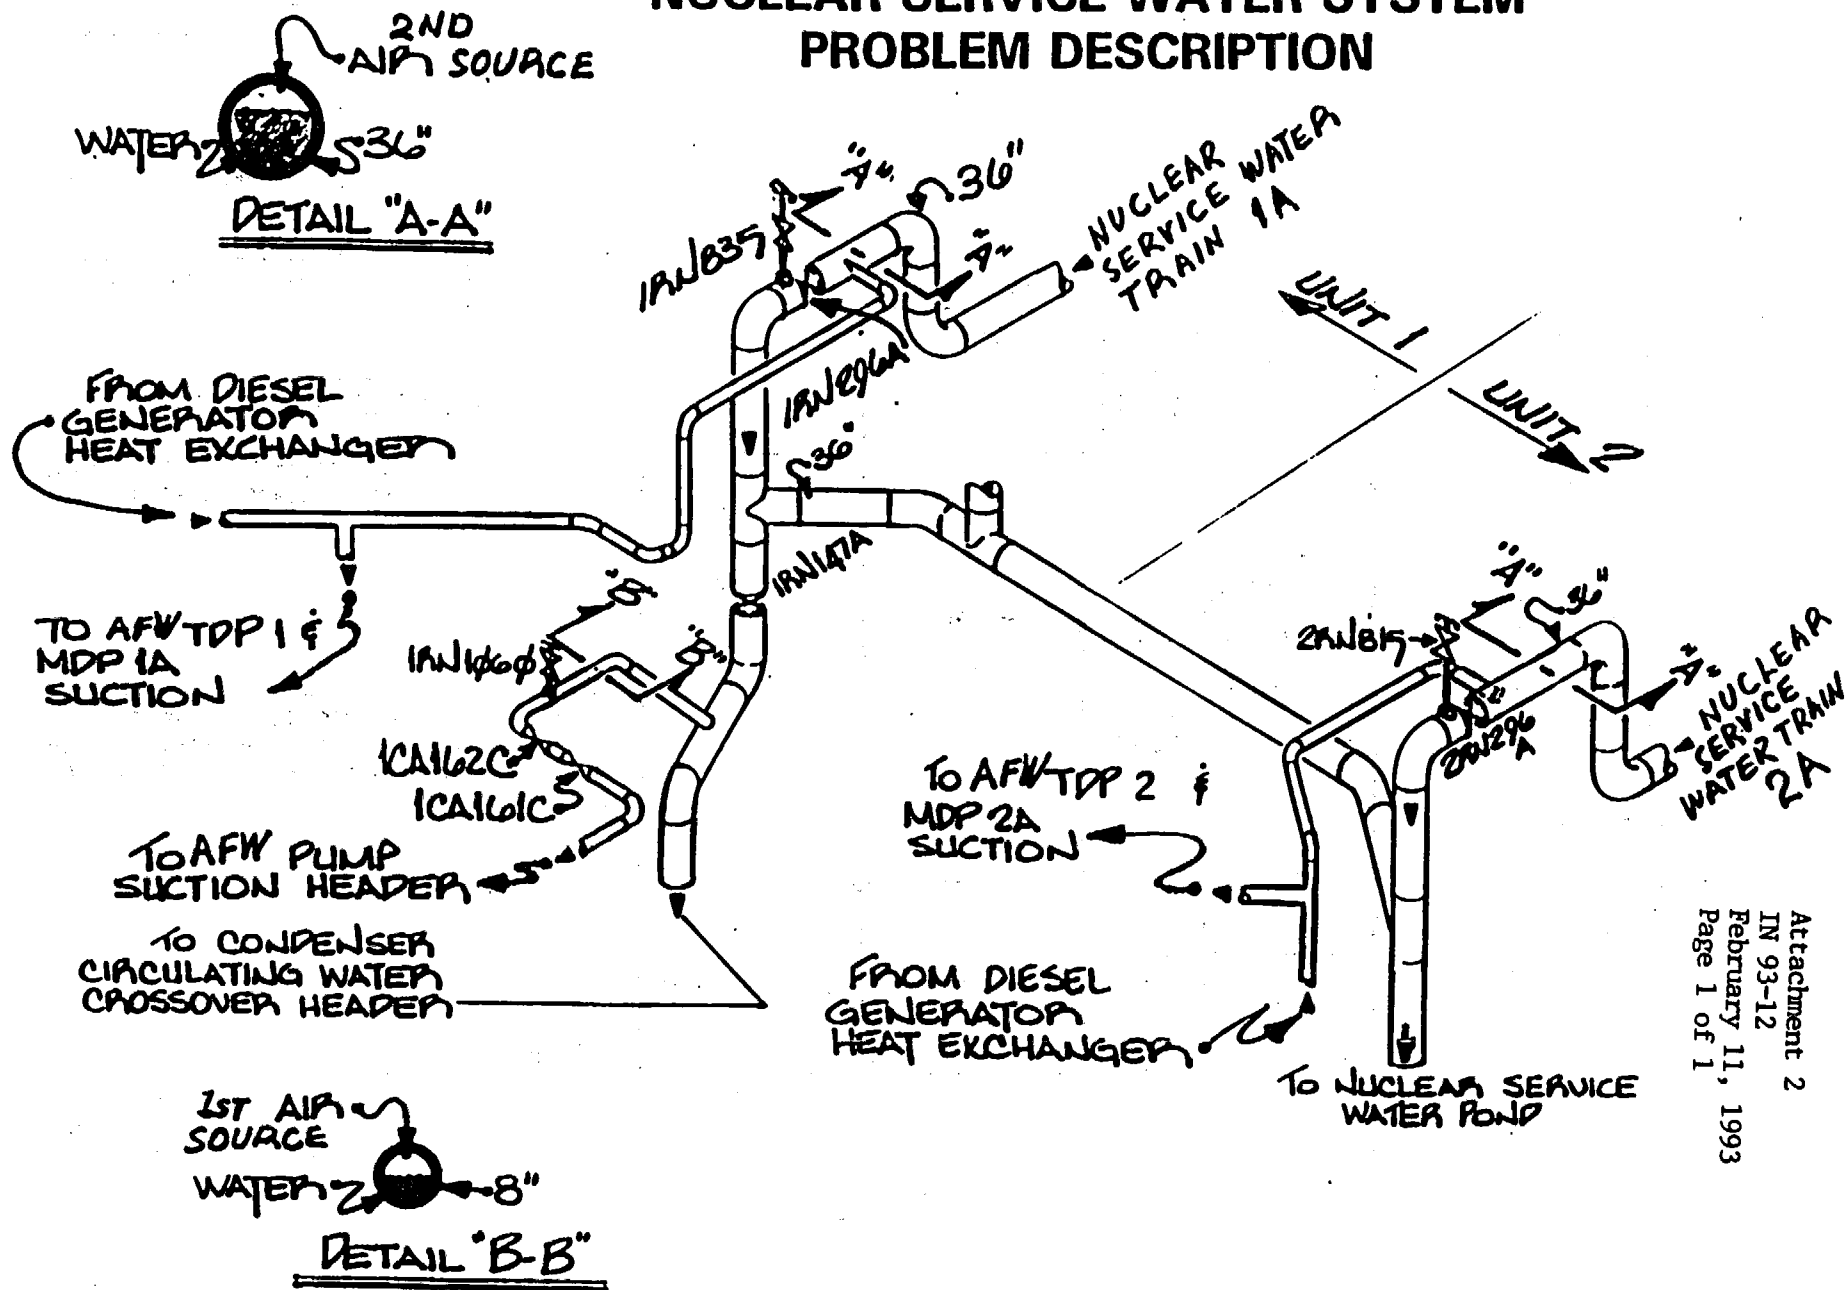
Figure 2

The auxiliary feedwater line from the "A" train on each unit is attached to the discharge line of the emergency diesel cooling heat exchanger, near the point where this line discharges into the main "A" train service water discharge header. The cooling water from the diesel generator heat exchanger flows at the rate of 900 gpm. With the diesel running and only one auxiliary feedwater pump drawing water from the diesel line, sufficient diesel coolant would be supplied to the feedwater pump suction without drawing water from the main "A" train discharge line. However, if the "A" diesel generator cooling is lost, or if both a motor-driven and a turbine-driven auxiliary feedwater pump are operated simultaneously, water could be drawn from the high point on the main "A" train discharge line along with any air that might have collected in this discharge line. The "B" train on each unit was not affected because it had a different piping configuration.

The events discussed in this information notice highlight the potential for off-gassing in auxiliary feedwater system raw water sources. According to Henry's law, the solubility of a gas in water at a constant temperature is approximately proportional to the partial pressure of the gas. The solubility at a constant pressure, however, generally decreases with increasing temperature. The solubility of air in water at atmospheric pressure, for example, is reduced from 29 milliliter per liter at 0°C (32°F) to 16 milliliter per liter at 30°C (86°F). Raw water that has become saturated with air in the outside environment is not likely to emit gas in the service water system supply piping because the pressure of the water has been increased by pumping while the temperature of the water remains near its original value. As this water is heated by the various plant systems, and as the pressure of the water decreases to near atmospheric levels in the discharge piping, some of the air can be expected to evolve from the water and collect above any elevated, slow moving water volumes in the discharge piping.

MCGUIRE NUCLEAR STATION NUCLEAR SERVICE WATER SYSTEM PROBLEM DESCRIPTION

The licensee considered several options to correct the problem permanently. One possible solution was to reroute the safety-grade auxiliary feedwater lines to take suction from the nuclear service water supply piping. A second possible solution was to reroute the suction of the auxiliary feedwater lines to sections of the nuclear service water discharge piping that were not susceptible to the formation of air pockets. However, the licensee chose a third alternative, which was to install permanent vent valves at the high points where air was accumulating (Valves 1RN1060, 1RN835 and 2RN815, Figure 2). The licensee piped these vent valves to drains and throttled the valves to provide a continuous drainage flow that was sufficient to vent any air that might accumulate in the emergency feedwater supply.
