**From:** Elaine Raphael  
**To:** Joelle Starefos; Robert Haag; Russ Bywater  
**Date:** 8/29/02 1:37PM  
**Subject:** draft report

### 3. REVIEW

### 3.1 The NRC Failed to Adequately Assess Operating Experience Relevant to Alloy 600 Nozzle Cracking and Boric Acid Corrosion of Carbon Steel Components

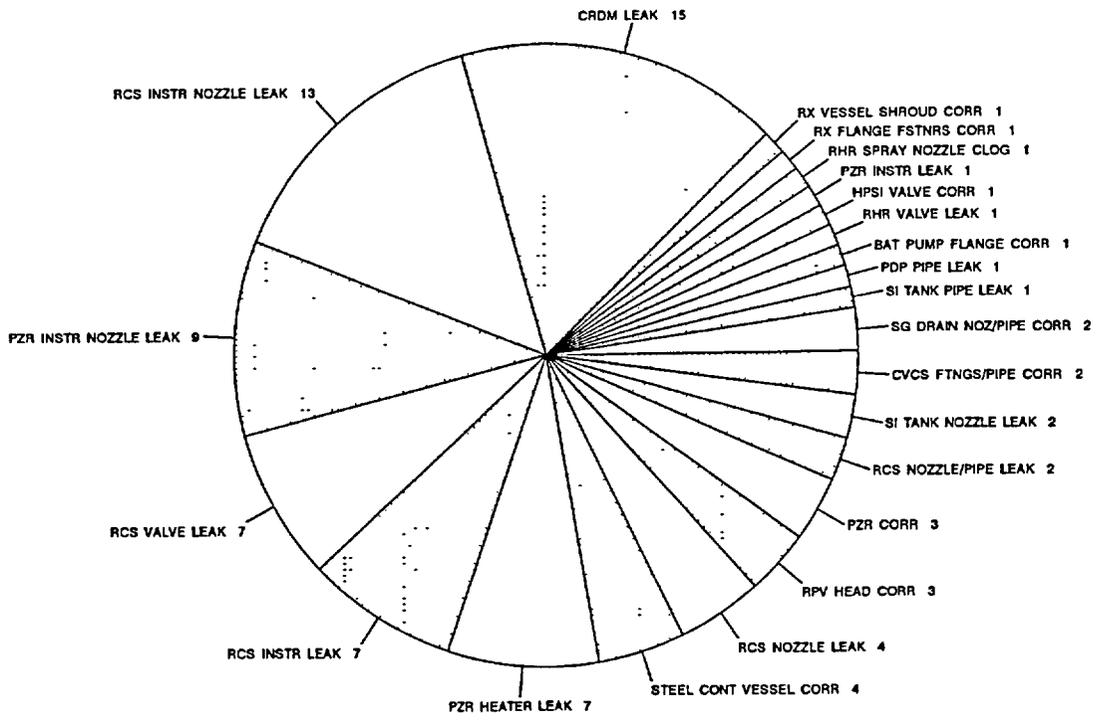
Figure 1. Reported Areas Involving Boric Acid Leakage (1986-2002)

Figure 1, "Reported Areas Involving Boric Acid Leakage (1986-2002)," lists the component experiencing a boric acid leak, or was affected by a boric acid leak. As seen by the figure, the most prominent events involving boric acid leakage included 15 documents relating to control rod drive mechanism (CRDM) leaks, 13 documents relating to reactor coolant system (RCS) nozzle leaks, nine documents relating to pressurizer (PZR) instrumentation nozzle leaks, seven RCS valve leaks, seven RCS instrumentation leaks, and seven pressurizer (PZR) heater sleeve leaks. Other less prominent events include four documents relating to corrosion of the steel containment vessel, four events relating to RCS nozzle leaks, three events involving wastage of the RPV head, three events involving wastage of the pressurizer.

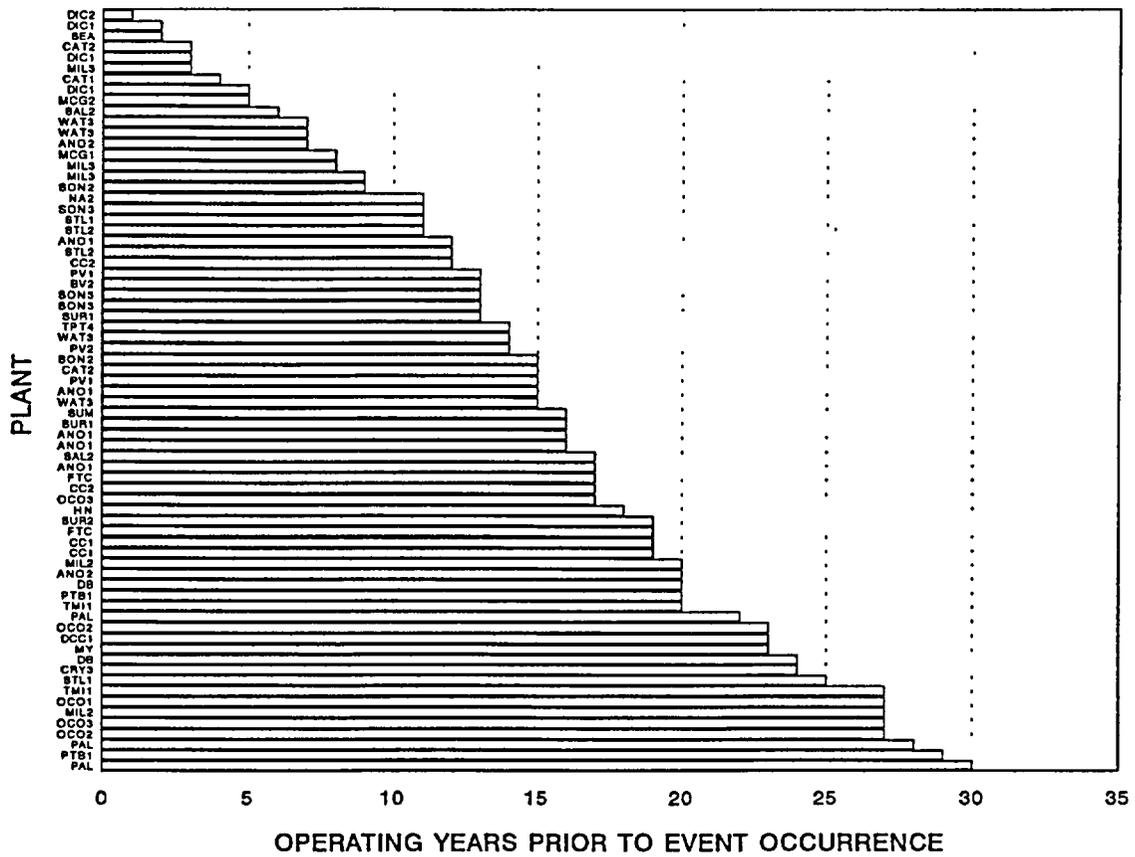
Figure 2. Number of Operating Years Prior to Event Occurrence

Figure 2, "Number of Operating Years Prior to Event Occurrence," displays an even distribution of boric acid leakage events. Figure 2 lists the plants that have reported a boric acid leak and the number of years of operation to the time that the leak was discovered. When taken as a group, it appears equally likely to have a boric acid leak after only a few years of operation, as it does after a long period of operation. In general, however, smaller components take longer to develop a leak than do the larger components. This observation is evident in subsequent figures.

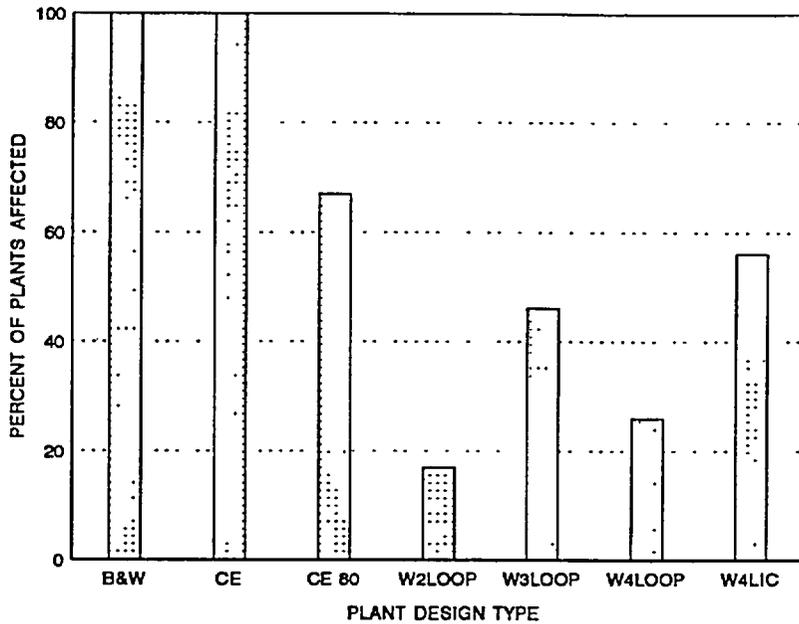
Figure 3. Percent of NSSS Design Manufacturers Reporting Boric Acid Leakage

As shown in Figure 3, "Percent of NSSS Design Manufacturers Reporting Boric Acid Leakage" Babcock and Wilcox (B&W) and Combustion Engineering (CE) plants appear to be highly susceptible to boric acid leakage and corrosion. One hundred percent of B&W plants have reported boric acid related problems. Given the high incidence rate of boric acid leakage problems at B&W plants, DBNPS should have been alerted and taken appropriate corrective actions. Combustion Engineering plants were broken up into the older CE plant design (12 units total) and the newer CE80 design (3 units total) to see if any differences were noted. As shown in the figure, 100 percent of the older CE plants reported boric acid leakage problems, while 67 percent of the CE80 design (two of three units) reported boric acid leakage problems.

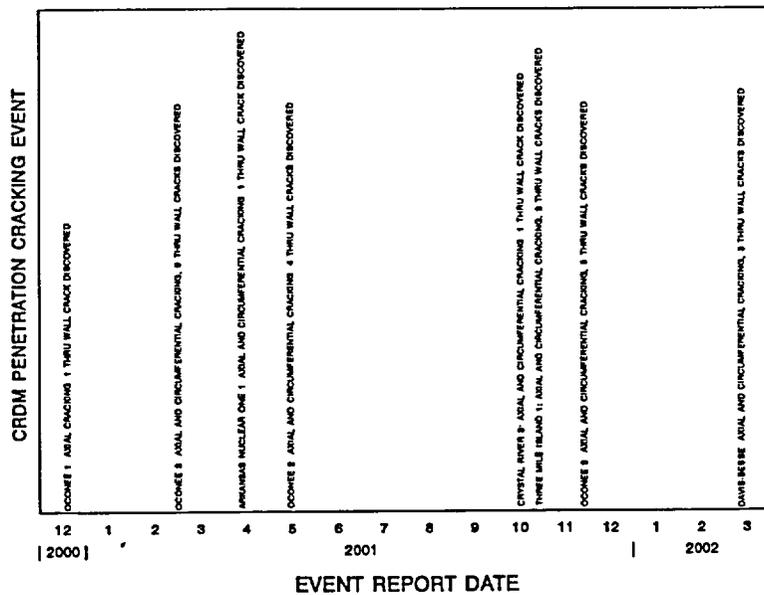
Figure 5. Control Rod Drive Mechanism Penetration Cracking Timeline for B&W Plants

Figure 5, "Control Rod Drive Mechanism Penetration Cracking Timeline for B&W Plants," presents a graphical representation of CRDM penetration cracking for all B&W plants. As shown in the figure, DBNPS was the last B&W plant to report cracking. However, had the boric acid crystal buildup that was identified during the 1996 refueling outage, the 1998 outage and the 2000 outage that was allowed to accumulate been removed, DBNPS may have been determined that CRDM penetration cracking had occurred long before February 2002. Ample B&W operating experience was available for DBNPS to conclude that a whole (RPV) head inspection was necessary to determine if cracking was evident, but instead made the decision to continue to operate without performing the penetration inspections.

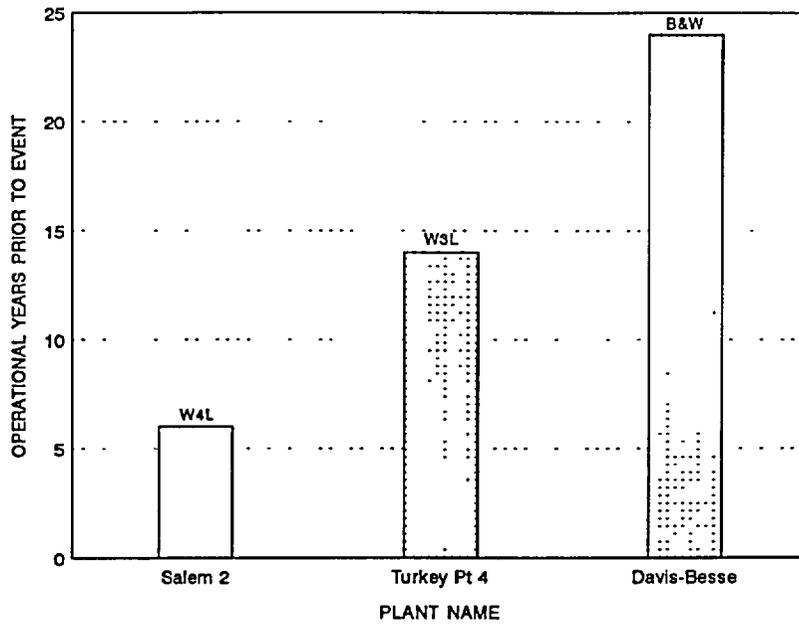
Figure 7. Reactor Pressure Vessel Head Base Metal Wastage Events  
2.9 Pressurizer Vessel Wastage Events Caused by Boric Acid Corrosion

Figure 7, "Reactor Pressure Vessel Head Base Metal Wastage Events," shows those plants which have experienced corrosion (beyond surface metal corrosion). The figure also shows the operating years prior to event occurrence. The Turkey Point 4 event in March 1987 was the major reason for issuing IN 86-108 Supplement 1 in April 1987, and the Salem 2 event in August 1987 was the major reason for issuing IN 86-108, Supplement 2 in November 1987. Both of these events and their lessons learned from 1987 should have been an indicator to DBNPS that RPV wastage from boric acid accumulation was possible, and should have been included in their Boric Acid Corrosion Control (BACC) program. Information gained through interviews of engineers and managers at DBNPS (also the NRC), indicated that a mind set had developed that boric acid corrosion on the RPV head was not a credible event because of its elevated temperature.

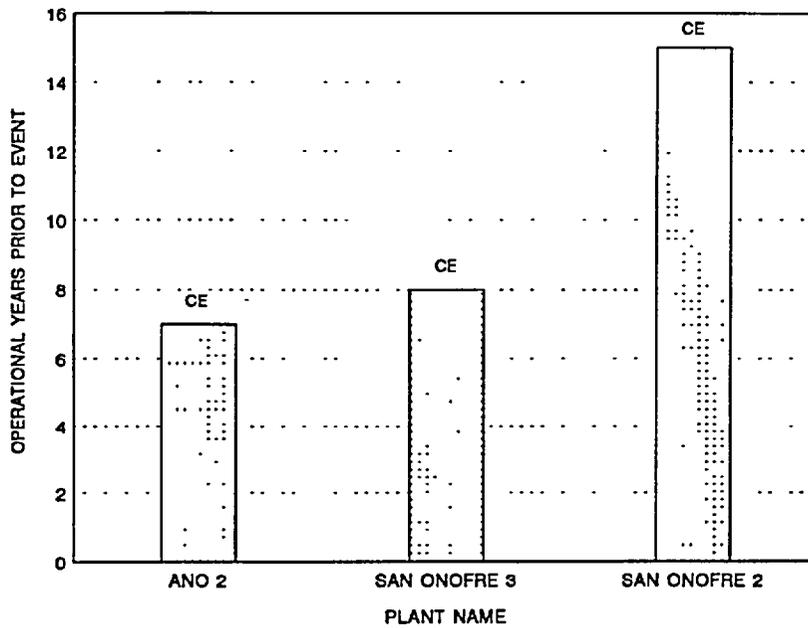
**Figure 8. Pressurizer Vessel Base Metal Wastage Events**  
**2.10 Reactor Coolant System Nozzle Leakage Operational Experience**

Figure 8, "Pressurizer Vessel Base Metal Wastage Events," shows those plants which have experienced corrosion (beyond surface metal corrosion). The figure also shows the number of

operating years prior to event occurrence. These events and their lessons learned in conjunction with RPV wastage events do indicate that boric acid corrosion of high temperature components is possible, and should be assessed.

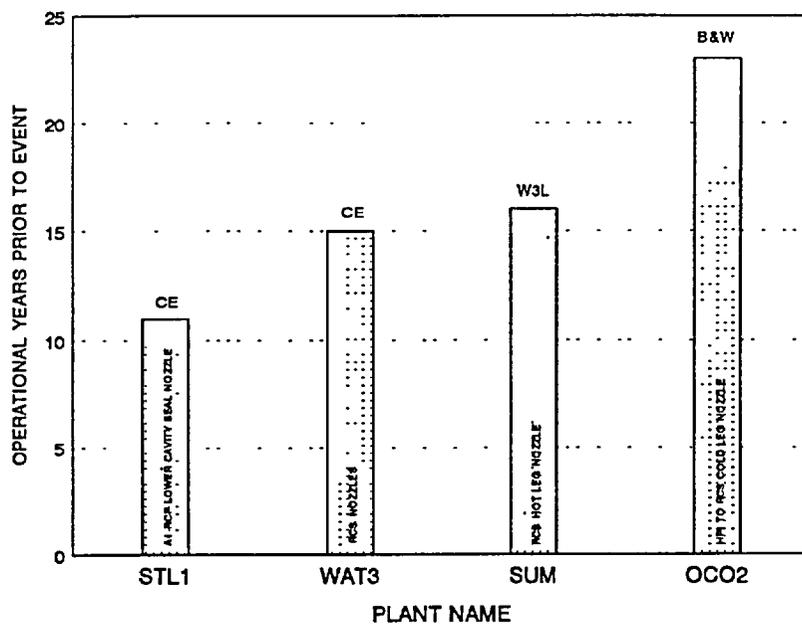
Figure 9. Reactor Coolant System Nozzle Leakage Events

Miscellaneous RCS nozzle leakage has occurred in varied locations. Figure 9, "Reactor Coolant System Nozzle Leakage Events," shows that the larger nozzles take longer to develop leakage. The figure would also show that no one Nuclear Steam System Supplier (NSSS) vendor dominates. Repetitive leakage from similar components is not evident.

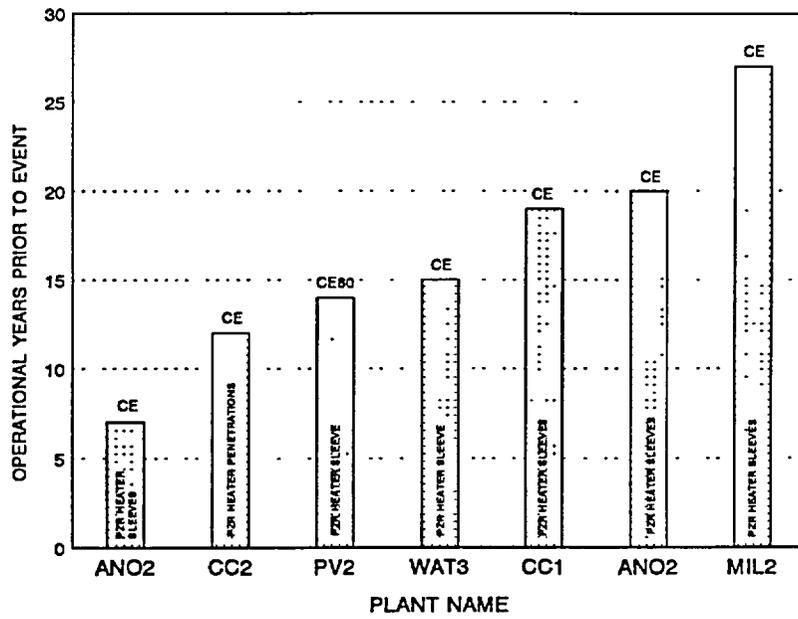
Figure 12. Pressurizer Heater Sleeve Leakage  
2.14 Combustion Engineering Dominates Reactor Coolant System Instrumentation Nozzle Leakage

Figure 12, "Pressurizer Heater Sleeve Leakage," shows a dominance by CE plants with 100 percent (7 of 7) of the events. The event occurring at Calvert Cliffs 2 was extensive, involving 28 of 120 leaking sleeves. Leaking boric acid from the Calvert Cliffs event also resulted in corrosion damage to the carbon steel base metal of the pressurizer. Other events involving pressurizer heater sleeves were less severe and involved one or two sleeves

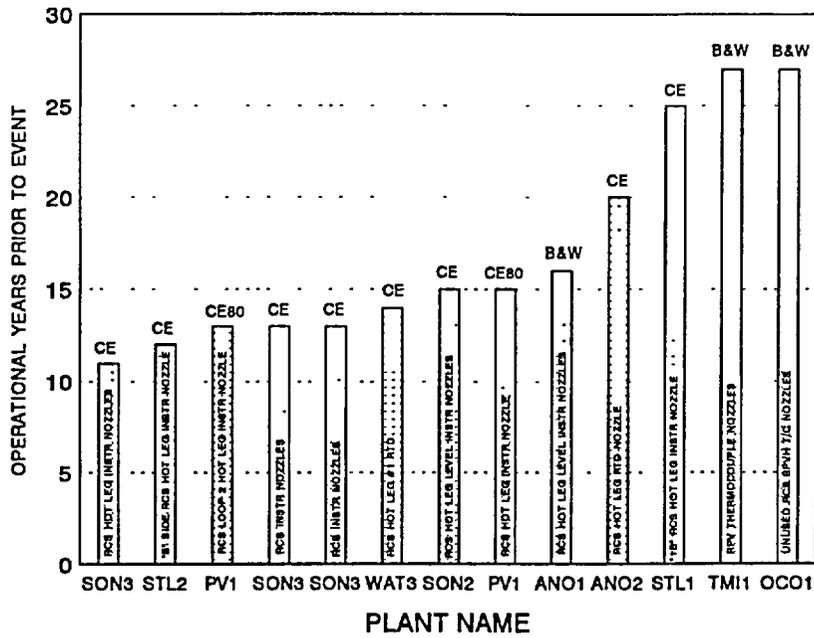
Figure 13 Reactor Coolant System Instrumentation Nozzle Leakage Events

As shown in Figure 13, "Reactor Coolant System Instrumentation Nozzle Leakage Events," CE dominates with 10 of 13 events. In addition, most of the events involved more than one leaking nozzle. The review also shows that most of the events involved hot leg nozzles. Nine of the 13 instrumentation nozzles occurred between 11 and 16 years of operation. Most of the nozzle cracking was attributed to primary water stress corrosion cracking (PWSCC).

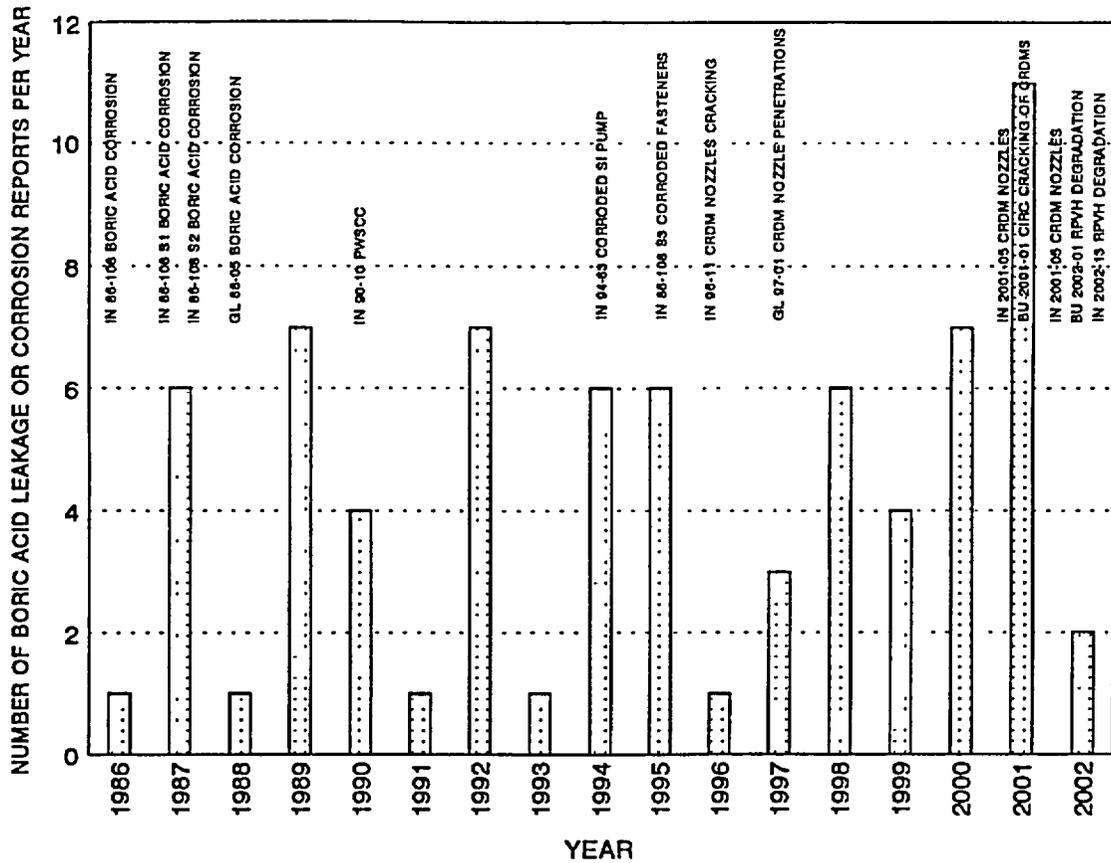
Figure 14. Boric Acid Leakage and Corrosion Events VS. Relevant NRC Generic Communication Documents

Figure 14, "Boric Acid Leakage and Corrosion Events Vs Relevant NRC Generic Communication Documents," shows that several years elapsed (with relatively high numbers of primary system leakage or boric acid corrosion events) with no boric acid leakage or corrosion generic communications being issued by the NRC. For example, during the period 1989 through 1994, two INs were issued (IN 90-10 on PWSCC of Inconel 600, and IN 94-63 on boric acid corrosion of a pump casing). In addition, during the period 1998-2000 there were numerous examples of RCS nozzle leaks with no generic communication being issued.
