UNITED STATES
NUCLEAR REGULATORY COMMISSION
OFFICE OF NUCLEAR REACTOR REGULATION
WASHINGTON, D.C. 20555

December 20, 1990

NRC INFORMATION NOTICE NO. IN 90-79: FAILURES OF MAIN STEAM ISOLATION CHECK VALVES RESULTING IN DISC SEPARATION

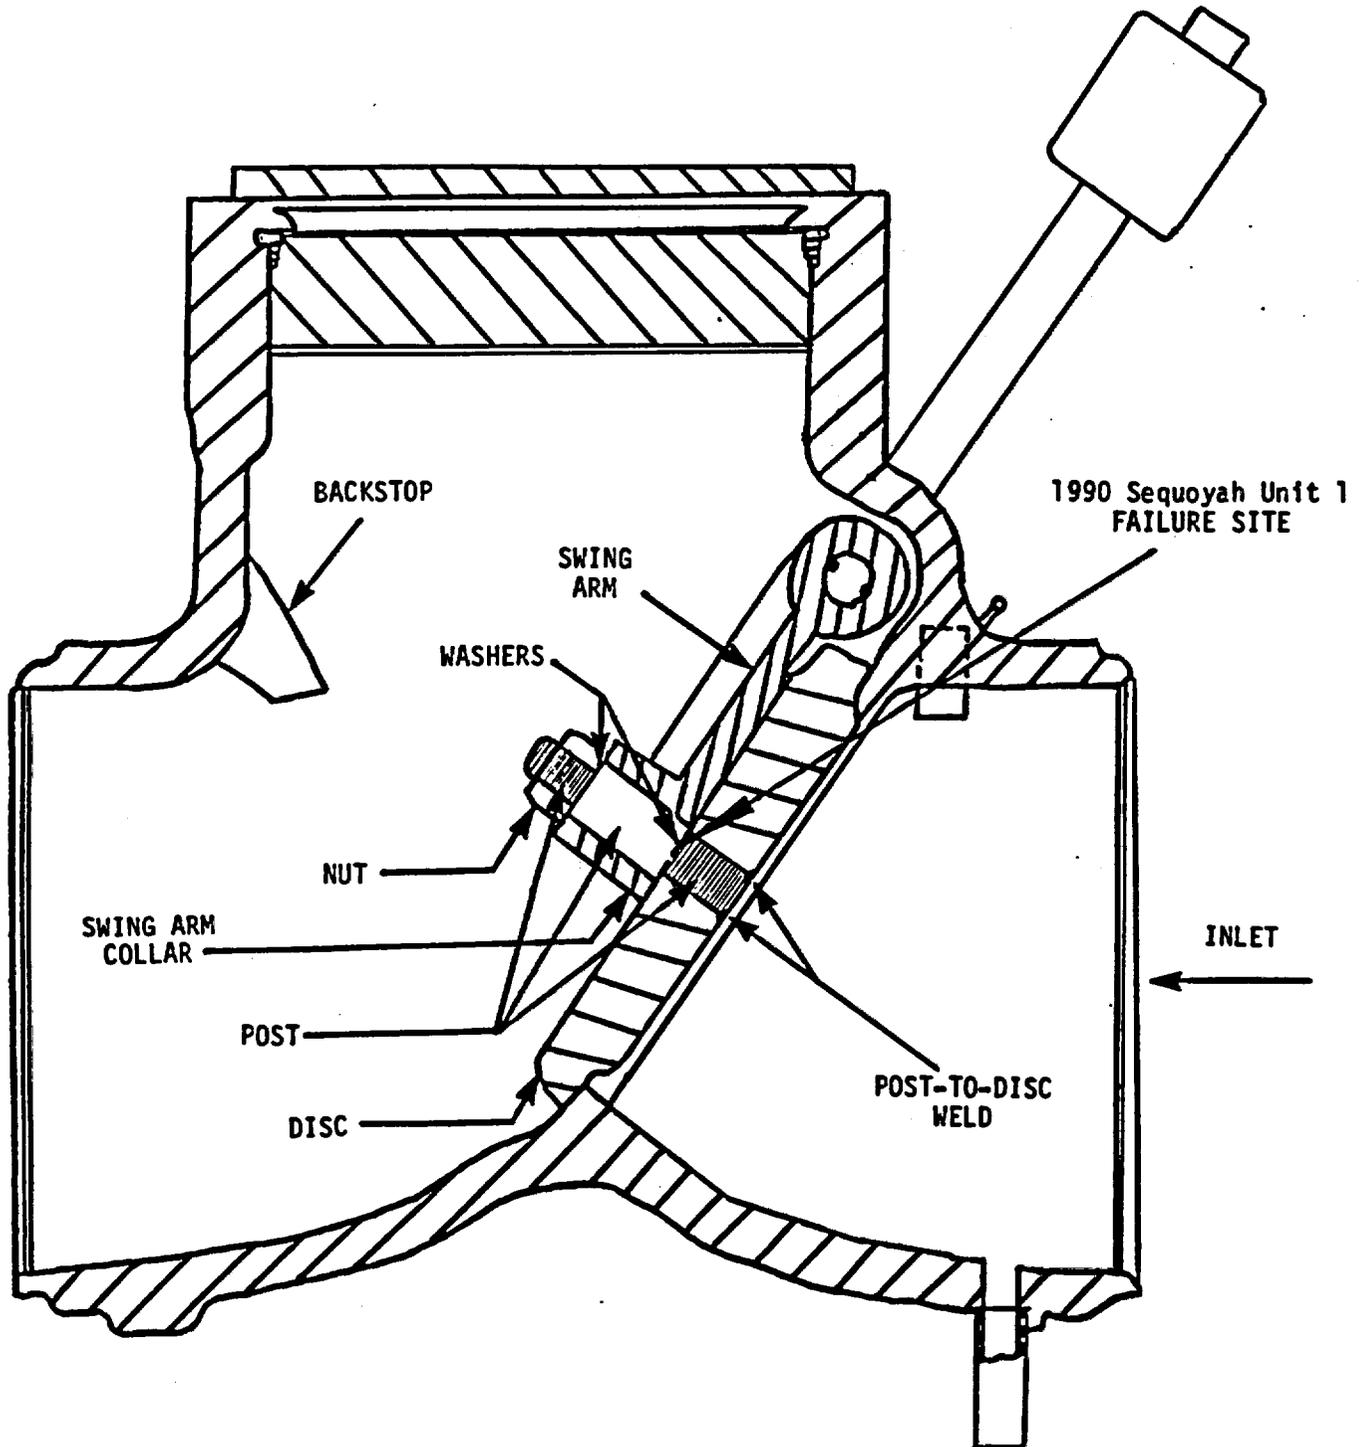
Figure 1. Articulated, Swing Check Valve with Single Backstop

The backstop design may be another possible contributor to the MSCV failures at Sequoyah Unit 1. The configuration is such that a single backstop makes contact with the disc edge. The swing arm is beveled where it contacts the disc, permitting oscillation of the disc that is further exaggerated by a 40-mil clearance between the post and swing arm collar. This arrangement allows a maximum resultant disc oscillation of up to approximately 0.25 inch at the rim of the disc. In the case of Sequoyah Unit 1, the effects of this design were magnified by having the post built up with filler material; this modification concentrated the stresses on the post where it meets the disc and accelerated the failure of the post. Atwood & Morrill recommended, as corrective action, modifying Sequoyah's single-backstop MSCV design to a three-point backstop design that may help limit lateral disc oscillation. The NRC staff has identified that other Atwood & Morrill and Schutte & Koerting swing check valves with single posts may be of this design and may, therefore, be susceptible to this mode of failure. Other valves with a similar design may also be affected.

It appears that any check valve with disc flexure is susceptible to cyclic fatigue failure of the posts. Such features as single-post design, backstop contact with the disc edge instead of the disc nut, and valve location near a source of turbulence, increase the susceptibility of a check valve to cyclic fatigue failure. The result may be that the post unscrews from the disc, unscrews from the nut, or simply fails; and the disc separates. An example of such a failure is a main feedwater regulator check valve (manufactured by Pacific Valve Company) disc separation at the San Onofre Nuclear Generating Station, Unit 1, in 1985, when the post failed because of high flow velocity and valve installation near a source of turbulence. (Other recent examples of failures of check valve internals are discussed in Information Notice 90-03, "Malfunction of Borg-Warner Bolted Bonnet Check Valves Caused by Failure of the Swing Arm", dated January 23, 1990, Information Notice 89-62, "Malfunction of Borg-Warner Pressure Seal Bonnet Check Valves Caused by Vertical Misalignment of Disk", dated August 31, 1989, NRC Bulletin No. 89-02, "Stress Corrosion Cracking of High-Hardness Type 410 Stainless Steel Internal Preloaded Bolting in Anchor Darling Model S350W Swing Check Valves or Valves of Similar Design", dated July 19, 1989, and Information Notice 83-54, "Common Mode Failure of Main Steam Isolation Nonreturn Check Valves", dated August 11, 1983.)

Among the corrective actions taken by the industry in response to these check valve failures are: tack welding the post to the disc, better disc nut locking devices, interference threads for the post, multiple-backstop designs, and multiple-post designs. Despite these actions, check valves continue to fail prematurely. Most recently, a potential problem was found at Sequoyah Unit 2 during their 1990 refueling outage, where an MSCV had cracks in its post and disc near the post-to-disc weld similar to those that led to the 1982 post-to-disc weld failure at Unit 1. These cracks occurred despite the corrective actions--i.e., reweld of the disc and increased torque preload on the post--taken by the licensee in response to the 1982 post failure.
