UNITED STATES  
NUCLEAR REGULATORY COMMISSION  
OFFICE OF NUCLEAR REACTOR REGULATION  
WASHINGTON, D.C. 20555

December 18, 1990

NRC INFORMATION NOTICE NO. 90-78: PREVIOUSLY UNIDENTIFIED RELEASE PATH FROM  
BOILING WATER REACTOR CONTROL ROD HYDRAULIC  
UNITS

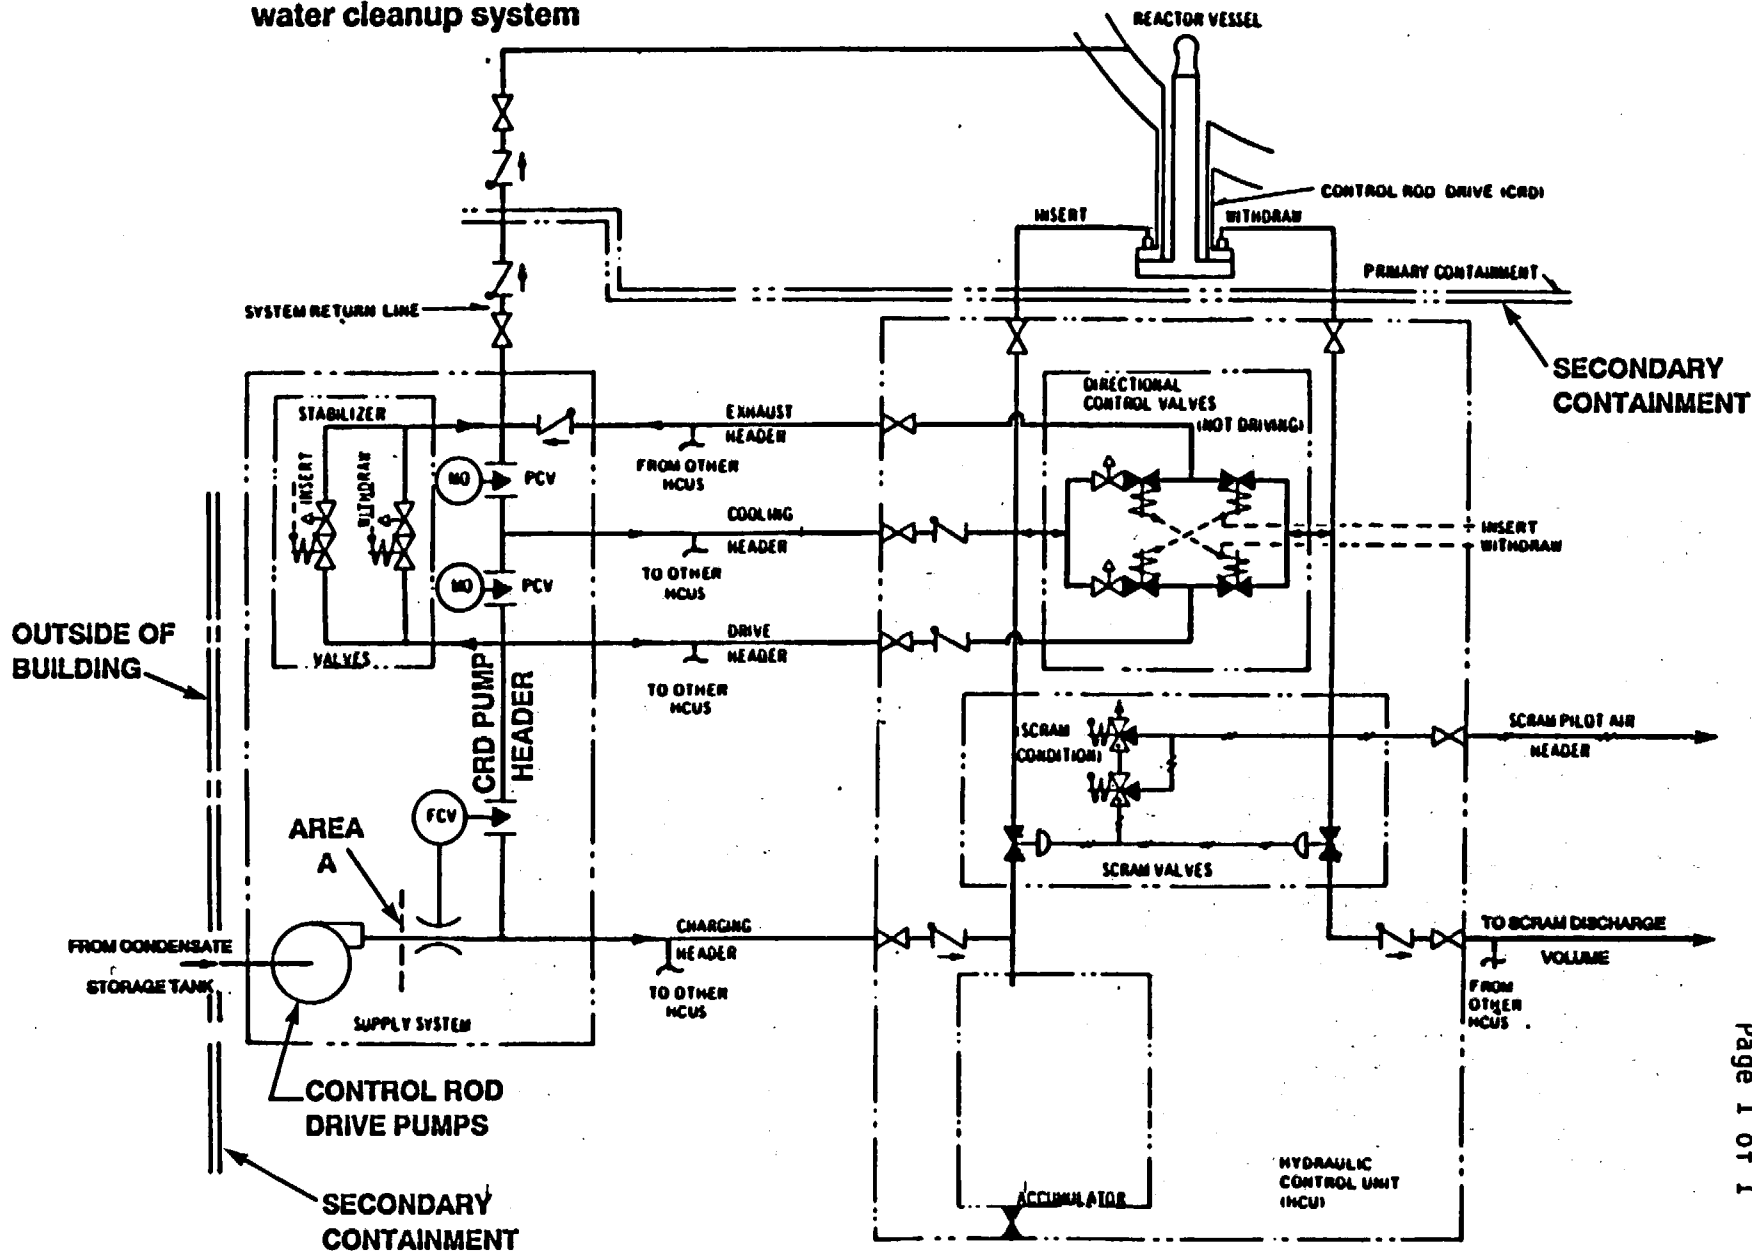
**Figure 1. BWR CONTROL ROD DRIVE SYSTEM**

As shown in Figure 1, four paths lead from each of the 185 hydraulic control units to the common CRD pump header. Three of these paths, the accumulator charging header, the drive header and the cooling header include check valves to prevent the return of water from the hydraulic units. In addition, water escaping through the accumulator charging header must leak through the insert side scram valve, and water escaping through the drive header must leak through one of the directional control valves. However, the check valve in the exhaust header is oriented so as to permit the flow of water back to the CRD pump header. The exhaust water then flows via the CRD pump header back to the reactor vessel (or, as at Washington Nuclear Power Plant Unit 2, to the reactor water cleanup system) along with the excess pump flow. Therefore, only one normally closed valve prevents water that is leaking out of each of the 185 control rod drives from returning through the associated exhaust header to the CRD pump header. During startup testing at Limerick Unit 1, and at Susquehanna Unit 1, the total leakage from all of the hydraulic control units combined was measured at 5 gpm and 11 gpm, respectively. Both of these reactors include additional check valves at the discharge of the control rod drive pump (area A in Figure 1). A partial audit by the NRC staff indicates that many of the newer BWR plants have check valves installed in the discharge pipe of the control rod drive pumps. However, this audit also showed that other BWR plants, mostly the earlier ones, did not have such check valves. The control rod drive system for BWR/6 plants is designed with a testable check valve and a motor-operated isolation valve. Therefore, this pathway is applicable to pre-BWR/6 plants only.

**Note: At Washington Nuclear Power Plant, Unit 2, the control rod drive return water is piped to the reactor water cleanup system**

This problem was resolved at Washington Nuclear Power Plant Unit 2 by the installation of two check valves in series in the common discharge pipe from the control rod drive pumps (at area A in Figure 1) to prevent backflow out of the reactor building (secondary containment). The Washington Nuclear Power Plant Unit 2 installation includes provisions for leak testing the valves and a leak rate criterion of 0.01 gpm was established for these valves.
