# UNITED STATES NUCLEAR REGULATORY COMMISSION OFFICE OF NUCLEAR REACTOR REGULATION WASHINGTON, D.C. 20555

December 18, 1990

NRC INFORMATION NOTICE NO. 90-78: PREVIOUSLY UNIDENTIFIED RELEASE PATH FROM BOILING WATER REACTOR CONTROL ROD HYDRAULIC UNITS

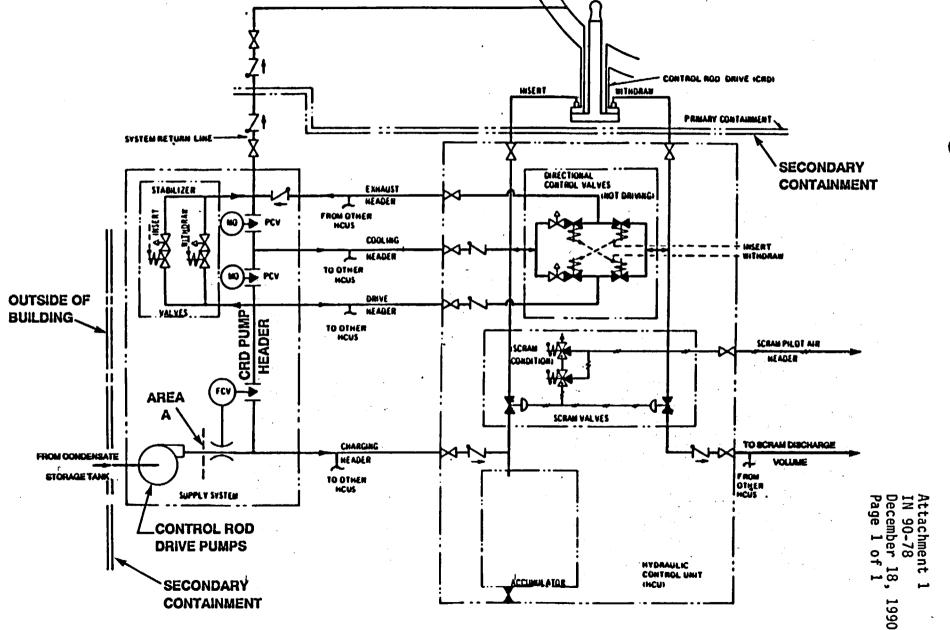
Figure 1. BWR CONTROL ROD DRIVE SYSTEM

As shown in Figure 1, four paths lead from each of the 185 hydraulic control units to the common CRD pump header. Three of these paths, the accumulator charging header, the drive header and the cooling header include check valves to prevent the return of water from the hydraulic units. In addition, water escaping through the accumulator charging header must leak through the insert side scram valve, and water escaping through the drive header must leak through one of the directional control valves. However, the check valve in the exhaust header is oriented so as to permit the flow of water back to the CRD pump header. The exhaust water then flows via the CRD pump header back to the reactor vessel (or, as at Washington Nuclear Power Plant Unit 2, to the reactor water cleanup system) along with the excess pump flow. Therefore, only one normally closed valve prevents water that is leaking out of each of the 185 control rod drives from returning through the associated exhaust header to the CRD pump header. During startup testing at Limerick Unit 1, and at Susquehanna Unit 1, the total leakage from all of the hydraulic control units combined was measured at 5 gpm and 11 gpm, respectively. Both of these reactors include additional check valves at the discharge of the control rod drive pump (area A in Figure 1). A partial audit by the NRC staff indicates that many of the newer BWR plants have check valves installed in the discharge pipe of the control rod drive pumps. However, this audit also showed that other BWR plants, mostly the earlier ones, did not have such check valves. The control rod drive system for BWR/6 plants is designed with a testable check valve and a motor-operated isolation valve. Therefore, this pathway is applicable to pre-BWR/6 plants only.

Combining the General Electric dose calculations for the postulated path with the leak rates measured from the hydraulic units at either Limerick or Susquehanna produces dose rates significantly in excess of the values in the Final Safety Analysis Report. Independent calculations by the NRC staff produced offsite dose values that were comparable to the General Electric results. Radiation release by this path is not possible as long as the control rod drive pumps are kept running. However, continued operation of these pumps following an accident cannot be assured, particularly if the non-seismically qualified suction piping were to fail.

This problem was resolved at Washington Nuclear Power Plant Unit 2 by the installation of two check valves in series in the common discharge pipe from the control rod drive pumps (at area A in Figure 1) to prevent backflow out of the reactor building (secondary containment). The Washington Nuclear Power Plant Unit 2 installation includes provisions for leak testing the valves and a leak rate criterion of 0.01 gpm was established for these valves.
