UNITED STATES
NUCLEAR REGULATORY COMMISSION
OFFICE OF NUCLEAR REACTOR REGULATION
WASHINGTON, D.C. 20555

December 12, 1990

NRC INFORMATION NOTICE NO. 90-77: INADVERTENT REMOVAL OF FUEL ASSEMBLIES
FROM THE REACTOR CORE

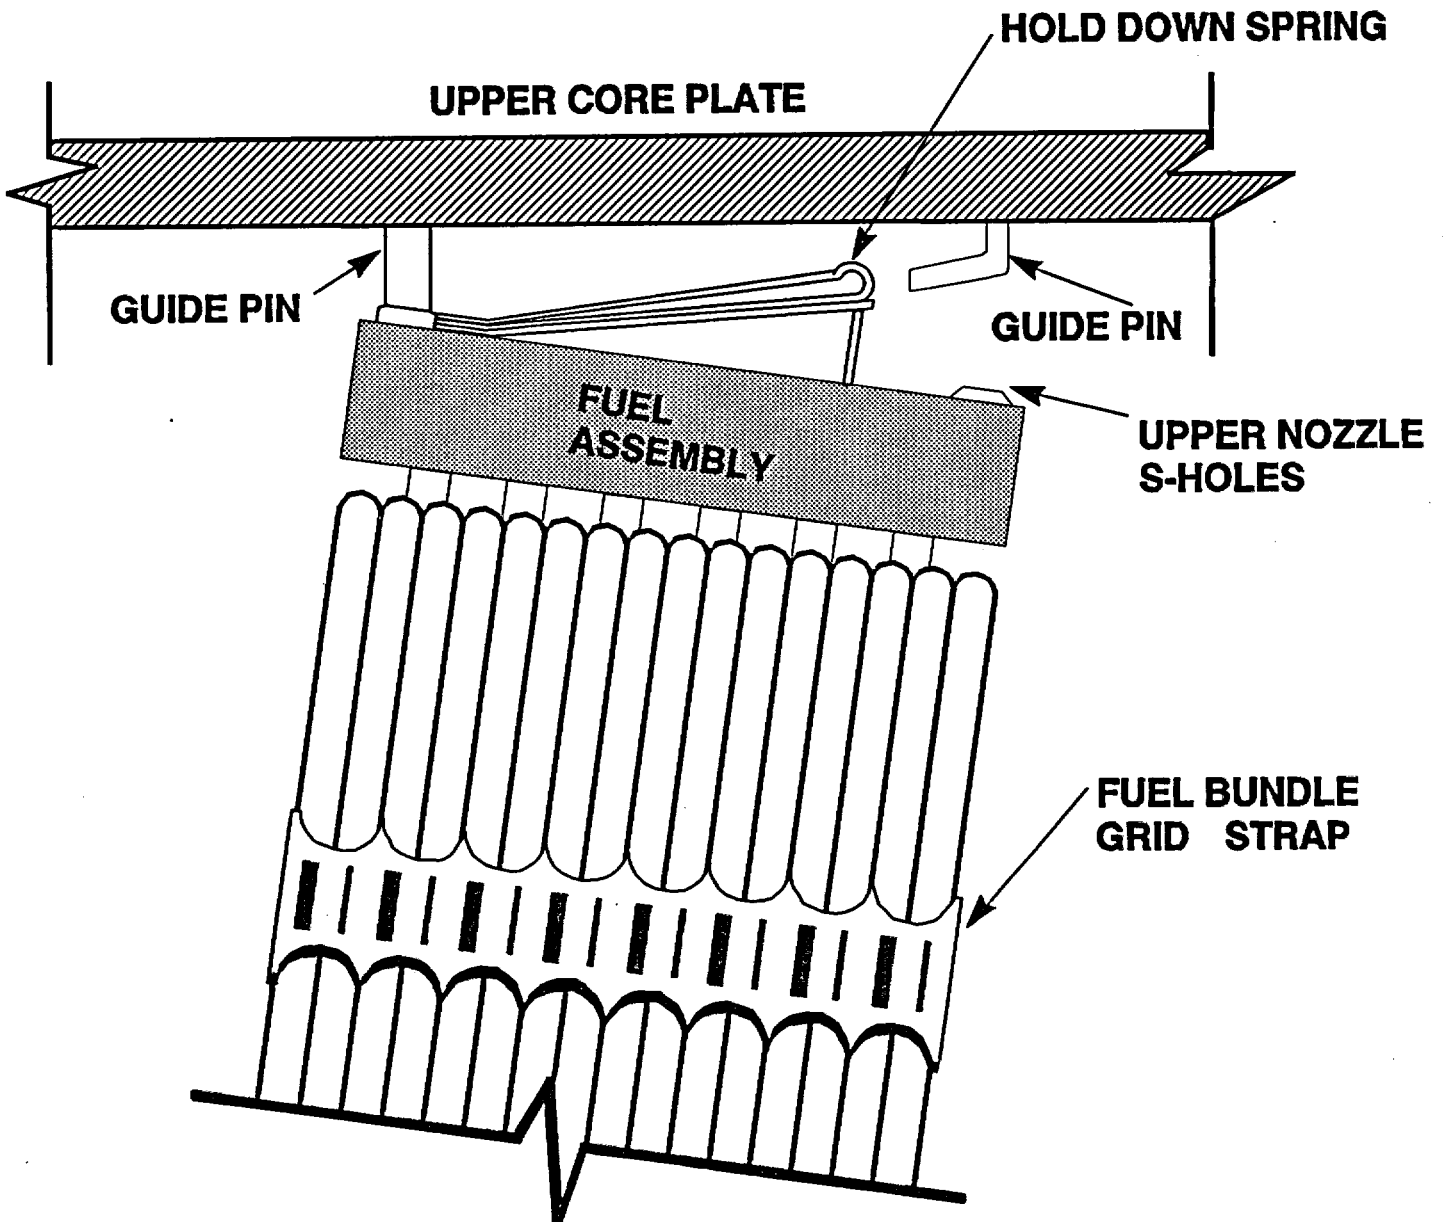
INDIAN POINT 3
Detailed View Showing Suspended Fuel Assembly from Bottom
of Upper Internals Package

On October 4, 1990, Indian Point Nuclear Generating Unit 3 was in a refueling outage. The licensee was removing the upper core support structure (upper internals) from the reactor vessel in preparation for refueling the core. Upon initiating a lateral move of the upper core support structure, crane movement was stopped upon the discovery that two peripheral fuel assemblies were attached to the bottom of the upper core plate, which is part of the upper internals package. An underwater camera inspection had been conducted after vertically lifting the upper core support structure from the reactor vessel. This inspection was prompted by earlier analysis of noise diagnostics data, confirming the existence of a loose part which resembled a fuel assembly locating pin in the steam generator channel head. Due to poor camera location and lighting, the attached fuel assemblies were not recognized during the initial camera inspection.

Each of the two assemblies were attached to the upper core plate by bent fuel assembly guide pins as shown in Attachment 1. These guide pins extend downward from the upper core plate and insert into two holes in the upper nozzle of the fuel assembly when the upper core internals structure is properly aligned over the top of the core. For each of the suspended fuel assemblies, the licensee found that one guide pin was bent and not inserted into the top nozzle hole (upper nozzle S-hole on Attachment 1) of the fuel assembly, with the other guide pin bent and wedged into the assembly. In this condition, the guide pin suspended the assembly at an angle of approximately 7 degrees. The licensee has determined that the fuel assembly guide pins were damaged during the previous refueling outage when the upper internals package was being removed from the upper internals storage stand.

Licensees may wish to consider reviewing their procedures and equipment prior to performing activities which may lead to inadvertent damage to fuel assembly guide pins and inspecting the guide pins before reinstallation of the upper internals package into the reactor vessel. When reviewing their procedures (to assure the ability of the reactor cavity seal to withstand the mechanical, thermal, and radiation impacts from a dropped fuel assembly) licensees may also wish to consider the need to carefully inspect the upper core support structure as it is initially raised from the reactor vessel to ensure that no core components are suspended.
