UNITED STATES  
NUCLEAR REGULATORY COMMISSION  
OFFICE OF NUCLEAR REACTOR REGULATION  
WASHINGTON, D.C. 20555

December 12, 1990

NRC INFORMATION NOTICE NO. 90-77: INADVERTENT REMOVAL OF FUEL ASSEMBLIES  
FROM THE REACTOR CORE

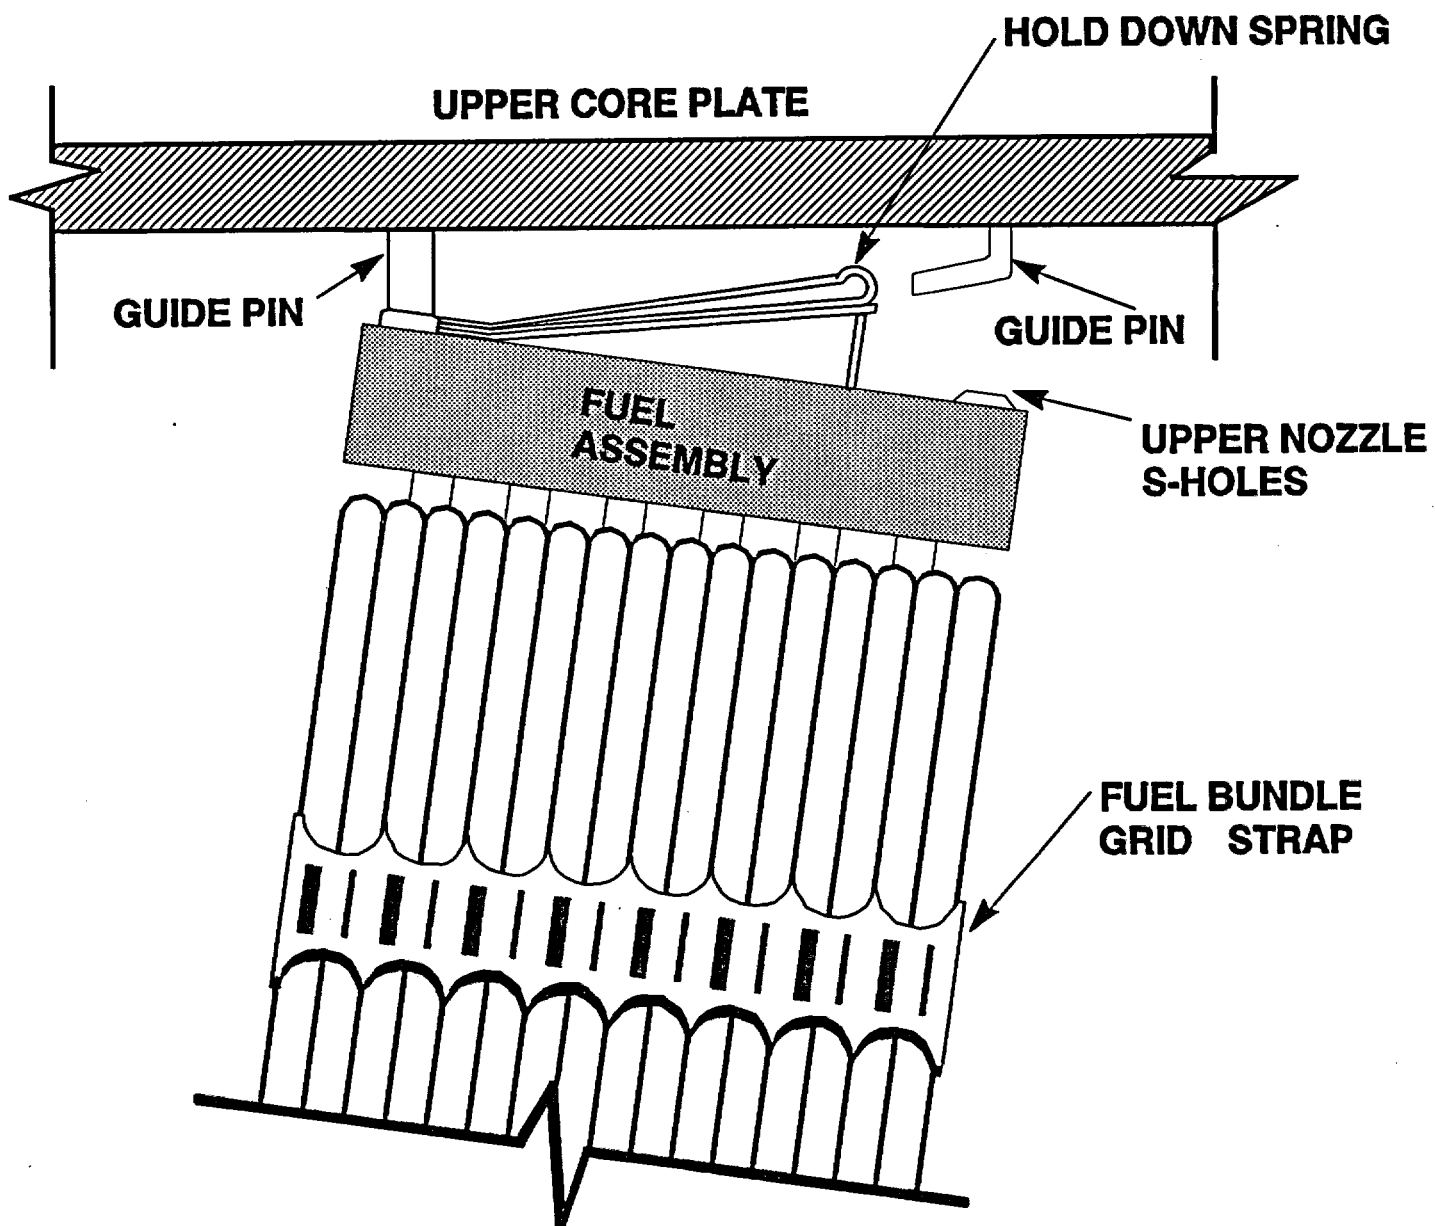
**INDIAN POINT 3**  
**Detailed View Showing Suspended Fuel Assembly from Bottom**  
**of Upper Internals Package**

The licensee was using a 350,000 lb-capacity polar crane with a Dillon load cell to lift the upper core internals package (weighing approximately 119,800 lbs). The suspended fuel assemblies together weighed approximately 2600 lbs. During the lift, the licensee did not detect the additional weight because the weight of the upper internals (with suspended fuel assemblies) was within the maximum allowable weight of 125,800 lbs, as specified by the licensee's refueling procedure.

Each of the two assemblies were attached to the upper core plate by bent fuel assembly guide pins as shown in Attachment 1. These guide pins extend downward from the upper core plate and insert into two holes in the upper nozzle of the fuel assembly when the upper core internals structure is properly aligned over the top of the core. For each of the suspended fuel assemblies, the licensee found that one guide pin was bent and not inserted into the top nozzle hole (upper nozzle S-hole on Attachment 1) of the fuel assembly, with the other guide pin bent and wedged into the assembly. In this condition, the guide pin suspended the assembly at an angle of approximately 7 degrees. The licensee has determined that the fuel assembly guide pins were damaged during the previous refueling outage when the upper internals package was being removed from the upper internals storage stand.

Licensees may wish to consider reviewing their procedures and equipment prior to performing activities which may lead to inadvertent damage to fuel assembly guide pins and inspecting the guide pins before reinstallation of the upper internals package into the reactor vessel. When reviewing their procedures (to assure the ability of the reactor cavity seal to withstand the mechanical, thermal, and radiation impacts from a dropped fuel assembly) licensees may also wish to consider the need to carefully inspect the upper core support structure as it is initially raised from the reactor vessel to ensure that no core components are suspended.
