UNITED STATES  
NUCLEAR REGULATORY COMMISSION  
OFFICE OF NUCLEAR REACTOR REGULATION  
WASHINGTON, D.C. 20555

NRC INFORMATION NOTICE NO. 90-76: FAILURE OF TURBINE OVERSPEED TRIP MECHANISM  
BECAUSE OF INADEQUATE SPRING TENSION

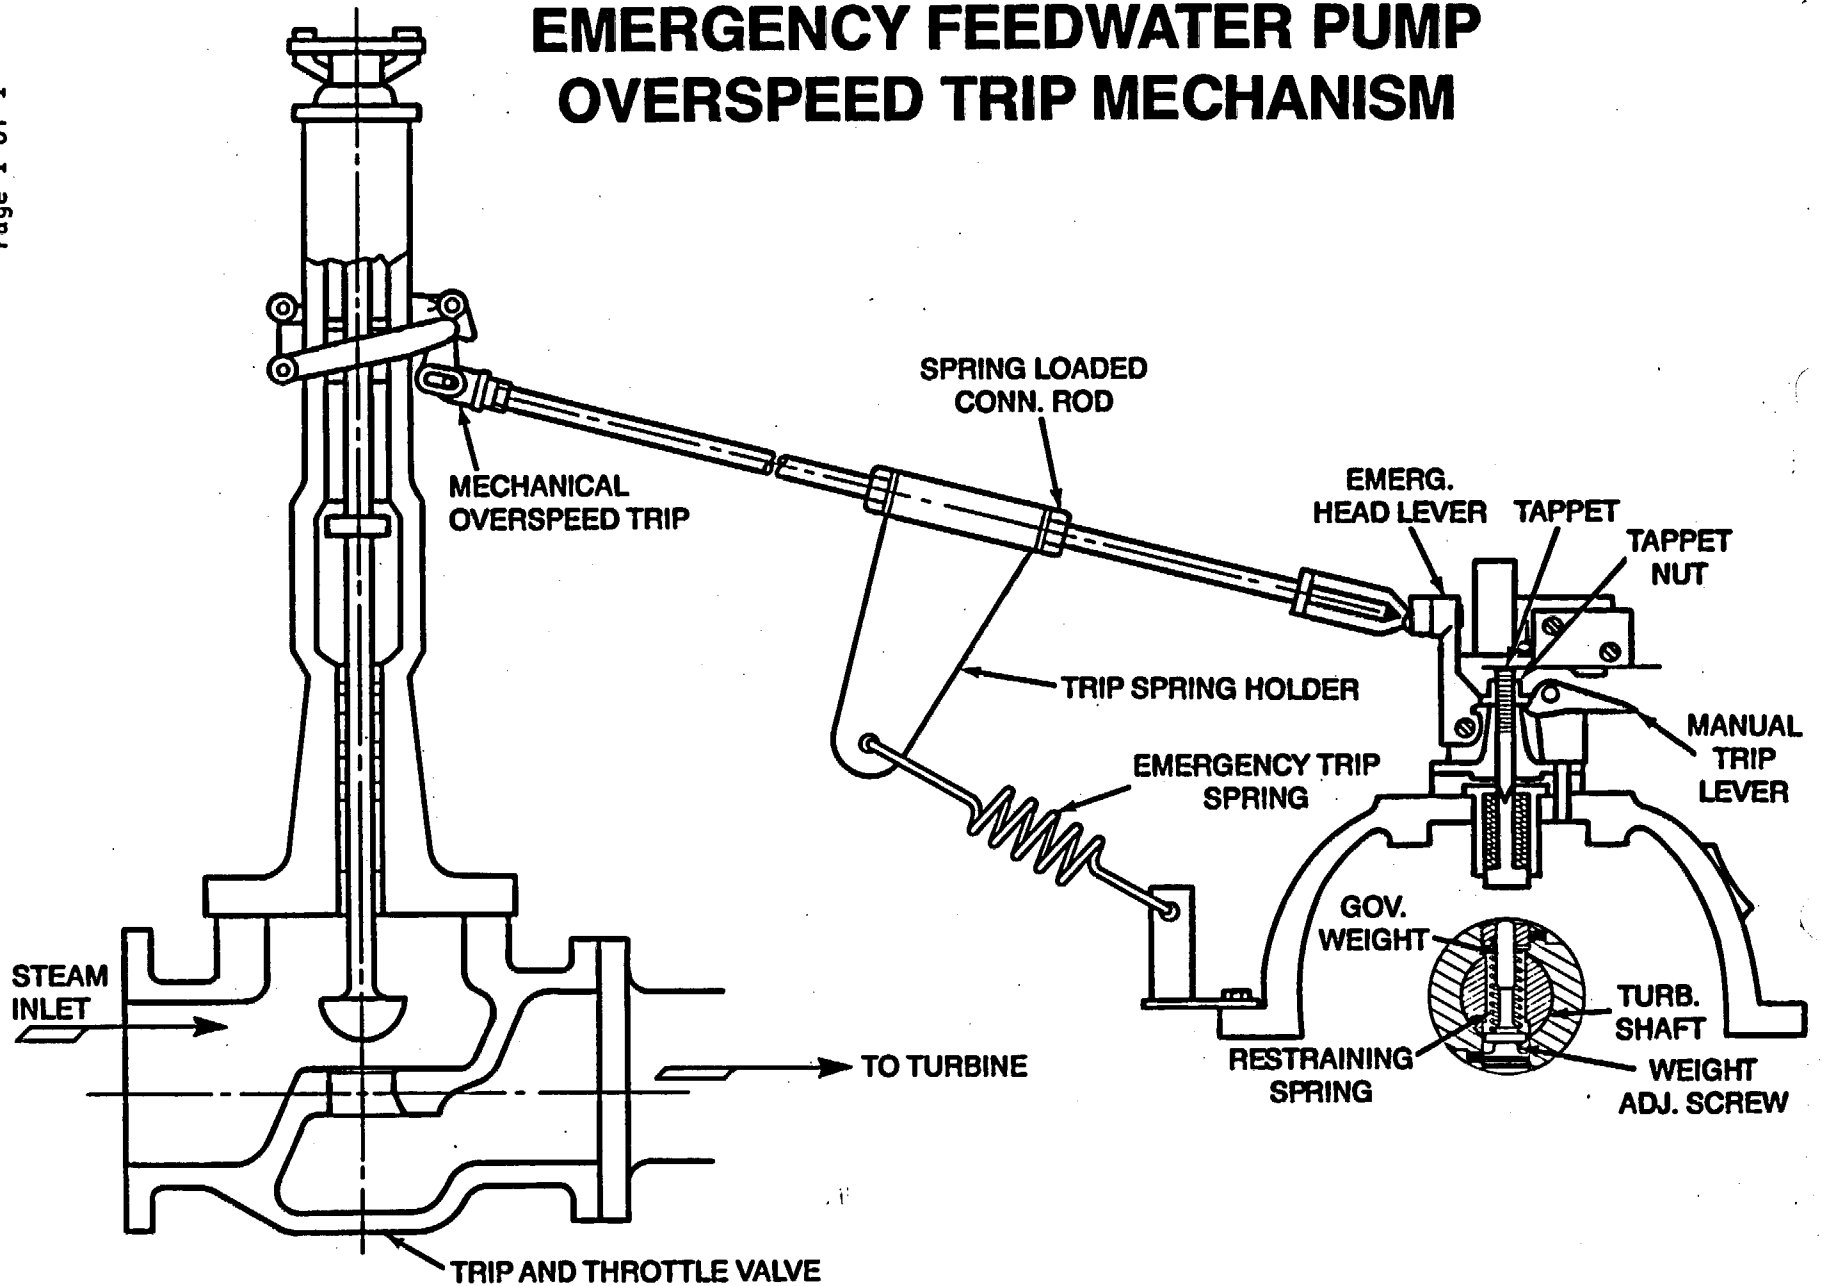
Figure 1  
**EMERGENCY FEEDWATER PUMP  
OVERSPEED TRIP MECHANISM**

In response to an overspeed, a weight in the turbine shaft is forced outward by the excessive centrifugal force, striking a tappet, which moves upward, releasing the emergency head lever (see Figure 1). This lever normally allows the emergency trip spring to move a rod connected to the turbine trip and throttle valve trip mechanism. The movement of the connecting rod should then disengage a trip hook lever on the trip and throttle valve allowing the valve to close. However, during the two failed tests, the emergency trip spring failed to move the connecting rod. During the first of these tests, the plant personnel were able to actuate the trip mechanism by tapping on the emergency trip spring holder, which produced an erratic response, indicating that the spring force and the frictional forces were evenly matched. Arkansas Nuclear One personnel lubricated the critical mating surfaces and achieved good trip response.

However, the second failure clearly indicated that insufficient spring force was the root cause of the problem. The original emergency trip spring, which had been in service approximately nine years, had stretched 1/8 inch beyond its normal at rest position. This spring was replaced with a new one of identical design. After this change, plant personnel successfully completed a number of trip tests.

Inspection of the original emergency trip spring provided neither evidence of a manufacturing defect nor that the spring had ever been stretched beyond its elastic limit. The observed elongation was apparently the result of a long-term relaxation process, which could develop on this or any other similar trip mechanism. The tension in the spring, and thus the force applied to the connecting rod, can be controlled by adjusting the position of the trip spring holder on a threaded portion of the connecting rod. This adjustment is made during turbine installation and normally is not changed or checked thereafter. The Arkansas Nuclear One staff intends to revise the maintenance procedures to specify adjustment of the trip spring holder position in the event of any future problems attributable to insufficient spring force.
