UNITED STATES
NUCLEAR REGULATORY COMMISSION
OFFICE OF NUCLEAR MATERIAL SAFETY AND SAFEGUARDS
WASHINGTON, D.C. 20555

September 4, 1990

NRC INFORMATION NOTICE NO. 90-56: INADVERTENT SHIPMENT OF A RADIOACTIVE SOURCE
IN A CONTAINER THOUGHT TO BE EMPTY

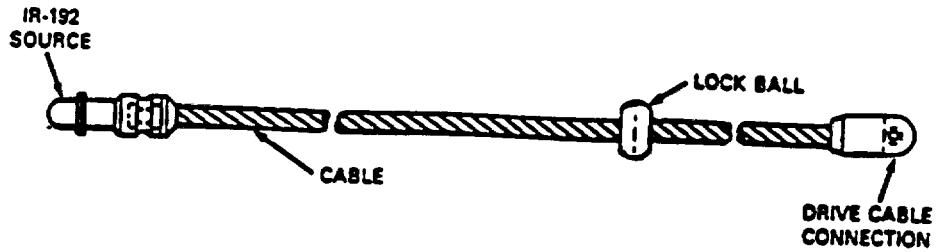
Typical Source Holder Assembly

Most radiographic operations involve projecting a radioactive source out of its shielded position within a radiography device into a pre-positioned tube. In order to facilitate handling, the source capsules are attached to one end of a short piece of cable with a connector attached to the other end. This piece of equipment is described as a "source assembly." An example of a typical source assembly is shown in Attachment 2. A drawing of Amersham's Model 500-SU source changer is also shown.

Apparently, Korean users were using source changers as storage devices for decaying depleted sources, before disposal. To store a source in a Model 500-SU source changer, the source capsule would be cut from the assembly, dropped into the source tube, and would fall to the shielded position. After the source decayed sufficiently, the source changer would be used to move the source to a disposal area. The IIT was able to verify that KIT used the source changer involved in this incident in such a manner, and that KIT failed to remove the source before returning the source changer. Amersham reported that it had received source changers containing severed source capsules (the source remained in the shielded area) on two previous occasions, and that from 1985 to 1989, at least nine source changers were returned from Korea with contaminated source tubes.
