UNITED STATES
NUCLEAR REGULATORY COMMISSION
OFFICE OF NUCLEAR MATERIAL SAFETY AND SAFEGUARDS
WASHINGTON, D.C. 20555

NRC INFORMATION NOTICE NO. 90-56: INADVERTENT SHIPMENT OF A RADIOACTIVE SOURCE
IN A CONTAINER THOUGHT TO BE EMPTY

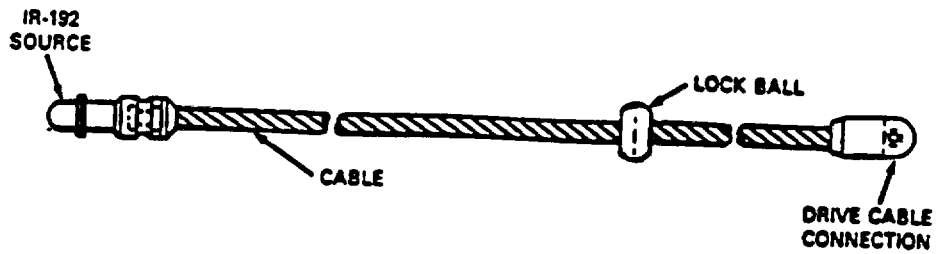
Typical Source Holder Assembly

Most radiographic operations involve projecting a radioactive source out of its shielded position within a radiography device into a pre-positioned tube. In order to facilitate handling, the source capsules are attached to one end of a short piece of cable with a connector attached to the other end. This piece of equipment is described as a "source assembly." An example of a typical source assembly is shown in Attachment 2. A drawing of Amersham's Model 500-SU source changer is also shown.

Apparently, Korean users were using source changers as storage devices for decaying depleted sources, before disposal. To store a source in a Model 500-SU source changer, the source capsule would be cut from the assembly, dropped into the source tube, and would fall to the shielded position. After the source decayed sufficiently, the source changer would be used to move the source to a disposal area. The IIT was able to verify that KIT used the source changer involved in this incident in such a manner, and that KIT failed to remove the source before returning the source changer. Amersham reported that it had received source changers containing severed source capsules (the source remained in the shielded area) on two previous occasions, and that from 1985 to 1989, at least nine source changers were returned from Korea with contaminated source tubes.

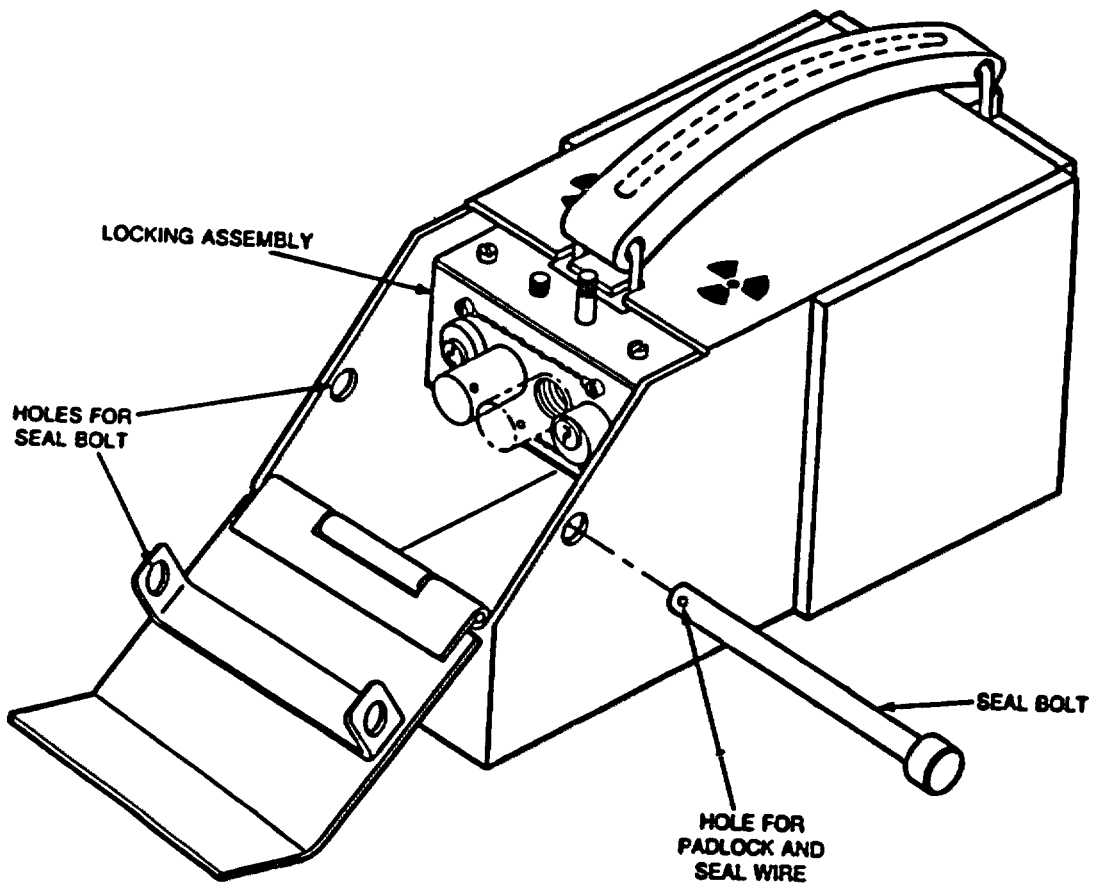
External View of Model 500-SU Source Changer

The Model 500-SU operations manual also informed the user to "... assure that there is no source in the container." However, the manual did not list specific procedures to make this determination. Ordinarily, a visual examination would verify the presence (or absence) of a source assembly, as the connector end of the assembly would be evident. However, a visual examination would not have revealed the source in this incident because the source was cut from the source assembly. A surface radiation survey could also be used to detect a source in a changer. However, NRC determined that even for a changer containing a 3-curie source, the surface readings would be indistinguishable from readings obtained from the DU shield of an empty source changer. Amersham estimated that the minimum source activity detectable through the DU shielding of the Model 500-SU is 4 curies.

3. Licensees returning shielded packages that do not contain radioactive material, especially those packages that incorporate DU shields, are cautioned that complete and accurate radiation surveys must be performed, and that a physical probe of the package may be necessary to verify that the package does not contain radioactive materials.

4. Manufacturers who receive returned packages should ensure that they provide complete instructions to customers for properly verifying that packages are empty as well as for meeting restrictions on surface radiation levels. Licensees that return such packages should ensure that these procedures are strictly followed.
