# Reactor Vessel Head Inspection Current Status and Future Plans

Calvert Cliffs  
Nuclear  
Power Plant  
Unit 2

March 18,  
2003

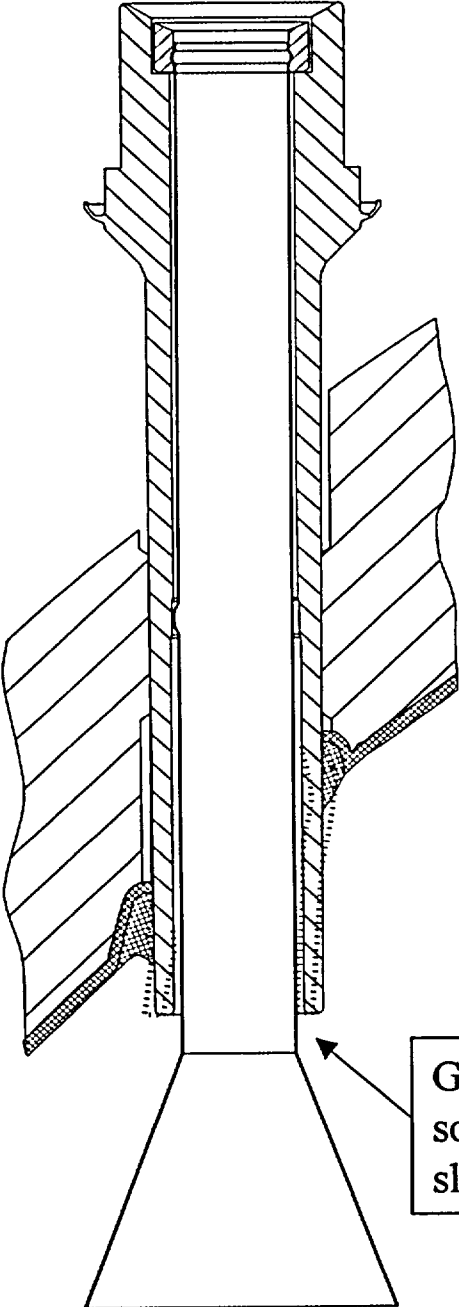
Gap becomes too small. In some cases nozzle and guide sleeve touch.

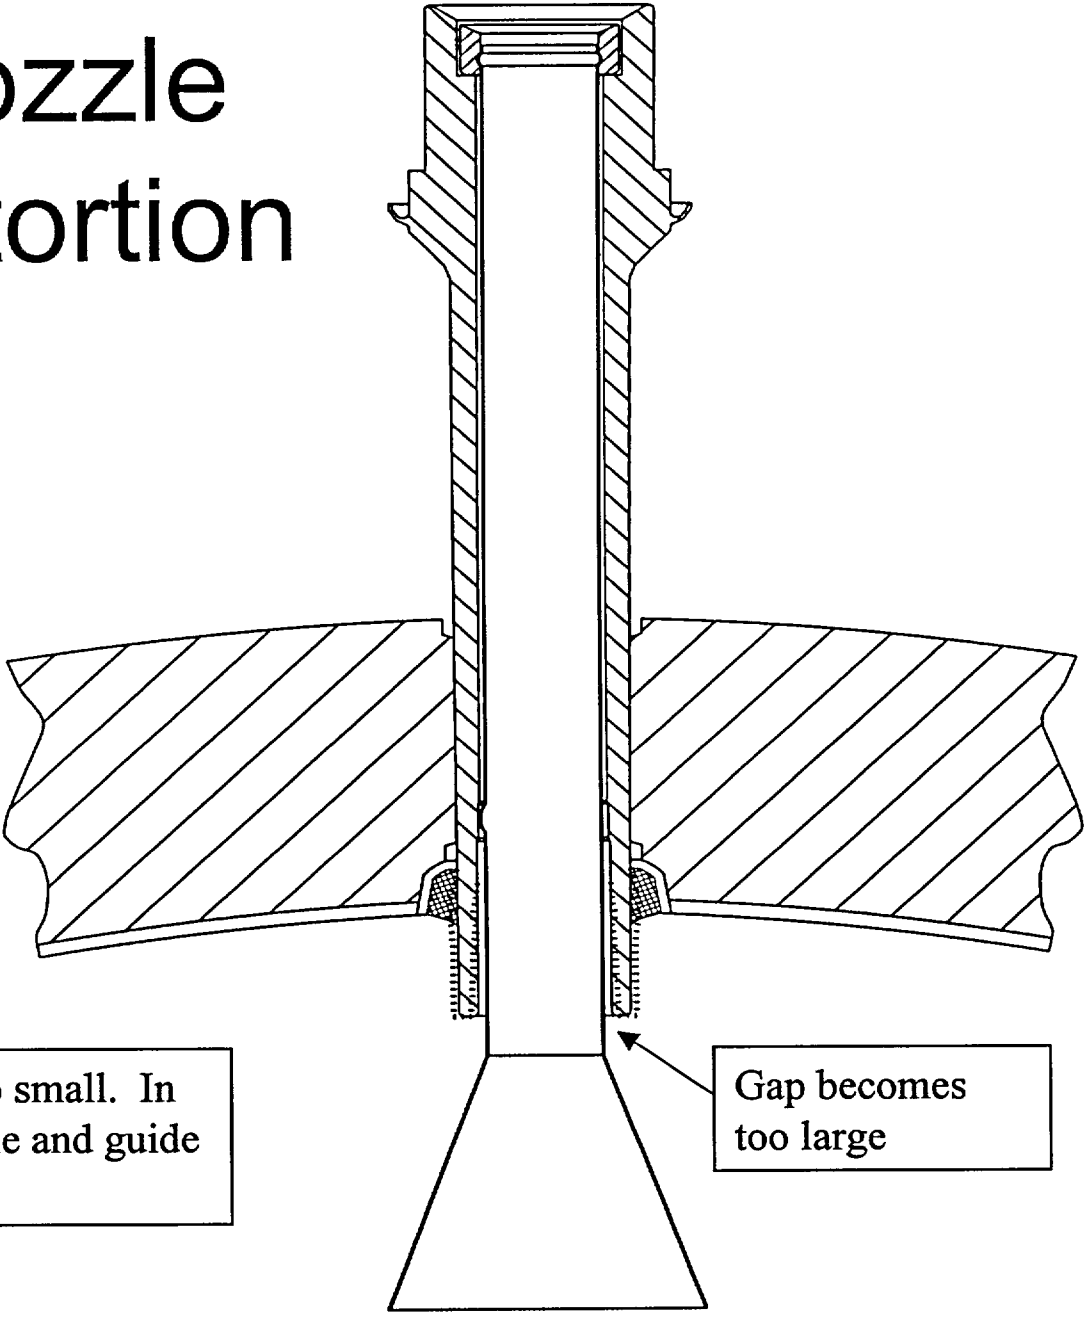
Gap becomes too large

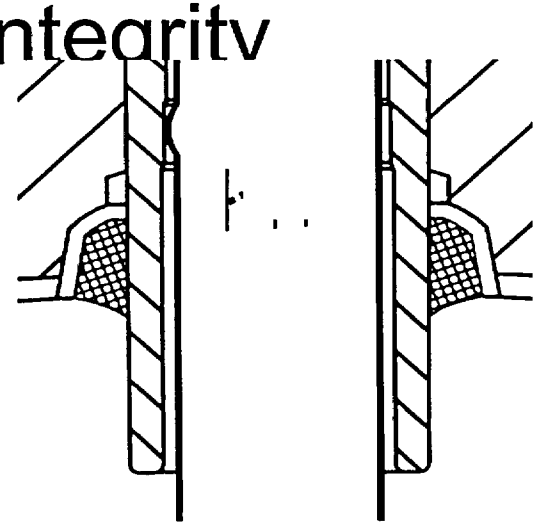
- Have achieved examination of approximately 214 of 227 in<sup>2</sup>
- Unavailable azimuths assessed deterministically for structural integrity
  - 11 nozzles have 360° coverage
  - One has 355° coverage
  - One has 117° coverage

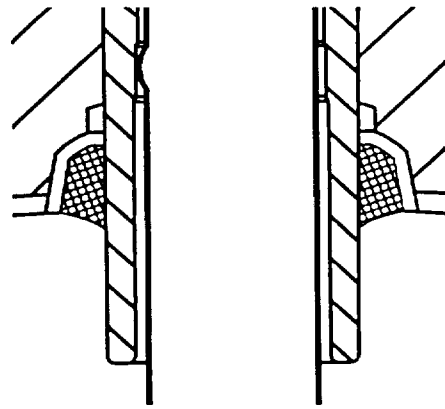
- Have examined approximately 37 of 117 total in<sup>2</sup>
- Fewer structural integrity concerns for unavailable azimuths in welds
