UNITED STATES
NUCLEAR REGULATORY COMMISSION
OFFICE OF NUCLEAR REACTOR REGULATION
WASHINGTON, D.C. 20555

December 16, 1987

NRC INFORMATION NOTICE NO. 87-35, SUPPLEMENT 1: REACTOR TRIP BREAKER,
WESTINGHOUSE MODEL DS-416,
FAILED TO OPEN ON MANUAL
INITIATION FROM THE CONTROL
ROOM

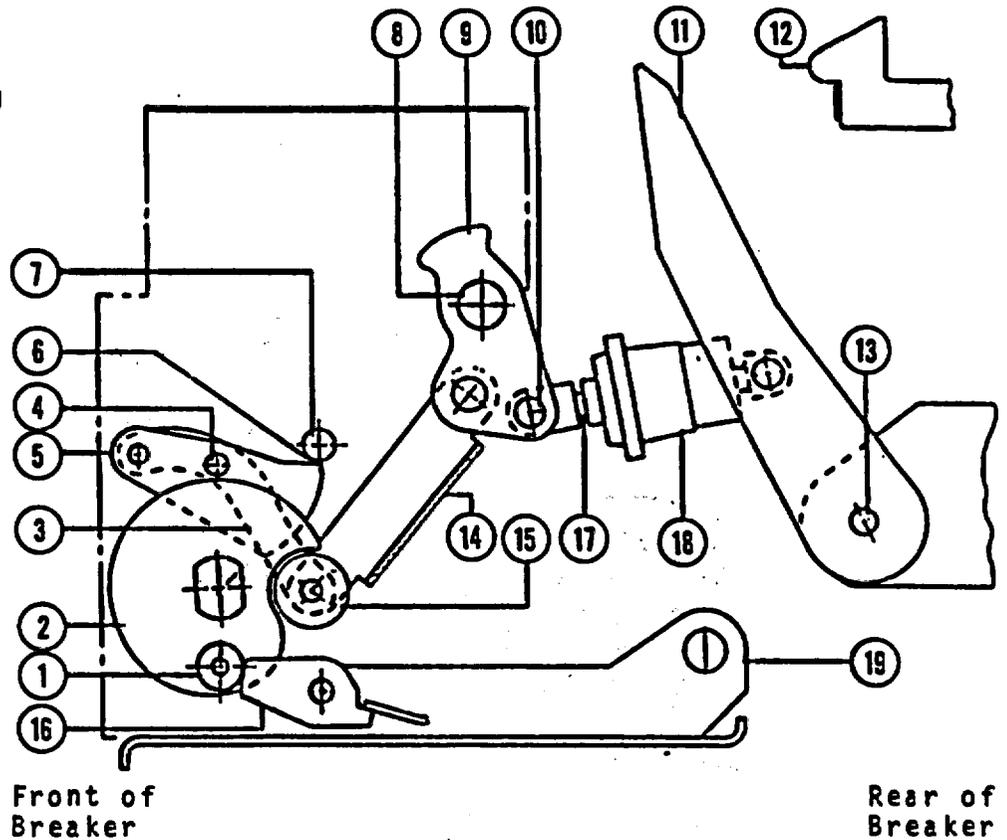
Figure 1. Linkages of DS-416 Breaker Mechanism Shown with CB Open and Springs Charged (Source: Instructions for Low-Voltage Power Circuit Breakers Types DS and DSL, Westinghouse Electric Corp., Instruction Bulletin 33-790-IE)

In the Westinghouse DS series breakers, the close cam (item 2 in Figure 1) is composed of four steel segments that are sandwiched together and held by three rivets. The two outer segments are heat-treated steel; the two inner segments are non-hardened steel. The surface of the segments is supposed to be of uniform shape. However, on the McGuire RTB, the two outer segments are slightly larger than the inner segments, providing the edge to catch the main roller (item 15). Only a slightly raised cam edge is necessary to allow binding. In addition, the distance between the inner surface of the close cam edge and the side frame plate (item 19) must be close to the width of the main roller.

Both lateral displacement of the main roller end of the main drive link (item 14) and a small rotation (3 to 5 degrees) of the main roller axis are necessary to allow wedging. If the weld joining the center pole lever (item 9) to the pole shaft (item 8) is sound, the main roller end of the main drive link could still move laterally and even allow the main roller to strike the side plate. However, a sound weld would not allow sufficient rotation of the axis for wedging to occur. A large number of cycles of operation (3000 or more), however, could cause wear that would allow the necessary rotation of the axis.

Trip Latch Pivot Pin. During an NRC inspection at Braidwood 2 in late September 1987, the licensee reported that a Westinghouse DS-416 RTB at Braidwood 1 failed to close because improper brazing of the pivot pin (item 4 in Figure 1) to the trip latch (item 5) resulted in disengagement of the two. While not of safety concern for an RTB, this failure to close condition would be of concern for a breaker in a Class 1E application requiring energization of the connected loads.

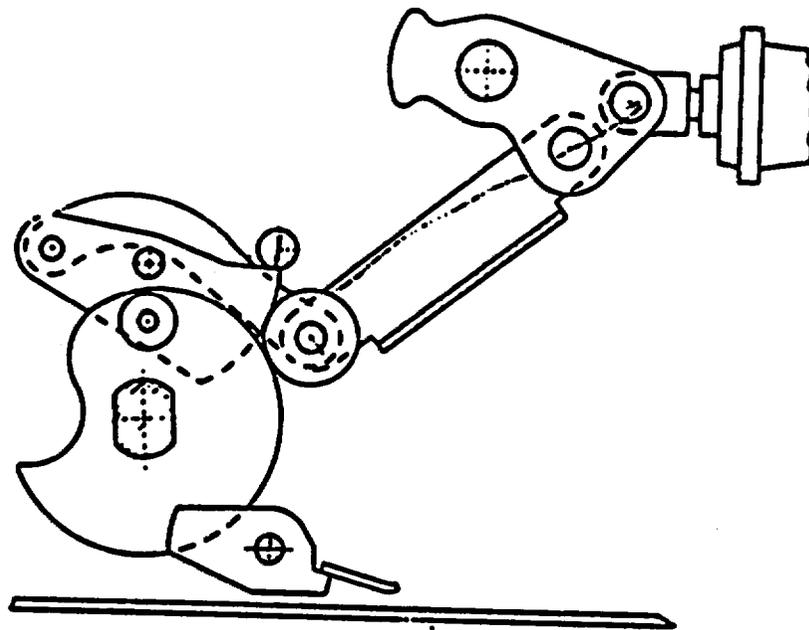
Figure 2. Position of Mechanism with RTB Closed (Source: Instructions for Low-Voltage Power Circuit Breakers, Types DS and DSL, Westinghouse Electric Corp., Instruction Bulletin 33-790-IE)

The McGuire 2 RTB failed to open because the main roller was wedged between the raised edge of the close cam and the right-hand side frame plate (viewing the RTB from the rear). A labeled view of the RTB mechanism is shown in Figure 1. When the RTB is closed, the position of the mechanism is as shown in Figure 2. A conceptual sketch showing the main roller wedged between the right side frame plate and the left cam segment, as viewed from the rear of the RTB, is shown in Figure 3. Similar wedging could occur between the left side frame plate and the right cam segment.

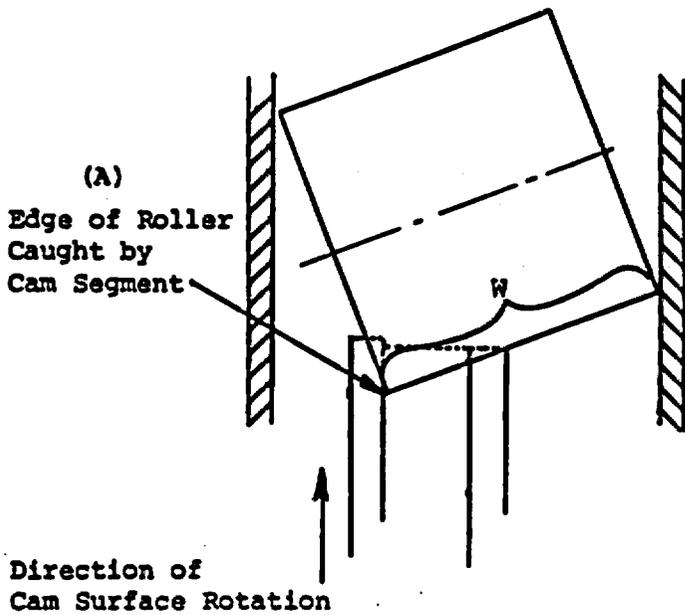
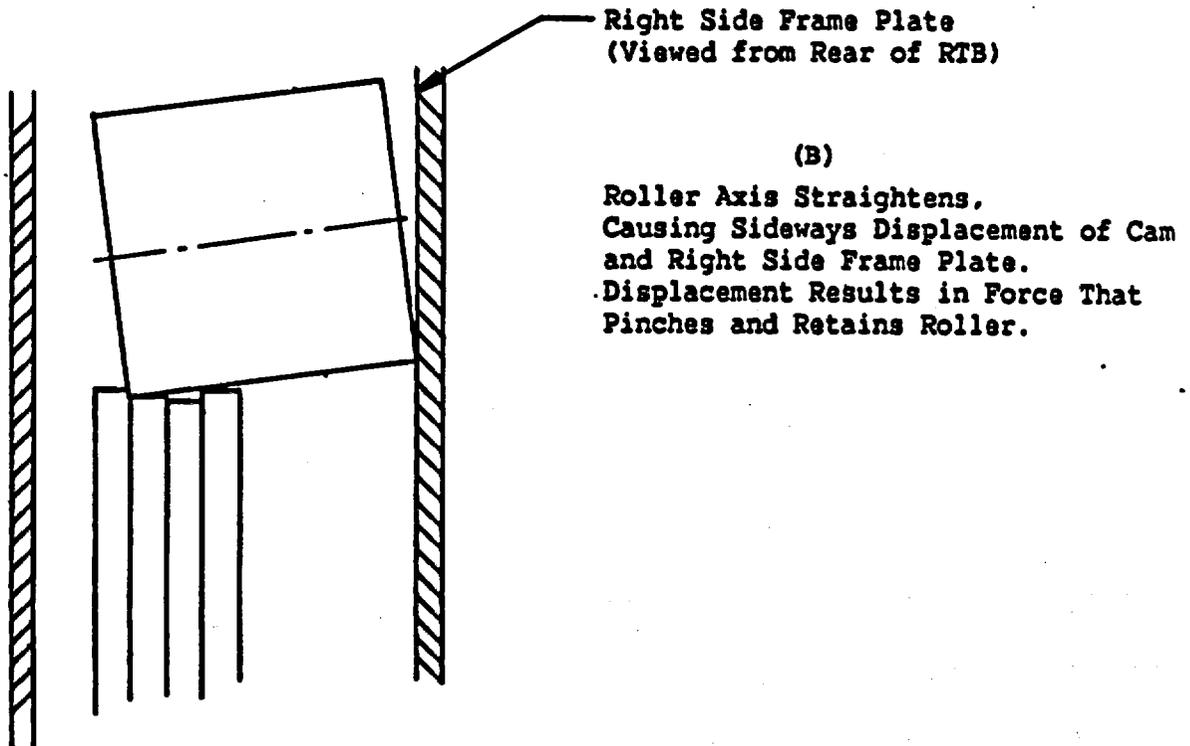
Figure 4. Binding of Roller
(Source: Franklin Research Center, Interim
Report, September 30, 1987)

The main roller can become wedged during the closing action of the breaker. As the close cam rotates, the edge of the main roller is caught, as shown in Figure 4. Continued rotation of the close cam causes the main roller axis to straighten. This action causes the edges of the main roller to attempt to separate the close cam and the side frame plate. However, the close cam and side frame plate are not free to move and, therefore, they wedge the main roller in place. When an attempt is made to trip the breaker, the wedging of the main roller prevents the main roller from rolling down the close cam face to allow the circuit breaker to open. The wedging of the main roller also prevents full discharge of the closing springs (not shown in Figure 1), leaving the close cam 18 degrees from a fully rotated position.
