UNITED STATES
NUCLEAR REGULATORY COMMISSION
OFFICE OF NUCLEAR REACTOR REGULATION
WASHINGTON, D.C. 20555

December 16, 1987

NRC INFORMATION NOTICE NO. 87-35, SUPPLEMENT 1: REACTOR TRIP BREAKER,
WESTINGHOUSE MODEL DS-416,
FAILED TO OPEN ON MANUAL
INITIATION FROM THE CONTROL
ROOM

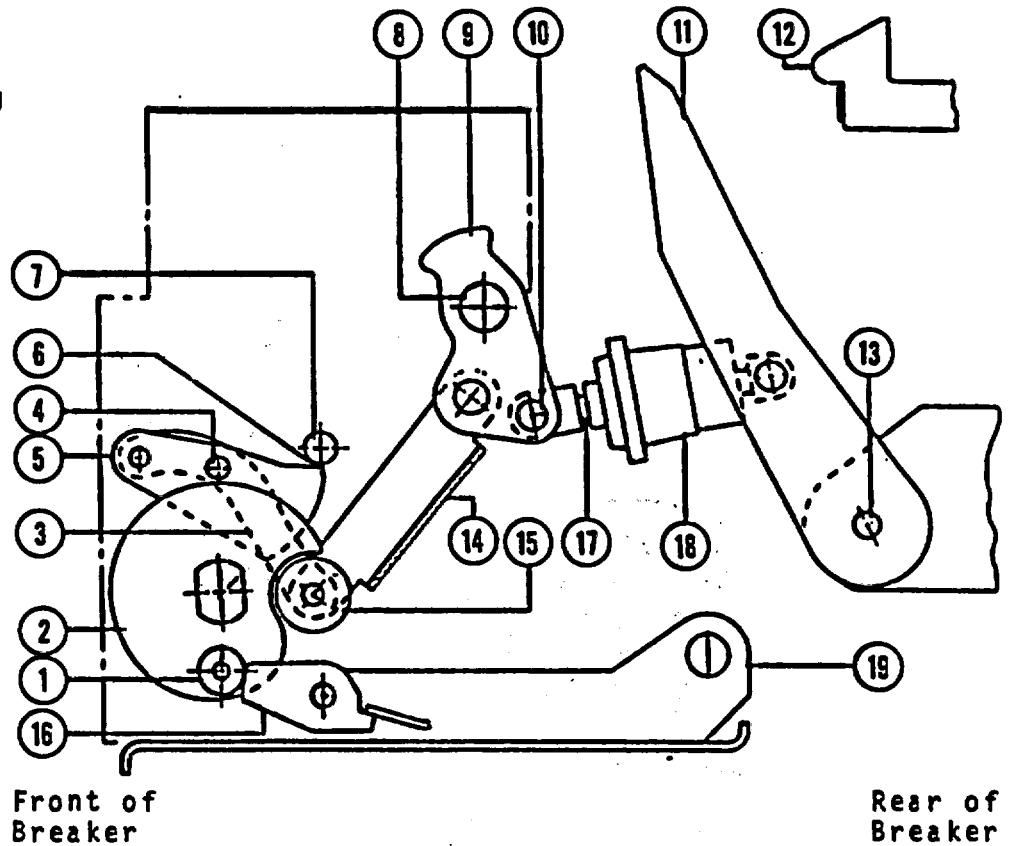
Figure 1. Linkages of DS-416 Breaker Mechanism Shown with CB Open and Springs Charged (Source: Instructions for Low-Voltage Power Circuit Breakers Types DS and DSL, Westinghouse Electric Corp., Instruction Bulletin 33-790-IE)

In the Westinghouse DS series breakers, the close cam (item 2 in Figure 1) is composed of four steel segments that are sandwiched together and held by three rivets. The two outer segments are heat-treated steel; the two inner segments are non-hardened steel. The surface of the segments is supposed to be of uniform shape. However, on the McGuire RTB, the two outer segments are slightly larger than the inner segments, providing the edge to catch the main roller (item 15). Only a slightly raised cam edge is necessary to allow binding. In addition, the distance between the inner surface of the close cam edge and the side frame plate (item 19) must be close to the width of the main roller.

Both lateral displacement of the main roller end of the main drive link (item 14) and a small rotation (3 to 5 degrees) of the main roller axis are necessary to allow wedging. If the weld joining the center pole lever (item 9) to the pole shaft (item 8) is sound, the main roller end of the main drive link could still move laterally and even allow the main roller to strike the side plate. However, a sound weld would not allow sufficient rotation of the axis for wedging to occur. A large number of cycles of operation (3000 or more), however, could cause wear that would allow the necessary rotation of the axis.

flattened and laterally expanded the surface of the outer cam segments, creating a mushroom shape. Of key concern was mushrooming in the area of the stop roller (item 1), which holds the mechanism in readiness for release of the spring release latch (item 16). The extreme mushrooming impeded rotation of the stop roller. It is possible that sufficient mushrooming could totally prevent operation of the stop roller, which could prevent closure of the circuit breaker upon demand. While not of safety concern for an RTB, this failure to close condition would be of concern for a breaker in a Class 1E application requiring energization of the connected loads.

Trip Latch Pivot Pin. During an NRC inspection at Braidwood 2 in late September 1987, the licensee reported that a Westinghouse DS-416 RTB at Braidwood 1 failed to close because improper brazing of the pivot pin (item 4 in Figure 1) to the trip latch (item 5) resulted in disengagement of the two. While not of safety concern for an RTB, this failure to close condition would be of concern for a breaker in a Class 1E application requiring energization of the connected loads.

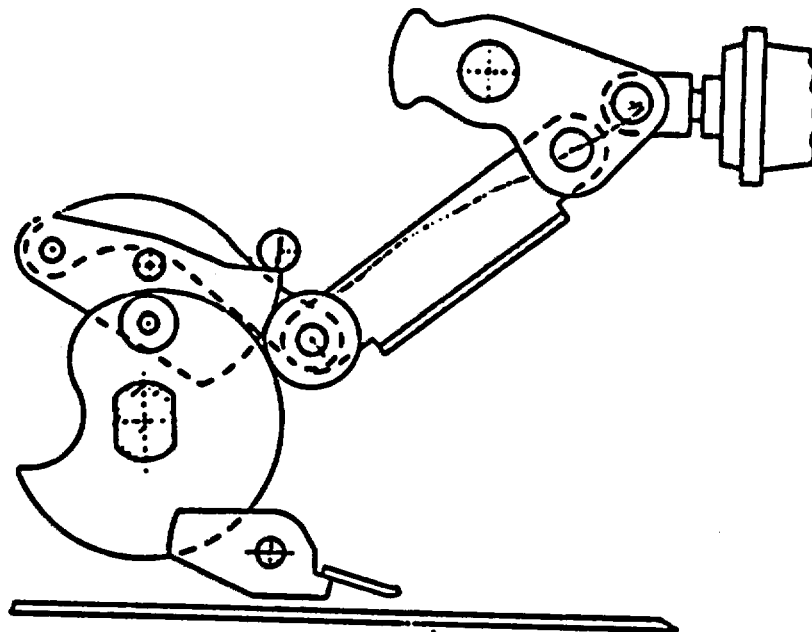
Figure 2. Position of Mechanism with RTB Closed (Source: Instructions for Low-Voltage Power Circuit Breakers, Types DS and DSL, Westinghouse Electric Corp., Instruction Bulletin 33-790-IE)

The McGuire 2 RTB failed to open because the main roller was wedged between the raised edge of the close cam and the right-hand side frame plate (viewing the RTB from the rear). A labeled view of the RTB mechanism is shown in Figure 1. When the RTB is closed, the position of the mechanism is as shown in Figure 2. A conceptual sketch showing the main roller wedged between the right side frame plate and the left cam segment, as viewed from the rear of the RTB, is shown in Figure 3. Similar wedging could occur between the left side frame plate and the right cam segment.

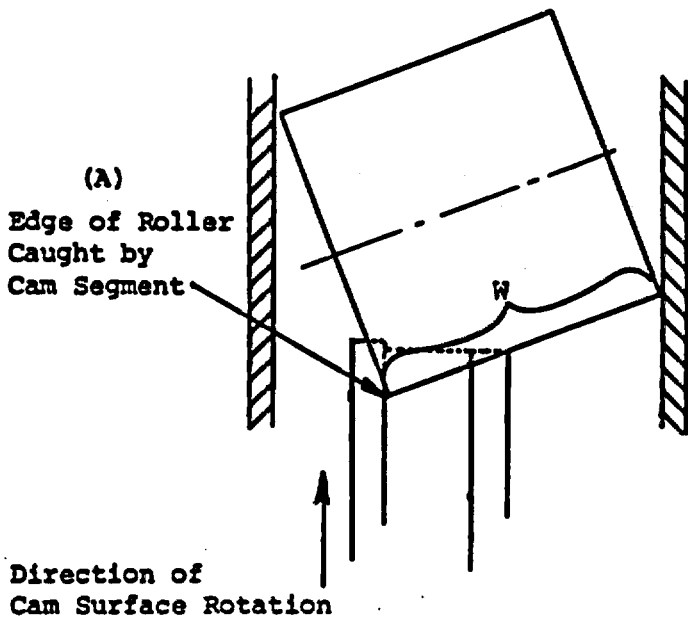
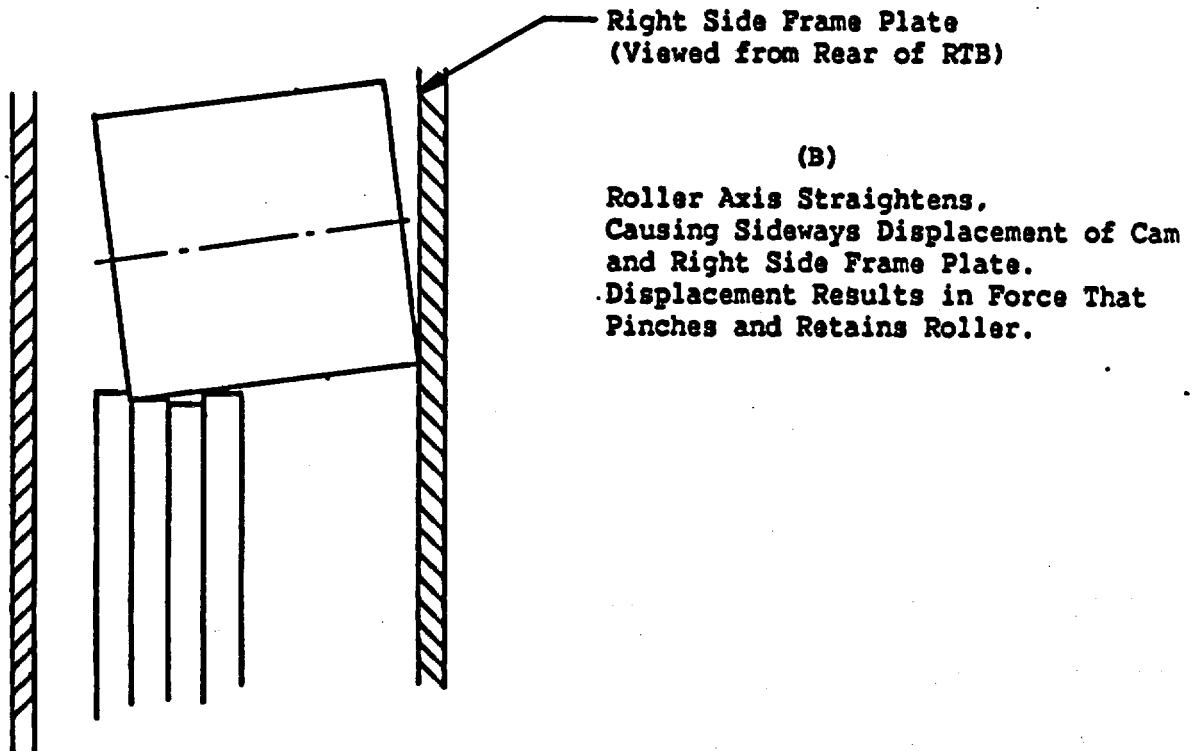
Figure 4. Binding of Roller
(Source: Franklin Research Center, Interim Report, September 30, 1987)

The main roller can become wedged during the closing action of the breaker. As the close cam rotates, the edge of the main roller is caught, as shown in Figure 4. Continued rotation of the close cam causes the main roller axis to straighten. This action causes the edges of the main roller to attempt to separate the close cam and the side frame plate. However, the close cam and side frame plate are not free to move and, therefore, they wedge the main roller in place. When an attempt is made to trip the breaker, the wedging of the main roller prevents the main roller from rolling down the close cam face to allow the circuit breaker to open. The wedging of the main roller also prevents full discharge of the closing springs (not shown in Figure 1), leaving the close cam 18 degrees from a fully rotated position.
