UNITED STATES  
NUCLEAR REGULATORY COMMISSION  
OFFICE OF NUCLEAR REACTOR REGULATION  
WASHINGTON, D.C. 20555

July 30, 1987

NRC INFORMATION NOTICE NO. 87-35: REACTOR TRIP BREAKER, WESTINGHOUSE MODEL DS-416, FAILED TO OPEN ON MANUAL INITIATION FROM THE CONTROL ROOM

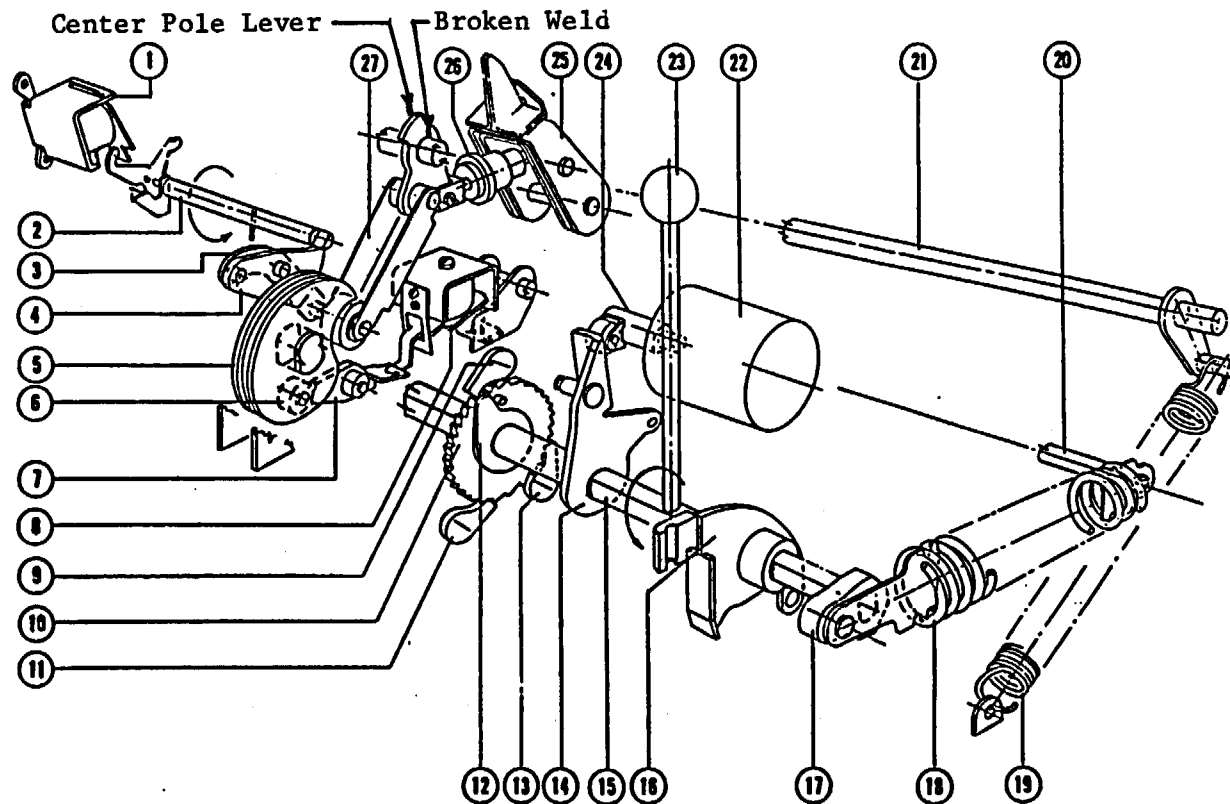
**Figure 2-16. Power-Operated (Stored-Energy) Mechanism Graphic Details  
(Close Spring Shown in the Charged Position)**

An NRC Augmented Inspection Team (AIT) evaluated the licensee's investigation into the reactor trip breaker problem. Abnormal wear and a broken weld were found in this early vintage of Westinghouse DS-416 breaker (see Westinghouse Figure, Attachment 1). The broken weld was on the main drive link between the center pole lever and the pole shaft. Except for the shunt trip coil that had burned and shorted while trying to open the breaker, the breaker's electrical controls and auxiliary contacts were verified to be properly wired and operating as designed. The cause for the anomalous breaker status indication is still under investigation.

Attempts to repeat the condition, where the breaker was mechanically binding in the closed position, were minimally successful. Preliminary conclusions of the AIT are that the breaker's mechanical binding was caused by a combination of wear (greater than 2000 cycles of operation), manufacturing tolerances in this early vintage breaker, and the broken weld. These factors may have combined to allow sufficient lateral movement of the main linkage to cause it to jam at or near full breaker closure and thus prevent the breaker from opening. Since the control room operating personnel stated that they observed the open indication on the closed B train RTB, the field wiring is being verified by the licensee to ensure that wiring is as designed. The shorted shunt trip coil had allowed 125 volts dc between the positive terminal and the chassis; a "sneak" circuit is possible.

Broken weld from center pole lever to pole shaft (21). Another lever not shown in diagram had an intact weld. The combination of broken weld, manufacturing tolerance, and high cycle wear are considered to be factors in the mechanical binding of the breaker.

The licensee is inspecting all of the RTBs for signs of abnormal wear, cracks in welds, and excessive lateral play (greater than 1/8 inch) in the roller end of the main drive link where it contacts the close cam. This measurement had not previously been part of the periodic preventive maintenance for the RTB. Moreover, following any reactor trip, the licensee is ensuring the open position of both RTBs by inspecting the breaker before reclosure. These are short-term corrective actions until the detailed analysis of the deficiencies is completed.
