UNITED STATES  
NUCLEAR REGULATORY COMMISSION  
OFFICE OF NUCLEAR REACTOR REGULATION  
WASHINGTON, D.C. 20555

September 16, 1987

NRC INFORMATION NOTICE NO. 87-44: THIMBLE TUBE THINNING IN WESTINGHOUSE  
REACTORS

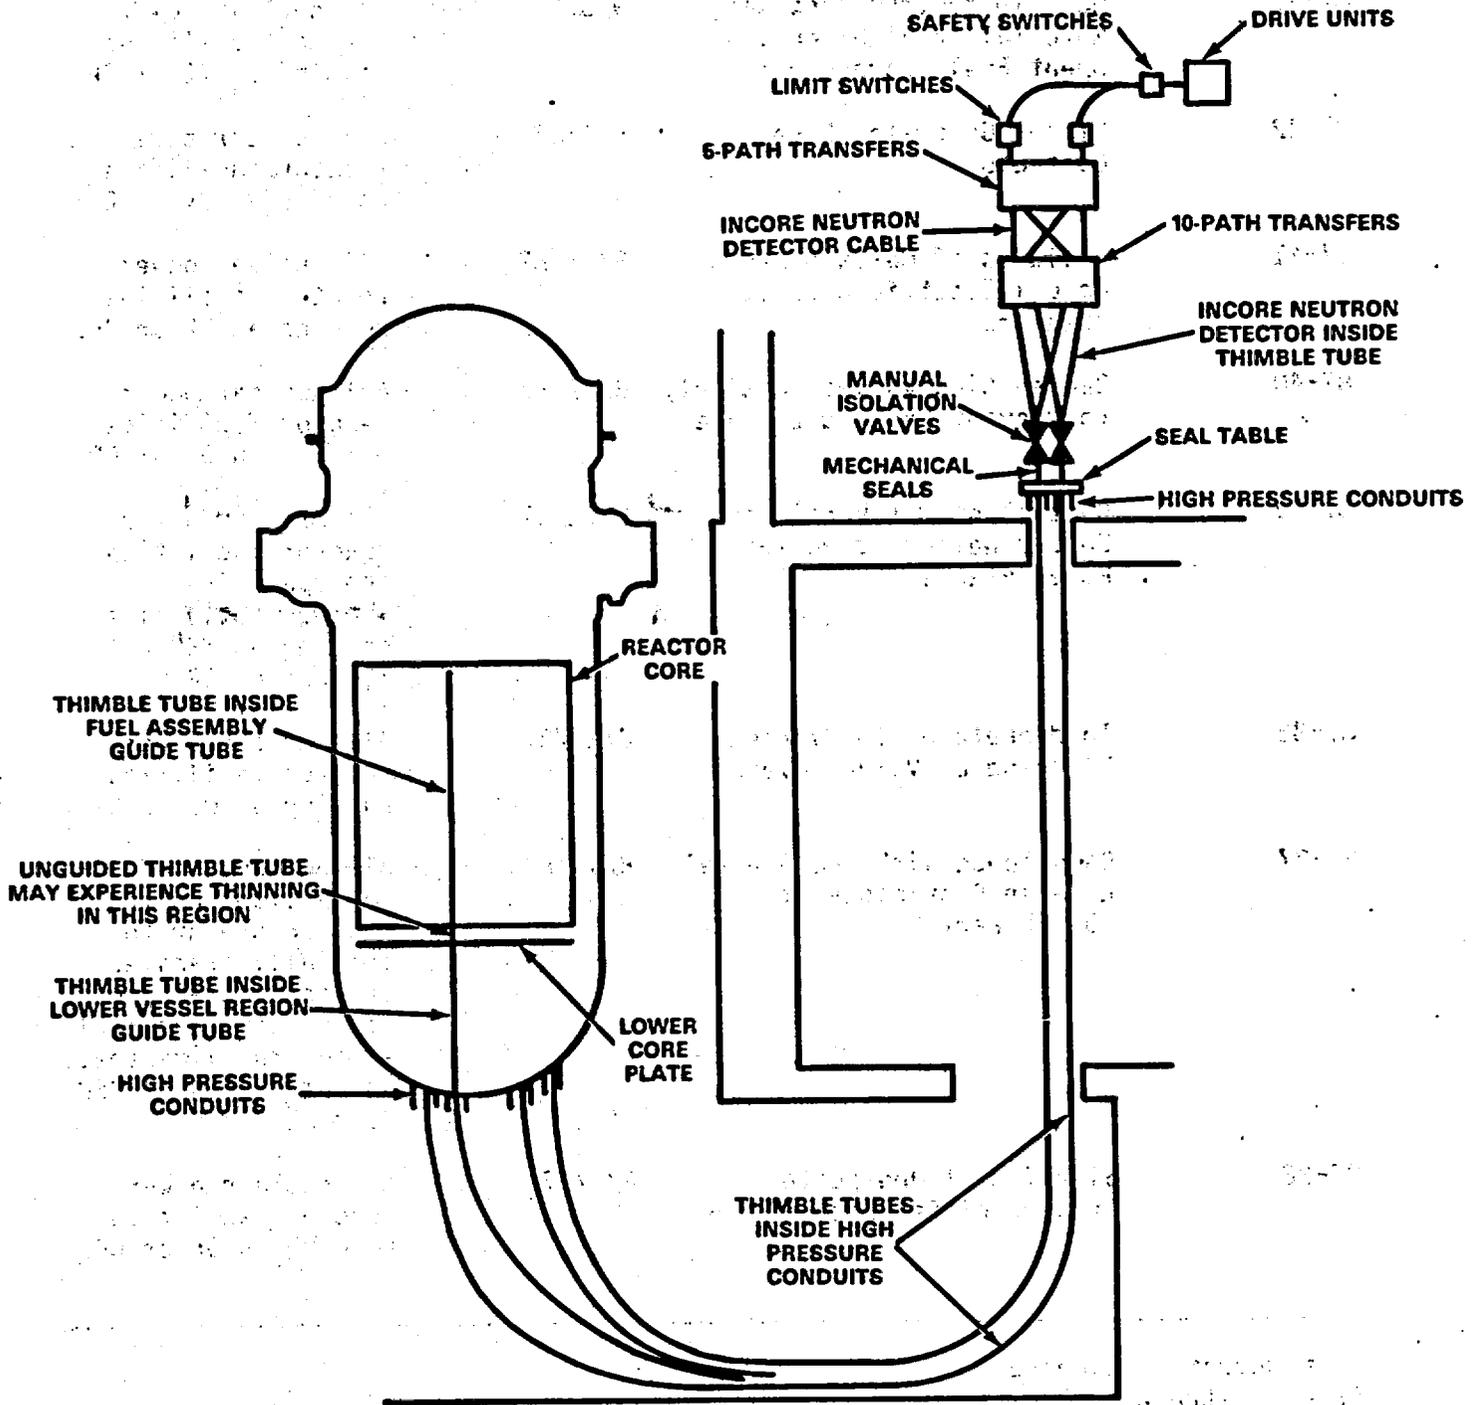
# TYPICAL WESTINGHOUSE INCORE NEUTRON MONITORING SYSTEM

The movable incore neutron detectors travel within retractable thimble tubes. The thimble tubes normally extend (as indicated in Attachment 1) from a 10-path transfer device, through the seal table, through the bottom of the reactor vessel, and into selected fuel assemblies. The thimble tubes are supported by guide tubes within the lower vessel region and the fuel assemblies, and by high-pressure conduits between the reactor vessel and the seal table.

As indicated, the thimble tubes are supported over most of their length. However, a small portion of the thimble tube is directly exposed to RCS flow. This exposed portion is between the top of the lower core plate and the bottom of the fuel assembly. This region is approximately 18.4 to 34.8 mm in length, depending on the reactor type. It is believed that flow-induced vibration on this exposed portion causes fretting at the adjacent guide tubes.

At North Anna Unit 1, the proposed corrective action was to retract selected thimble tubes approximately 2 inches. This would move the thinned area out of the region of high turbulence. In addition, the thimble tube that experienced the most degradation will be taken out of service by closing the corresponding isolation valve.
