UNITED STATES
NUCLEAR REGULATORY COMMISSION
OFFICE OF NUCLEAR REACTOR REGULATION
WASHINGTON, D.C. 20555

June 29, 1990

NRC INFORMATION NOTICE NO. 90-44: DOSE-RATE INSTRUMENTS UNDERRESPONDING
TO THE TRUE RADIATION FIELDS

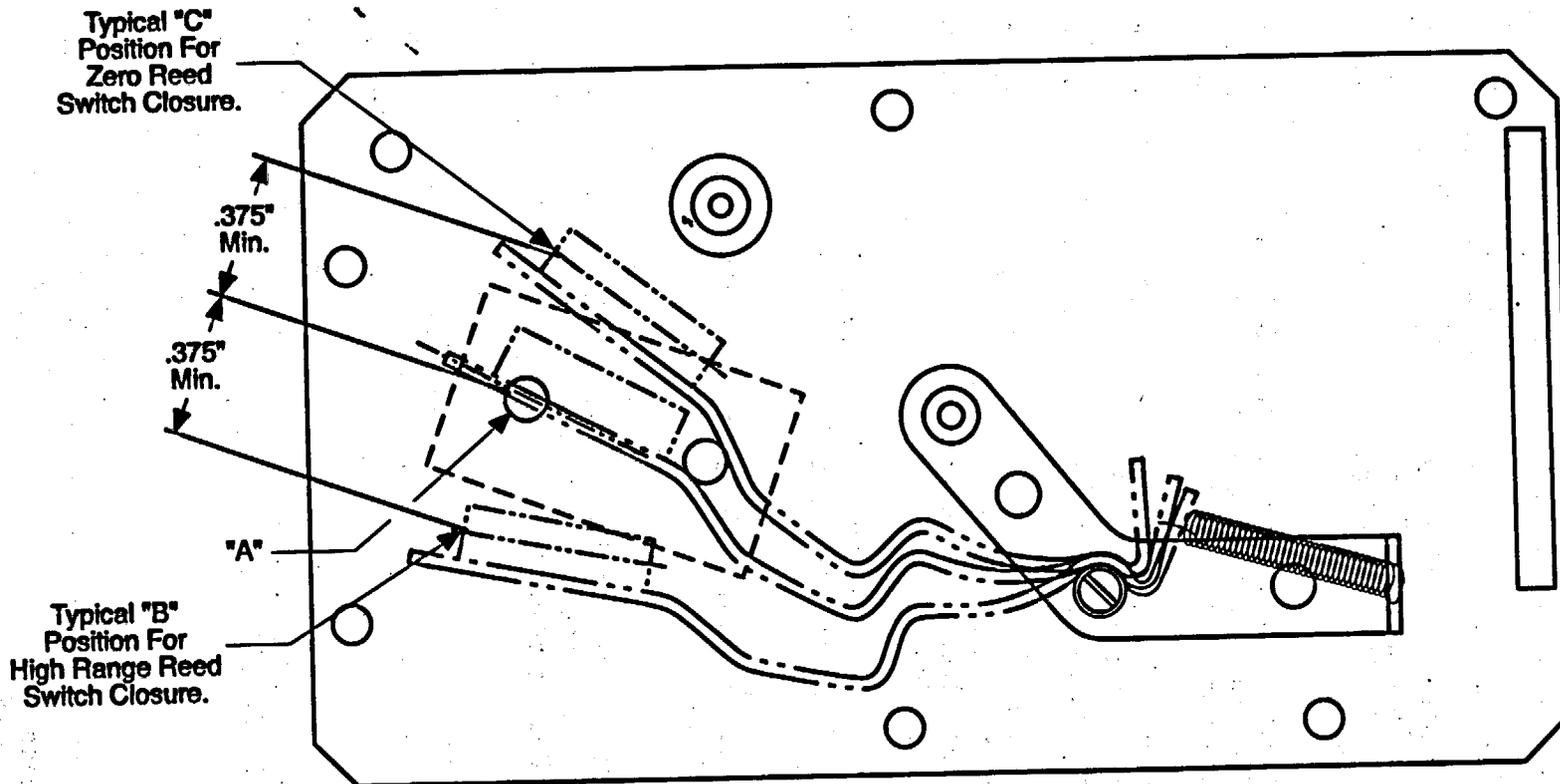
Figure 1, Typical Magnet Arm Position, RSO Instruments

The instruments were removed from service and were returned to the manufacturer. Bicron's examination confirmed the effect and found that the failure had been caused by a change in positioning of the magnet that activates reed switches in the ion chamber. This magnet moves on a cam-actuated arm, and the cam is attached to the range switch. Figure 1 illustrates typical magnet arm positions for the Bicron RSO series of instruments. At the zero position (one end) of the range switch rotation, the arm moves the magnet over the zero reed switch and shorts the electronic input for zeroing. Switching from zero to the first (0-5 mR/h) and second (0-50 mR/h) ranges, the cam moves the end of the magnet arm to the center position between the zero and high-range reed switches, and neither reed switch is closed. If the magnet arm is not properly aligned with the cam at the point of contact, the extra room allowed (play) for movement of the magnet arm with respect to the cam can result in the magnet at

the other end of the magnet arm being placed sufficiently past the center position to close the high-range reed switch upon range switching between the first (0-5 mR/h) and the second (0-50 mR/h) of the lower two ranges even though the magnet arm is not supposed to move.

Because of this possible mechanical problem, severe underresponse to the true radiation fields for these dose-rate survey instruments can occur as a result of switching between these lower two ranges. This is because when the high-range reed switch is in the closed position, a different electronic circuit is actuated which reduces the sensitivity on these ranges by a factor of about 100. This reduced sensitivity requires a true dose rate of 5,000 mR/h to produce a full-scale deflection on the second-range (0-50 mR/h) scale or a true dose-rate of 500 mR/h to produce a full-scale deflection on the first-range (0-5 mR/h) scale.

Although the magnet arm is aligned properly at the time of production, this alignment can shift with time and normal field usage. Therefore, the Department of Energy Safety Action Notice recommends that all magnet arm switching dose-rate instruments be inspected at regular intervals for proper alignment of the magnet arm. Both Bicron and Eberline have prepared new inspection procedures for their instruments. For copies of revised maintenance procedures and other technical information concerning their instrument, contact the appropriate manufacturer at one of the following addresses:
