UNITED STATES
NUCLEAR REGULATORY COMMISSION
OFFICE OF NUCLEAR REACTOR REGULATION
WASHINGTON, D.C. 20555

NRC INFORMATION NOTICE NO. 90-44: DOSE-RATE INSTRUMENTS UNDERRESPONDING
TO THE TRUE RADIATION FIELDS

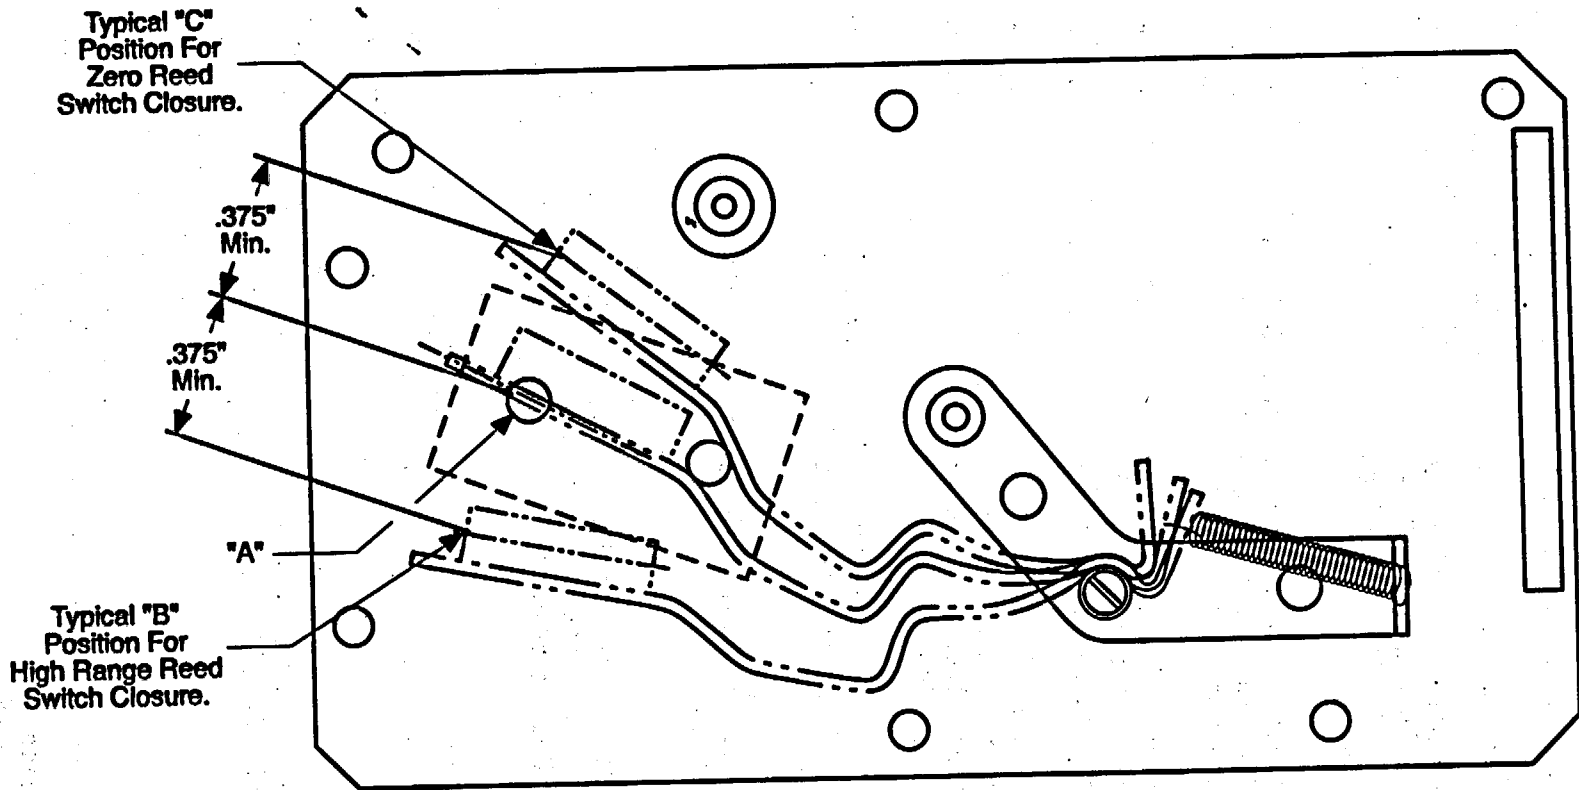
Figure 1, Typical Magnet Arm Position, RSO Instruments

The instruments were removed from service and were returned to the manufacturer. Bicron's examination confirmed the effect and found that the failure had been caused by a change in positioning of the magnet that activates reed switches in the ion chamber. This magnet moves on a cam-actuated arm, and the cam is attached to the range switch. Figure 1 illustrates typical magnet arm positions for the Bicron RSO series of instruments. At the zero position (one end) of the range switch rotation, the arm moves the magnet over the zero reed switch and shorts the electronic input for zeroing. Switching from zero to the first (0-5 mR/h) and second (0-50 mR/h) ranges, the cam moves the end of the magnet arm to the center position between the zero and high-range reed switches, and neither reed switch is closed. If the magnet arm is not properly aligned with the cam at the point of contact, the extra room allowed (play) for movement of the magnet arm with respect to the cam can result in the magnet at

the other end of the magnet arm being placed sufficiently past the center position to close the high-range reed switch upon range switching between the first (0-5 mR/h) and the second (0-50 mR/h) of the lower two ranges even though the magnet arm is not supposed to move.

Because of this possible mechanical problem, severe underresponse to the true radiation fields for these dose-rate survey instruments can occur as a result of switching between these lower two ranges. This is because when the high-range reed switch is in the closed position, a different electronic circuit is actuated which reduces the sensitivity on these ranges by a factor of about 100. This reduced sensitivity requires a true dose rate of 5,000 mR/h to produce a full-scale deflection on the second-range (0-50 mR/h) scale or a true dose-rate of 500 mR/h to produce a full-scale deflection on the first-range (0-5 mR/h) scale.

The Instrument Engineering Department of Bicron has included an additional quality assurance (QA) test to ensure the proper alignment of the magnet arm with respect to the reed switch and latitude for minor position changes that might occur. This QA test is to be performed during the final acceptance test of a new instrument and again before the new instrument is calibrated for shipment.

Although the magnet arm is aligned properly at the time of production, this alignment can shift with time and normal field usage. Therefore, the Department of Energy Safety Action Notice recommends that all magnet arm switching dose-rate instruments be inspected at regular intervals for proper alignment of the magnet arm. Both Bicron and Eberline have prepared new inspection procedures for their instruments. For copies of revised maintenance procedures and other technical information concerning their instrument, contact the appropriate manufacturer at one of the following addresses:
