UNITED STATES  
NUCLEAR REGULATORY COMMISSION  
WASHINGTON, D. C. 20555

SUBJECT: REQUEST FOR ADDITIONAL INFORMATION-ASSESSMENT OF LICENSEE MEASURES  
TO MITIGATE AND/OR IDENTIFY POTENTIAL DEGRADATION OF MARK I DRYWELLS  
(GENERIC LETTER 87-05)

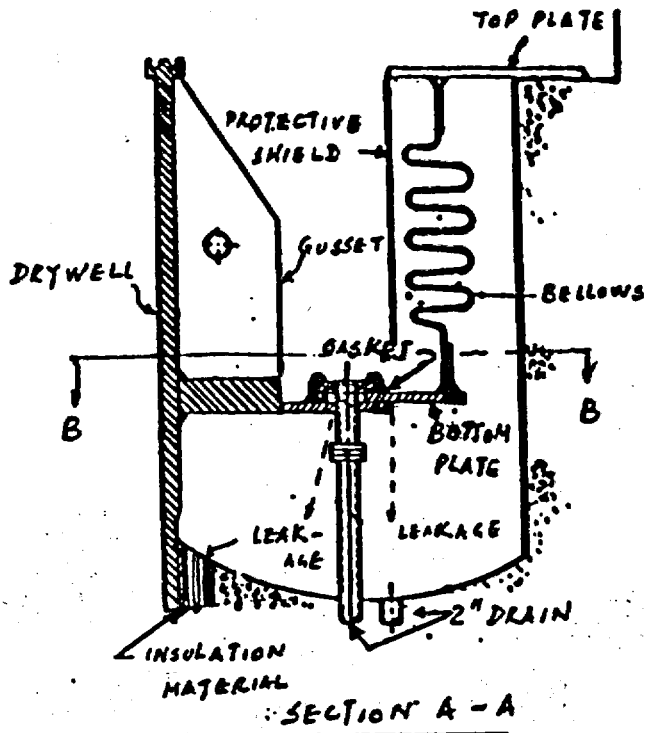
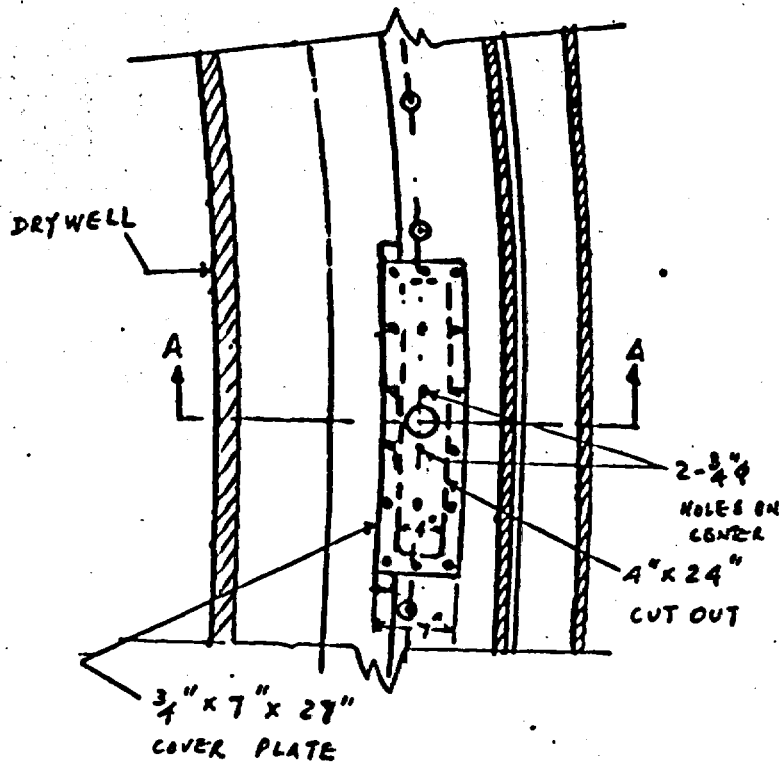
Figure 1

From the information obtained from the review of the Oyster Creek event, it appears one source of leakage that resulted in wetting the sand cushion was related to the deterioration of a drain line gasket at the drywell to cavity seal (see figure 1). There also is some question as to whether or not the drain line which serves to remove any leakage past the drywell to cavity seal was functioning properly.

DRYWELL TO CAVITY SEAL

- 1) Provide a discussion of your current program and any future plans for determining if the drain lines that were provided at your facility for removing any leakage that may result from refueling or from spillage of water into the gap between the drywell and the surrounding concrete or from the sand cushion itself are unplugged and functioning as designed.

- 2) Provide a discussion of preventive maintenance and inspection activities that are currently performed or are planned to minimize the possibility of leakage from the refueling cavity past the various seals and gaskets that might be present.
- 3) Confirm the information listed in Table 1 is correct with regard to your facility.

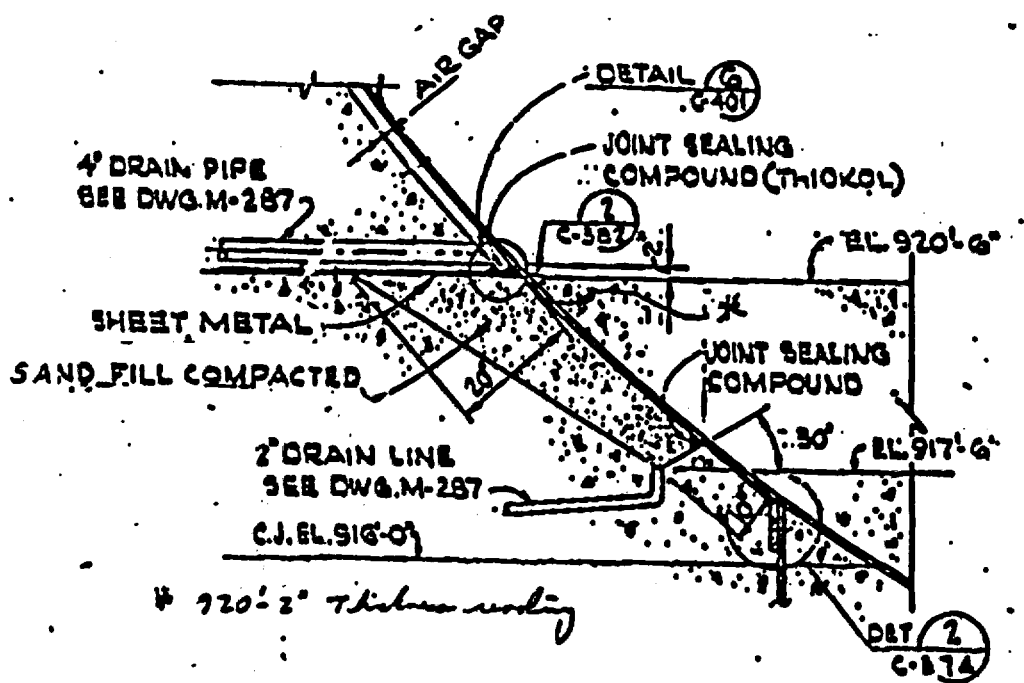
Figure 2

Upon reviewing the details of the sand cushion design at the various Mark I facilities, there appears to be a design feature that varies, dependent on the architect-engineer, that may be significant. In some designs, Figure 2, the sand cushion is covered with a galvanized steel plate which is sealed to the drywell shell and the surrounding concrete. Further, drains are provided to remove water which might collect on the plate from above. In other designs, Figure 3, the sand cushion is open to the gap between the drywell shell and the surrounding concrete and the only path for water to drain from the sand cushion is through the small drain lines at the bottom of the sand cushion. It appears from the Oyster Creek experience that, with the high permeability of the sand cushion and the small bottom drains, the likelihood of adequately drying the sand cushion is low if copious amounts of water have entered the sand cushion. The staff has sufficient concern to initiate the collection of information of the licensee's current or proposed action to assure the degradation of the drywell shell plates adjacent to the sand cushion has not occurred and to determine if augmented inspections above and beyond those planned by the licensee's are necessary.

SAND POCKET DETAIL  
SEALED

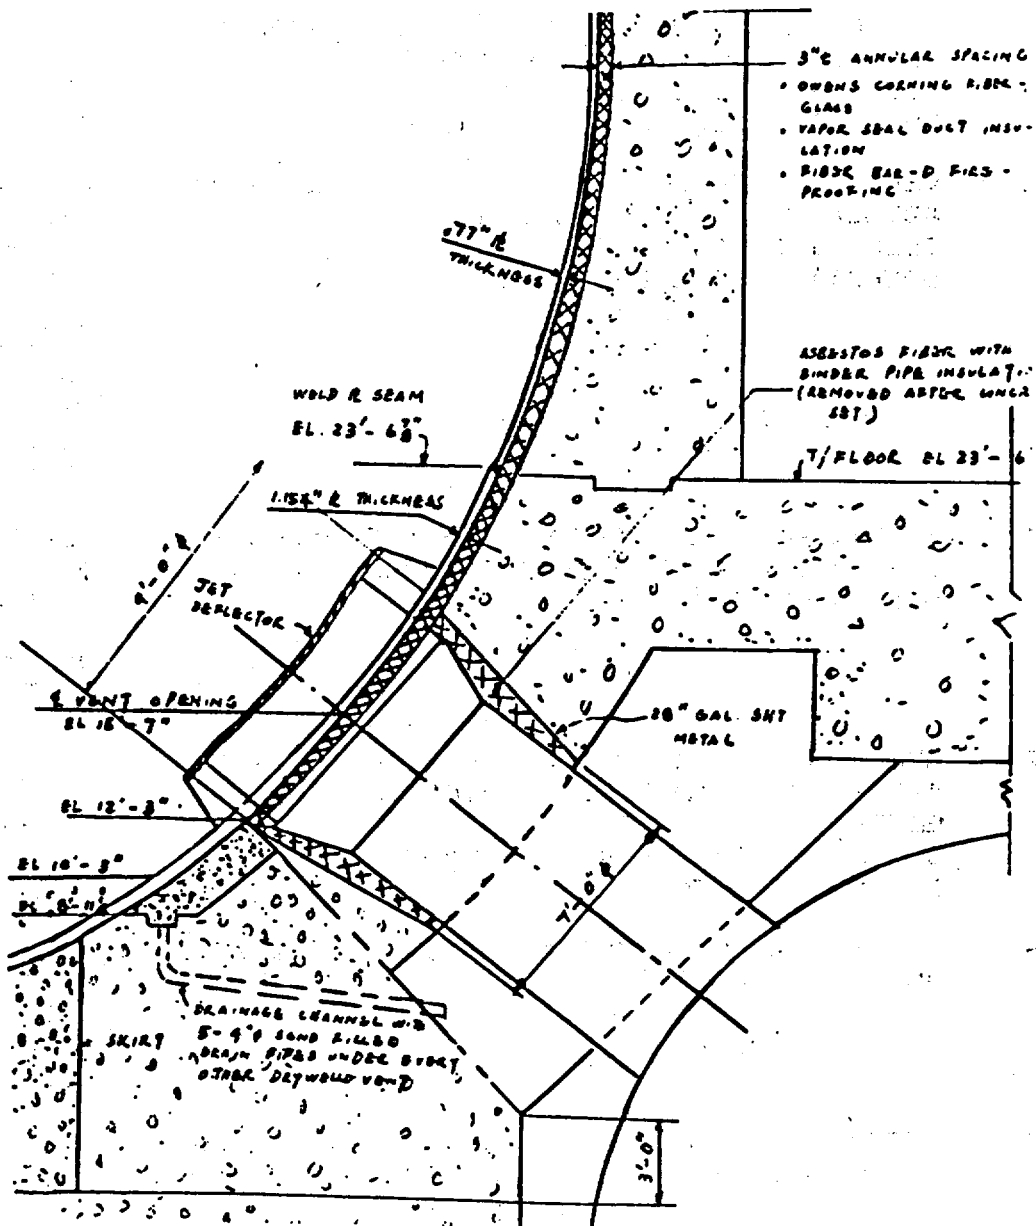
Figure 3

# SAND POCKET DETAIL OPEN

Provide any plans for performing ultrasonic thickness measurements of the drywell shell plates adjacent to the sand cushion or any other proposed actions to ascertain if plate degradation has occurred. Since the degradation that has occurred at Oyster Creek is localized, sufficient details should be included to show that the sampling basis for ultrasonic thickness measurements is adequate in terms of size and test location.
