UNITED STATES
NUCLEAR REGULATORY COMMISSION
WASHINGTON, D. C. 20555

MAR 12 1987

SUBJECT: REQUEST FOR ADDITIONAL INFORMATION-ASSESSMENT OF LICENSEE MEASURES
TO MITIGATE AND/OR IDENTIFY POTENTIAL DEGRADATION OF MARK I DRYWELLS
(GENERIC LETTER 87-05)

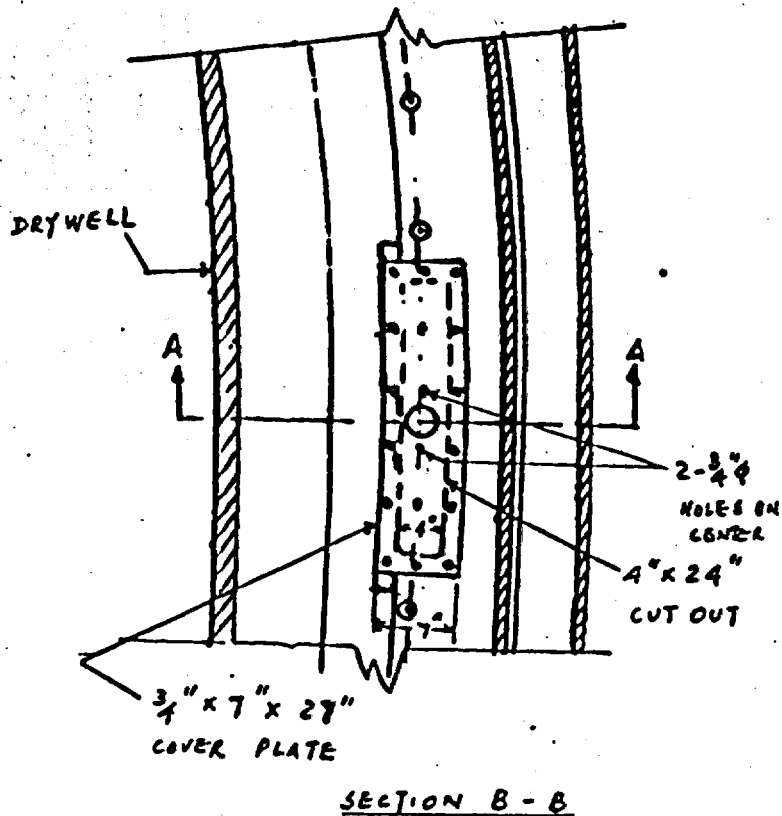
Figure 1

From the information obtained from the review of the Oyster Creek event, it appears one source of leakage that resulted in wetting the sand cushion was related to the deterioration of a drain line gasket at the drywell to cavity seal (see figure 1). There also is some question as to whether or not the drain line which serves to remove any leakage past the drywell to cavity seal was functioning properly.

DRYWELL TO CAVITY SEAL

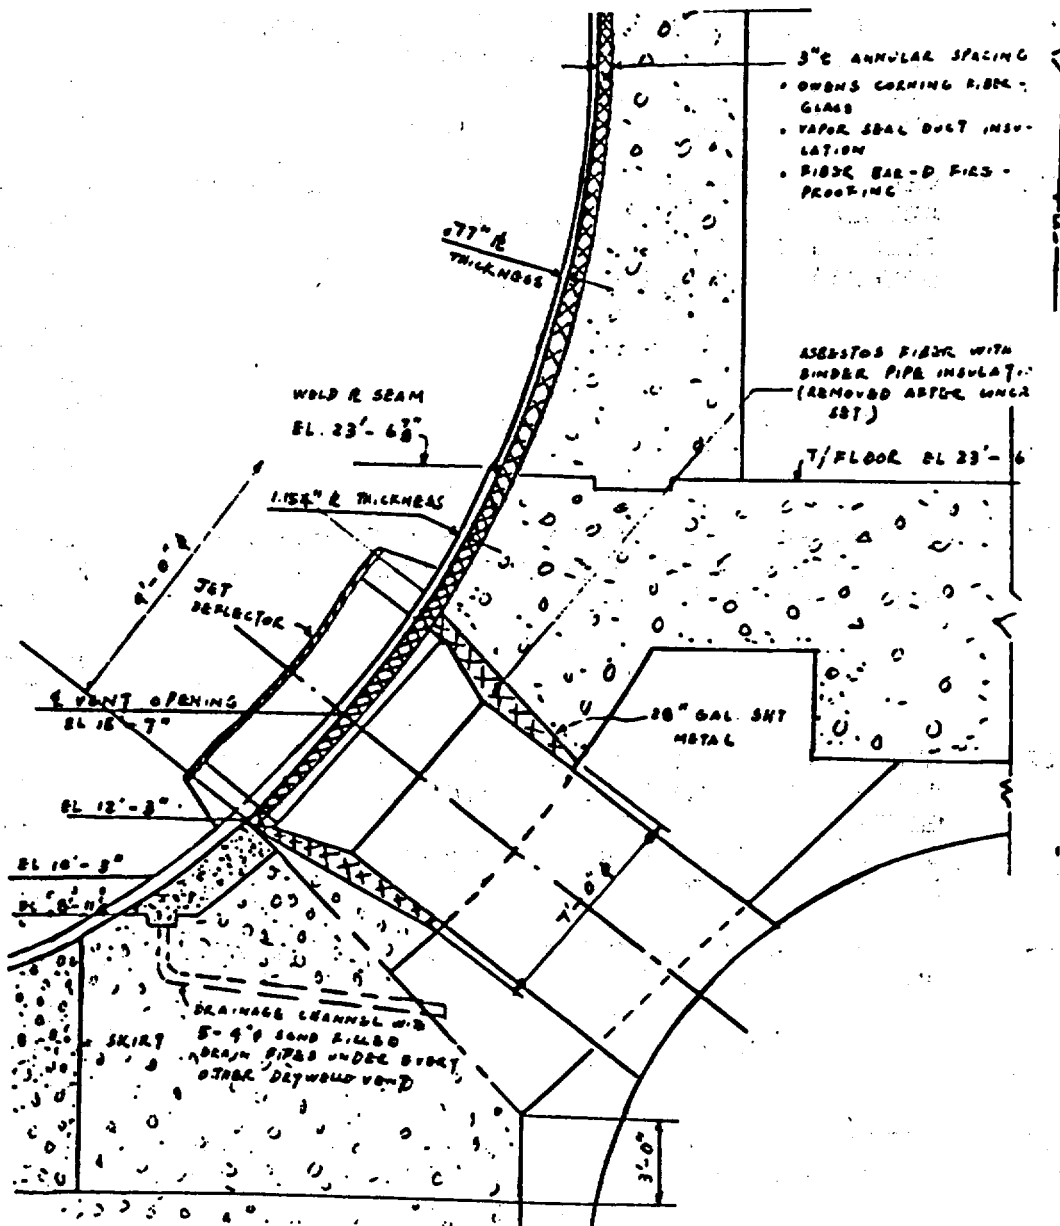
Figure 3

SAND POCKET DETAIL
OPEN

Provide any plans for performing ultrasonic thickness measurements of the drywell shell plates adjacent to the sand cushion or any other proposed actions to ascertain if plate degradation has occurred. Since the degradation that has occurred at Oyster Creek is localized, sufficient details should be included to show that the sampling basis for ultrasonic thickness measurements is adequate in terms of size and test location.
