UNITED STATES
NUCLEAR REGULATORY COMMISSION
OFFICE OF INSPECTION AND ENFORCEMENT
WASHINGTON, D.C. 20555

January 16, 1987

IE INFORMATION NOTICE NO. 87-04: DIESEL GENERATOR FAILS TEST BECAUSE
OF DEGRADED FUEL

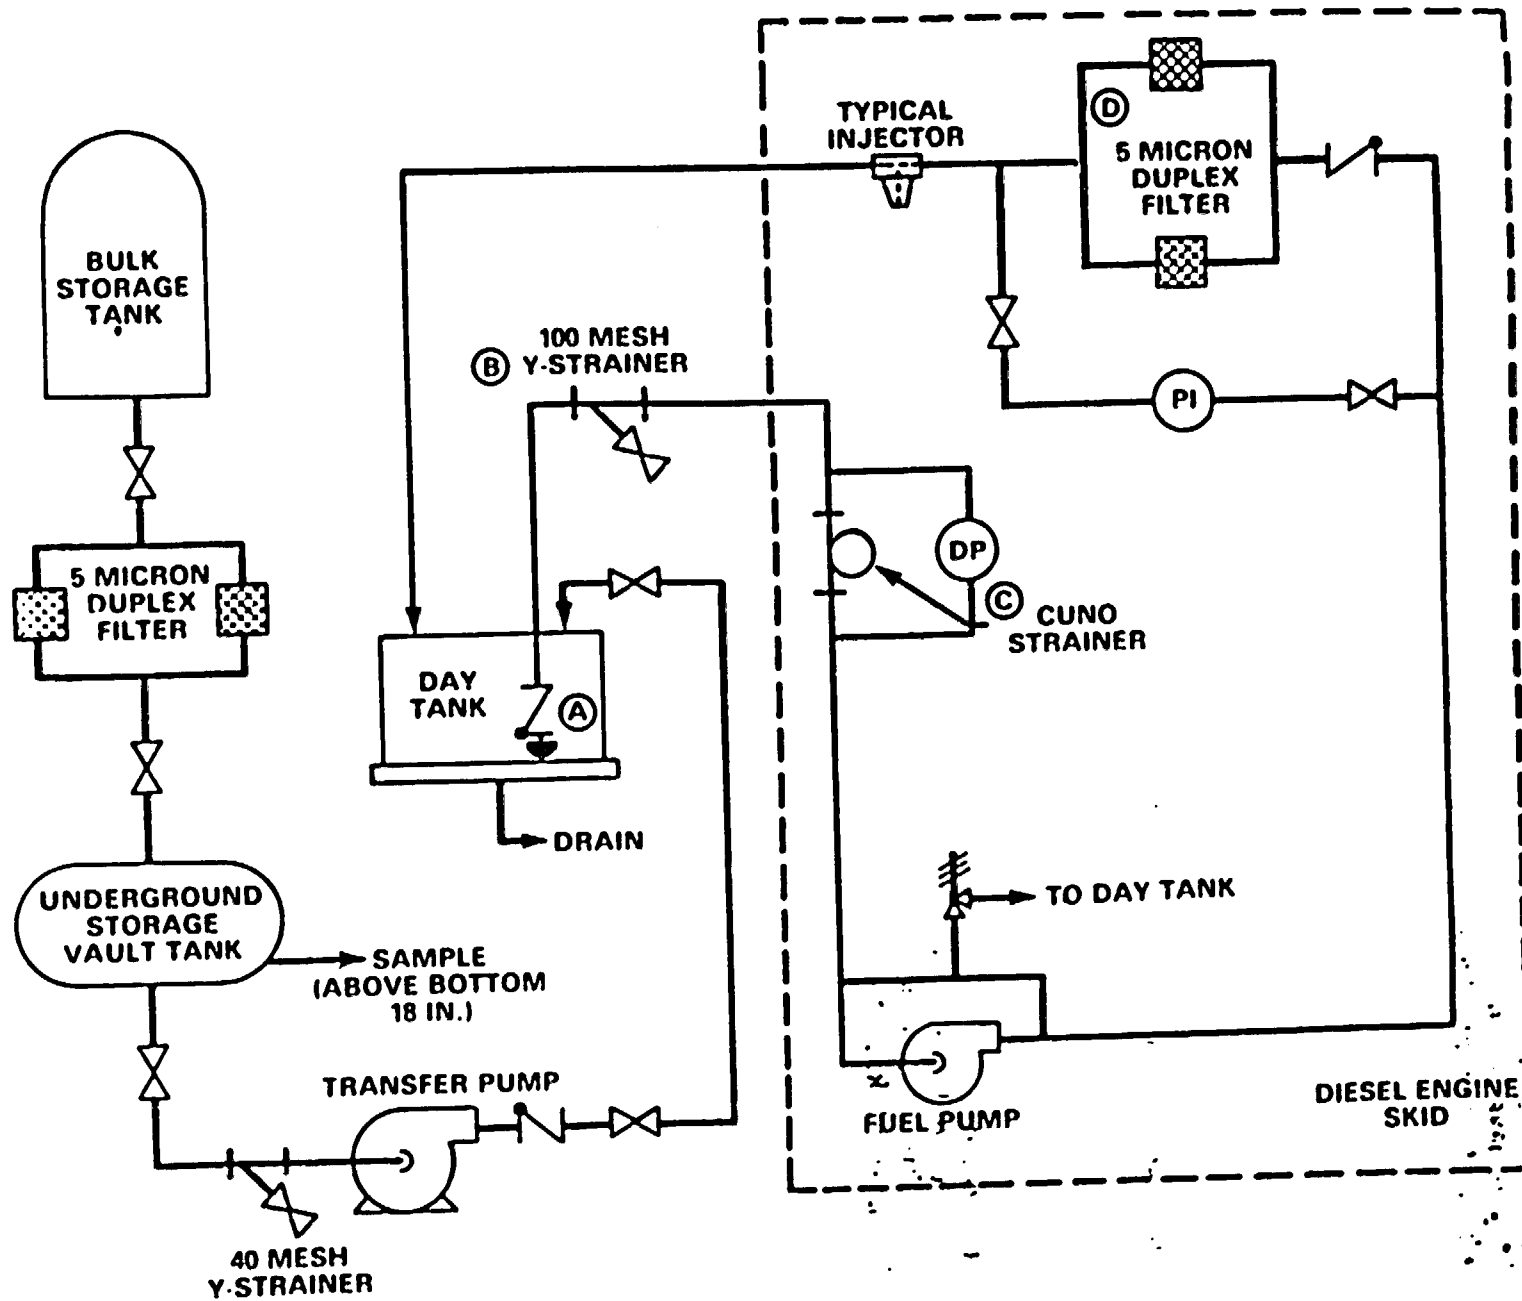
Figure 1. Schematic Fuel Supply System for Emergency Diesel Generator at Arkansas 2

On June 27, 1986, at Arkansas Nuclear One Unit 2 (ANO 2), one of the two emergency diesel generators (EDGs) failed to complete a prescribed 24-hour endurance test because of fuel starvation (Reference 1). The licensee found the screen element in the Y-strainer between the day tank and the engine severely fouled (component B in Figure 1), restricting flow of fuel to the engine. Cleaning the element required using a hand-held torch to remove a hard carbonaceous coating. The licensee cleaned the tank and piping and successfully completed the endurance test.

The licensee virtually inspected and cleaned the fuel supply system for each EDG as short-term corrective action. In addition, the licensee installed temporary piping, pumps, and filters to recirculate and clean the fuel inventory. The interior surfaces of the day tanks and underground vault tanks had coatings of sludge that were easily removed. The fuel suction line foot valves and strainers (component A in Figure 1) did not appear to be fouled.

During the evaluation of the event, the licensee determined that the day tank strainers (components A and B in Figure 1) had not been routinely inspected and cleaned because the station procedures did not address this action. Although these components are identified on the fuel supply system piping drawings, they had not been considered in station procedures. The licensee also determined that the function of the component B strainers was adequately served by the engine mounted strainers (Cuno-type; component C in Figure 1), which are capable of removing particulates smaller than the rated removal size of the component B strainers and are readily cleaned in service. In addition, the Cuno-type strainers are equipped with differential pressure indication. Subsequently, in accordance with 10 CFR 50.59, the licensee removed the screen element from the component B strainers for both EDGs.

It should be noted that the fuel supply systems differed between Unit 1 and Unit 2 in the absence on Unit 1 of the day tank strainers (components A and B in Figure 1).

The licensee engaged a contract laboratory to analyze the fuel. The contractor reported that a high concentration of particulates existed in the fuel as a result of oxidation and biological contamination. The licensee instituted a program to enhance fuel quality by periodic inspection and cleaning of the storage tanks and frequent sampling of the fuel. The laboratory strongly recommended use of a proprietary additive to prevent oxidation and to inhibit biological growth; however, a decision has not been made on the use of any additive. Further, the licensee is considering design modifications to include dual filters and strainers and a permanent storage tank recirculation system to facilitate filtering of the complete inventory each refueling outage.
