Subject: CONFIRMATORY ACTION LETTER (CAL No. 02-02-005)

**ESTIMATION OF EMPLOYEE EXPOSURES  
DURING THE  
REMOVAL OF A DAMAGED GAUGE AT SWVA  
ON  
16 DECEMBER 2002**

**Report Date 03 February 2003**

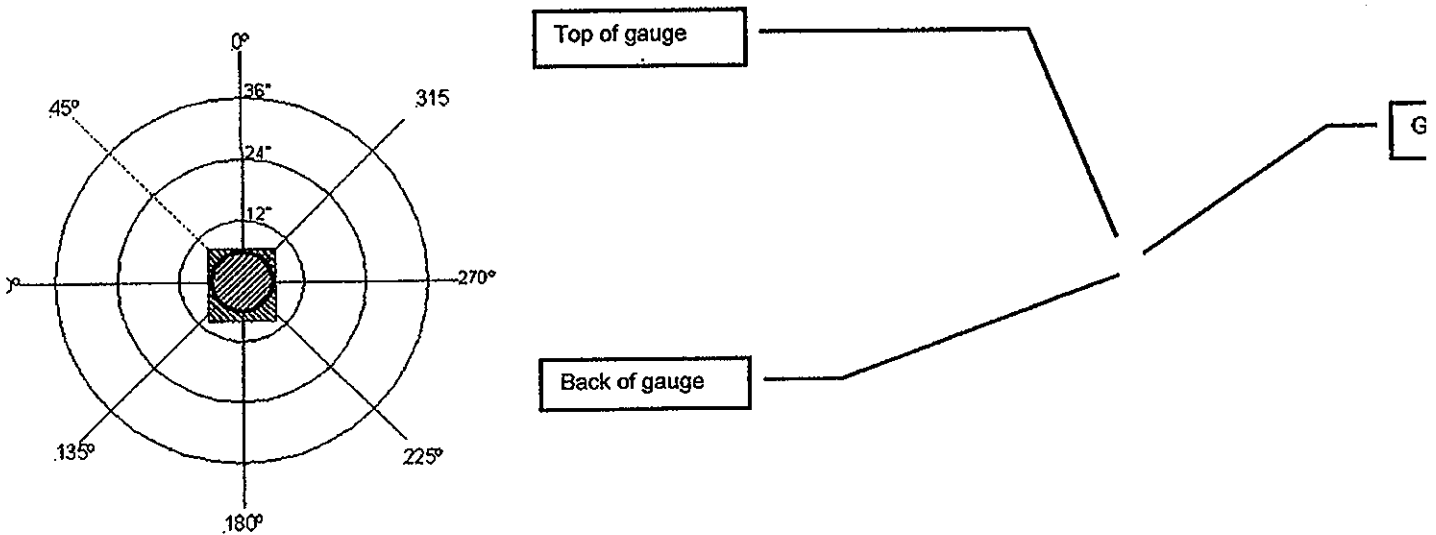
In the table of survey measurements below, 0° refers to the top of the gauge as it was installed at SWVA and angles are measured in the counter clockwise direction from this reference. These measurements were made in a plane bisecting the gauge housing and perpendicular to the beam axis. The "Back Surface" referred to below is the surface of the gauge housing opposite the beam port and the "Front Surface" is the plane containing the shutter mechanism.

**Figure 1. Radiation Survey Coordinate System Depicting Gauge as Installed at SWVA**
