UNITED STATES
NUCLEAR REGULATORY COMMISSION
OFFICE OF NUCLEAR REACTOR REGULATION
WASHINGTON, D.C. 20555

August 11, 1988

NRC INFORMATION NOTICE NO. 88-60: INADEQUATE DESIGN AND INSTALLATION OF
WATERTIGHT PENETRATION SEALS

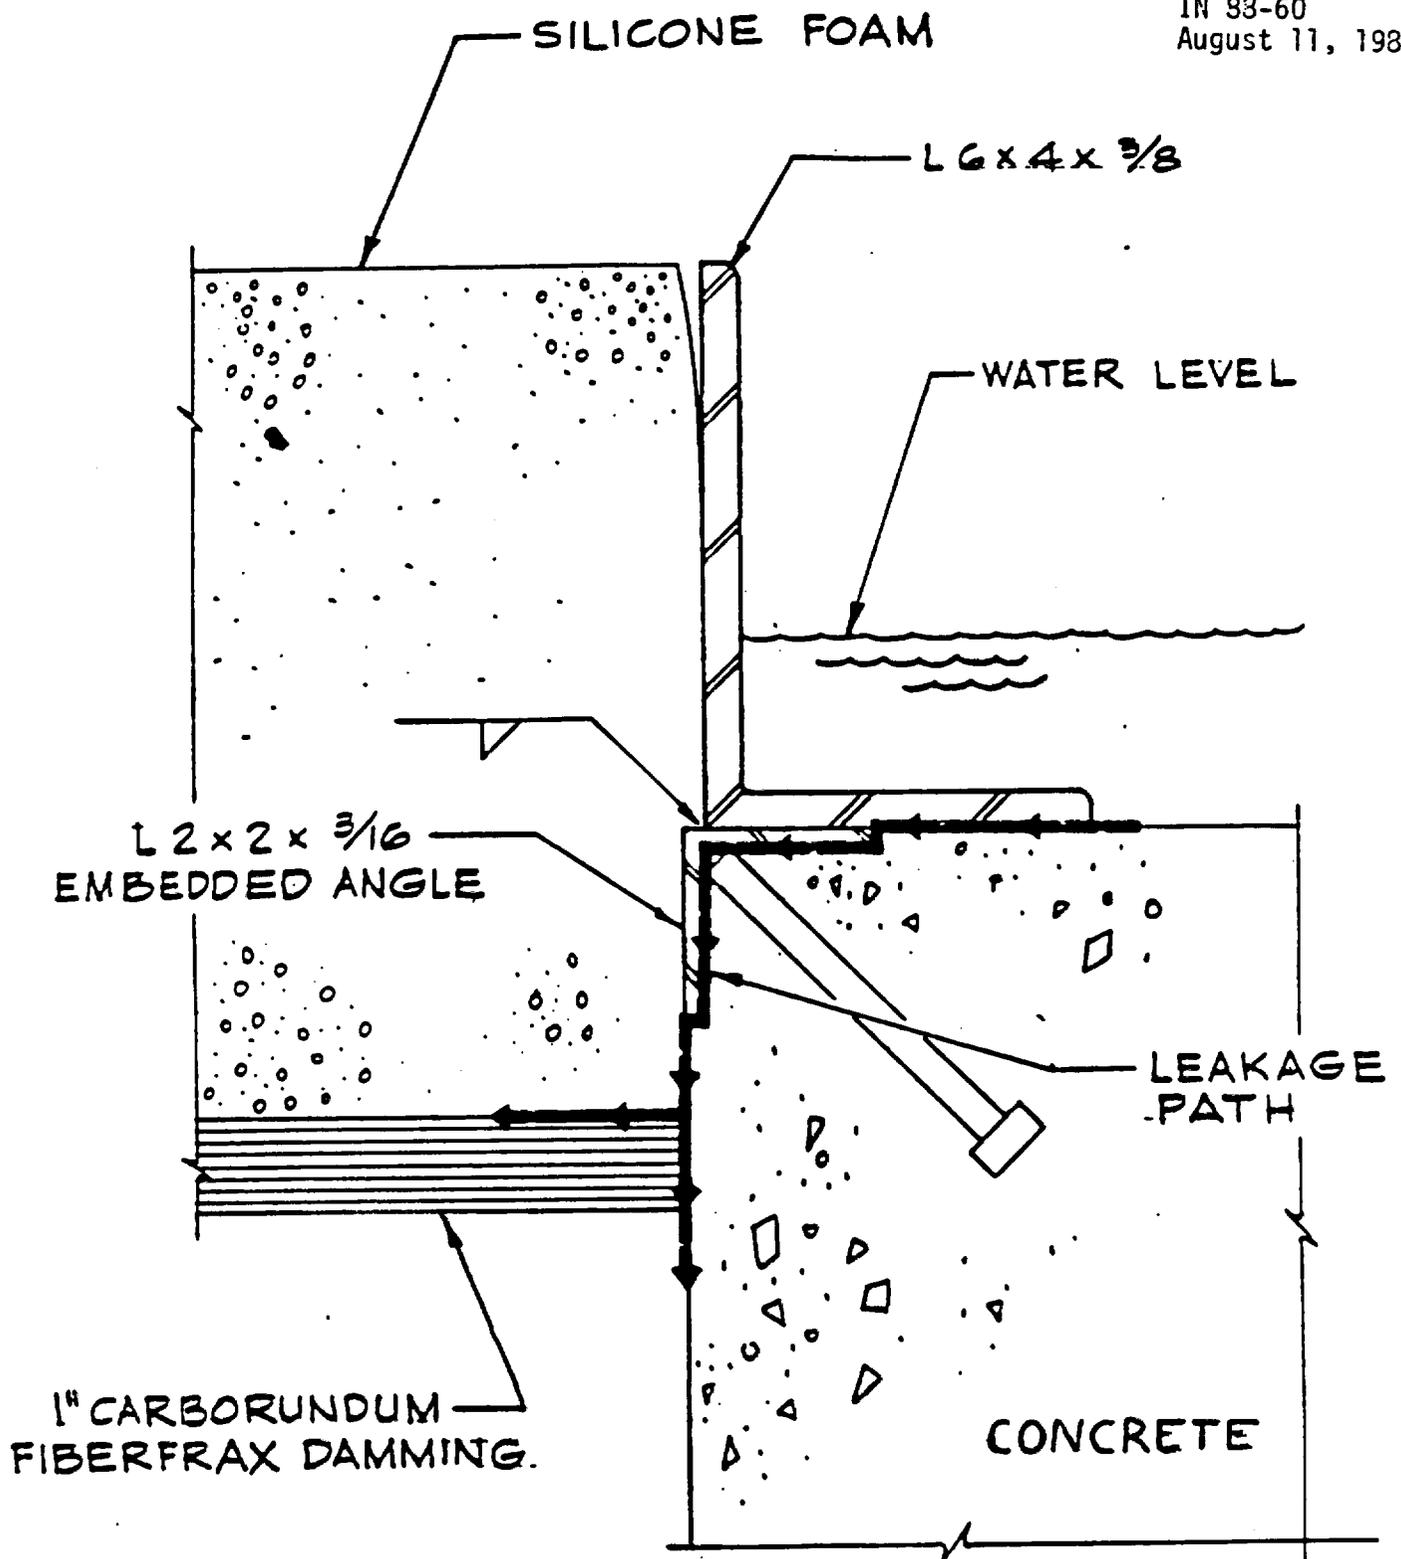
FIGURE 1

Testing showed that the water seeped between the concrete floor and the penetration embedded steel angle (see Figure 1, attached). The licensee applied a silicone sealant around the perimeter of all the floor penetrations where the concrete and the angle iron meet. Testing showed that the sealant was watertight.

PENETRATION SEAL LEAKAGE PATH

Testing showed that the water seeped between the concrete floor and the penetration embedded steel angle (see Figure 1, attached). The licensee applied a silicone sealant around the perimeter of all the floor penetrations where the concrete and the angle iron meet. Testing showed that the silicone caulk modification was watertight.

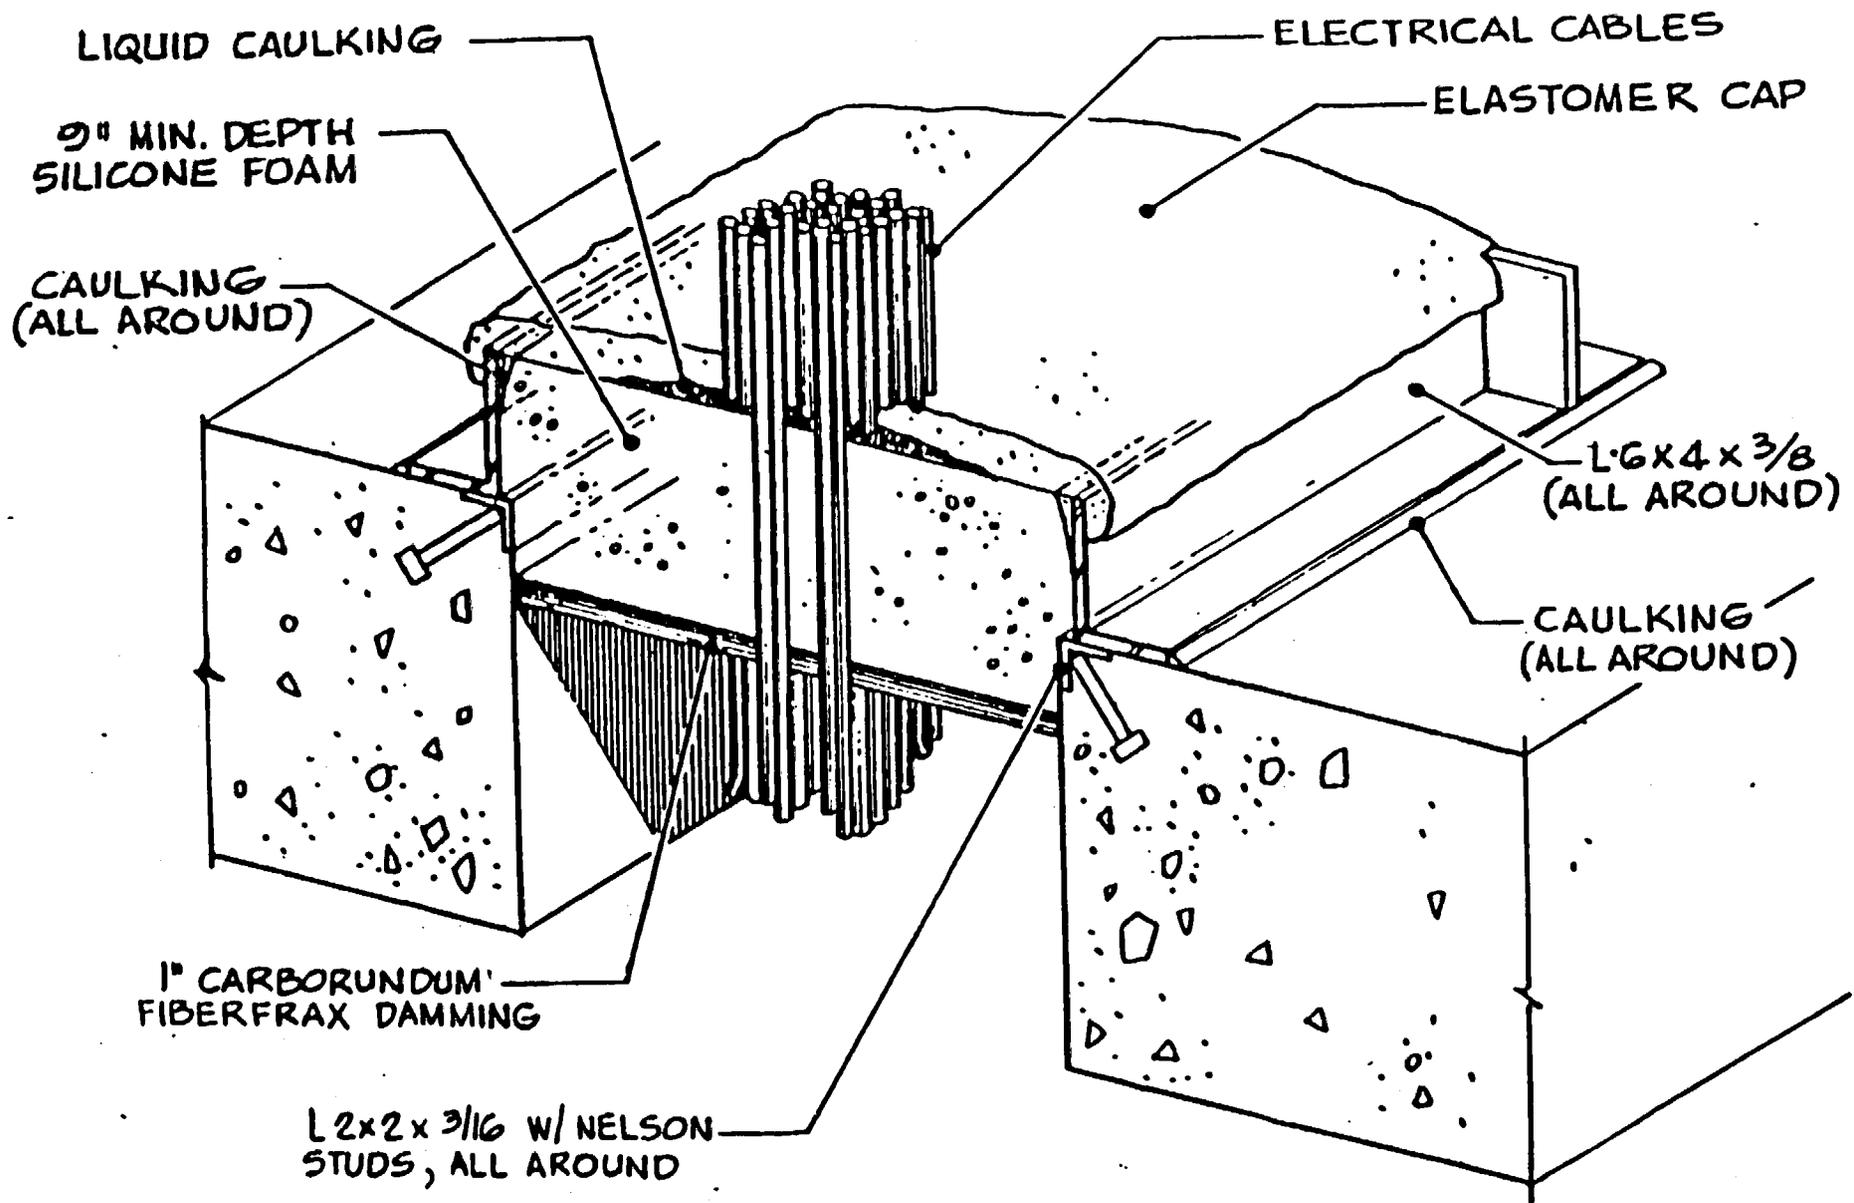
FIGURE 2

The licensee found through additional testing that there was a second leak path within the cable bundles penetrating the foam sealant material. If a large number of cables are so tightly massed that foam does not completely surround the individual cables, leakage can occur along the cables. The licensee applied sealant around and between individual cables and at the interface of the foam and the steel angle where foam shrinkage can cause a gap.

PROPOSED TYPICAL SEAL REPAIR
 (UPPER CABLE SPREADING ROOM)

Through testing, the licensee showed that a penetration seal with limited conductors penetrating the silicone seal material is watertight. As an additional precaution, an elastomer cap was placed over the seal to protect the foam and sealant from damage by water impingement in the event of fire suppression activity (see Figure 2, attached).
