UNITED STATES  
NUCLEAR REGULATORY COMMISSION  
OFFICE OF NUCLEAR REACTOR REGULATION  
WASHINGTON, D.C. 20555

August 11, 1988

NRC INFORMATION NOTICE NO. 88-60: INADEQUATE DESIGN AND INSTALLATION OF  
WATERTIGHT PENETRATION SEALS

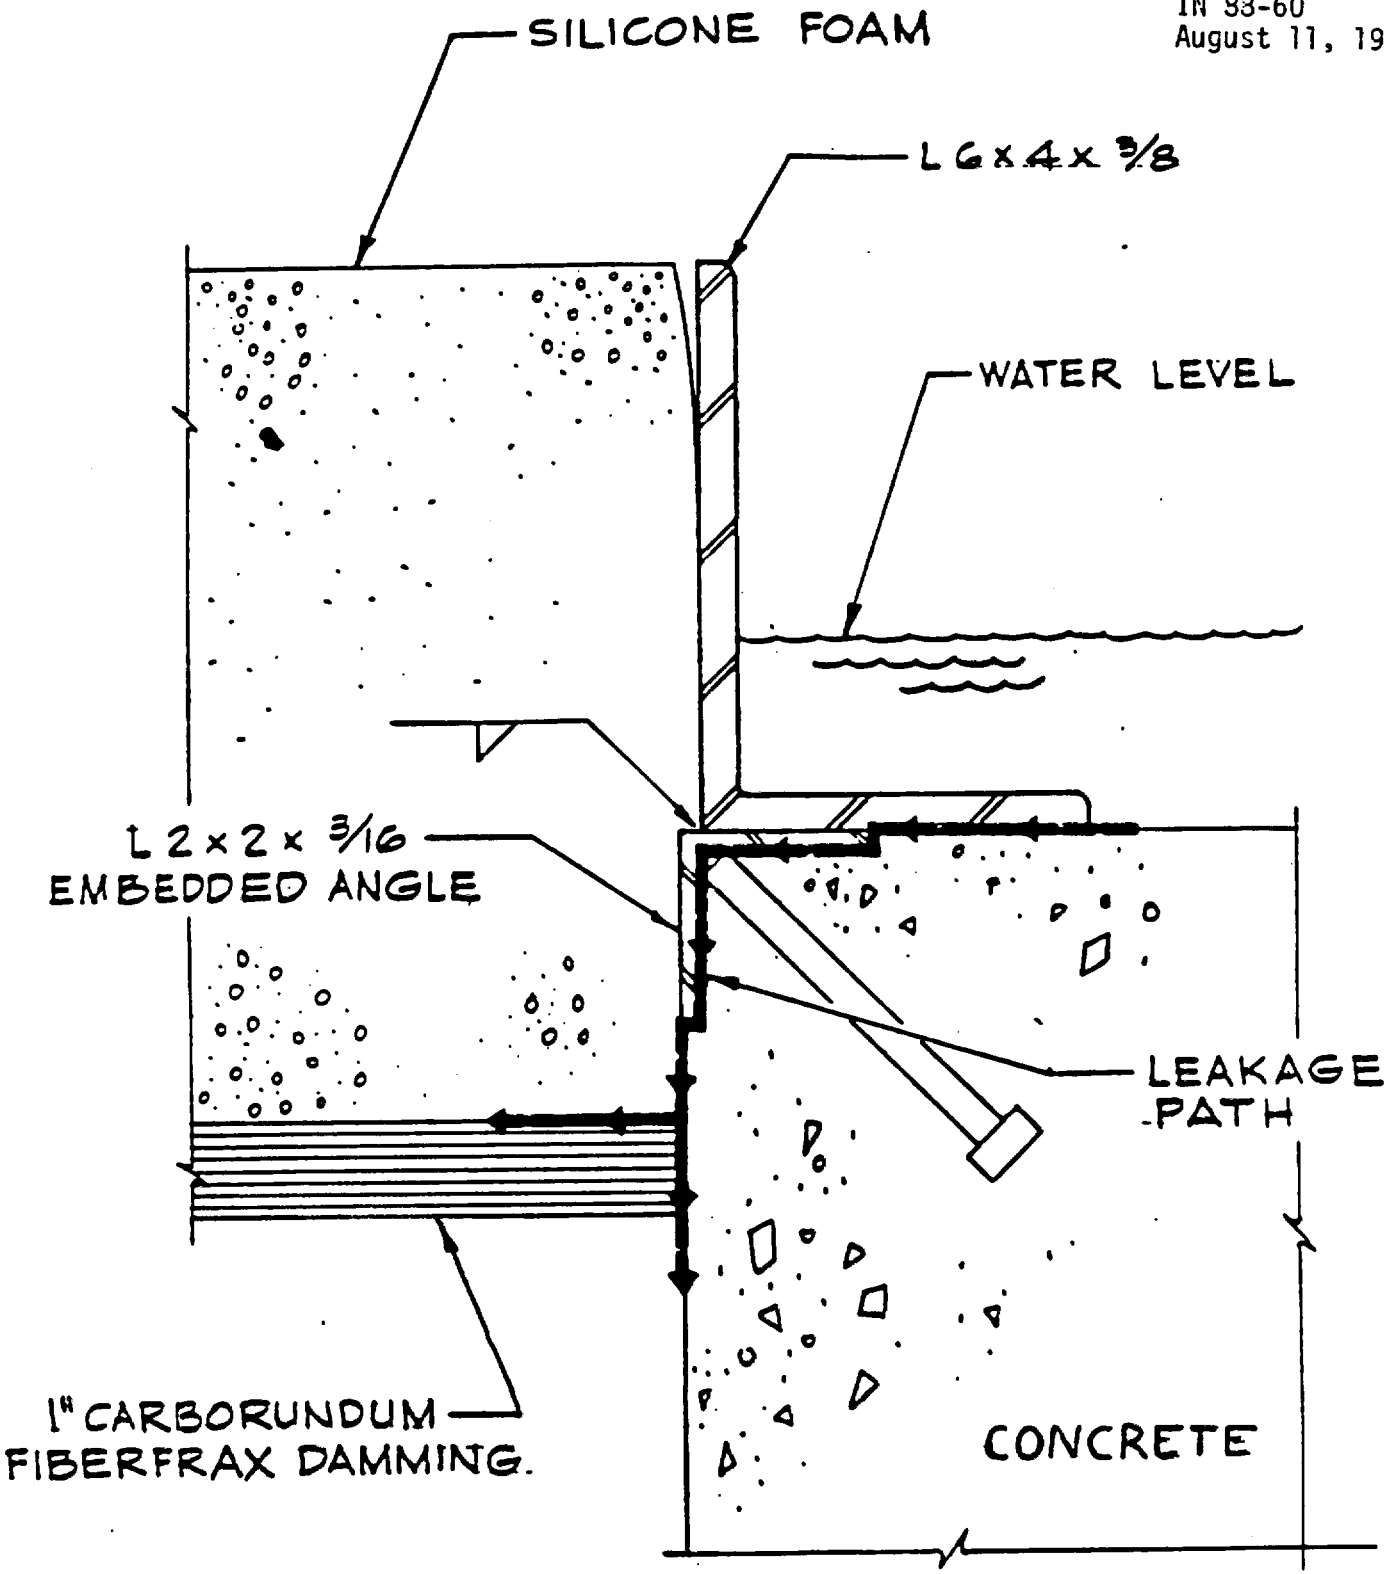
FIGURE 1

Testing showed that the water seeped between the concrete floor and the penetration embedded steel angle (see Figure 1, attached). The licensee applied a silicone sealant around the perimeter of all the floor penetrations where the concrete and the angle iron meet. Testing showed that the sealant was watertight.

PENETRATION SEAL LEAKAGE PATH

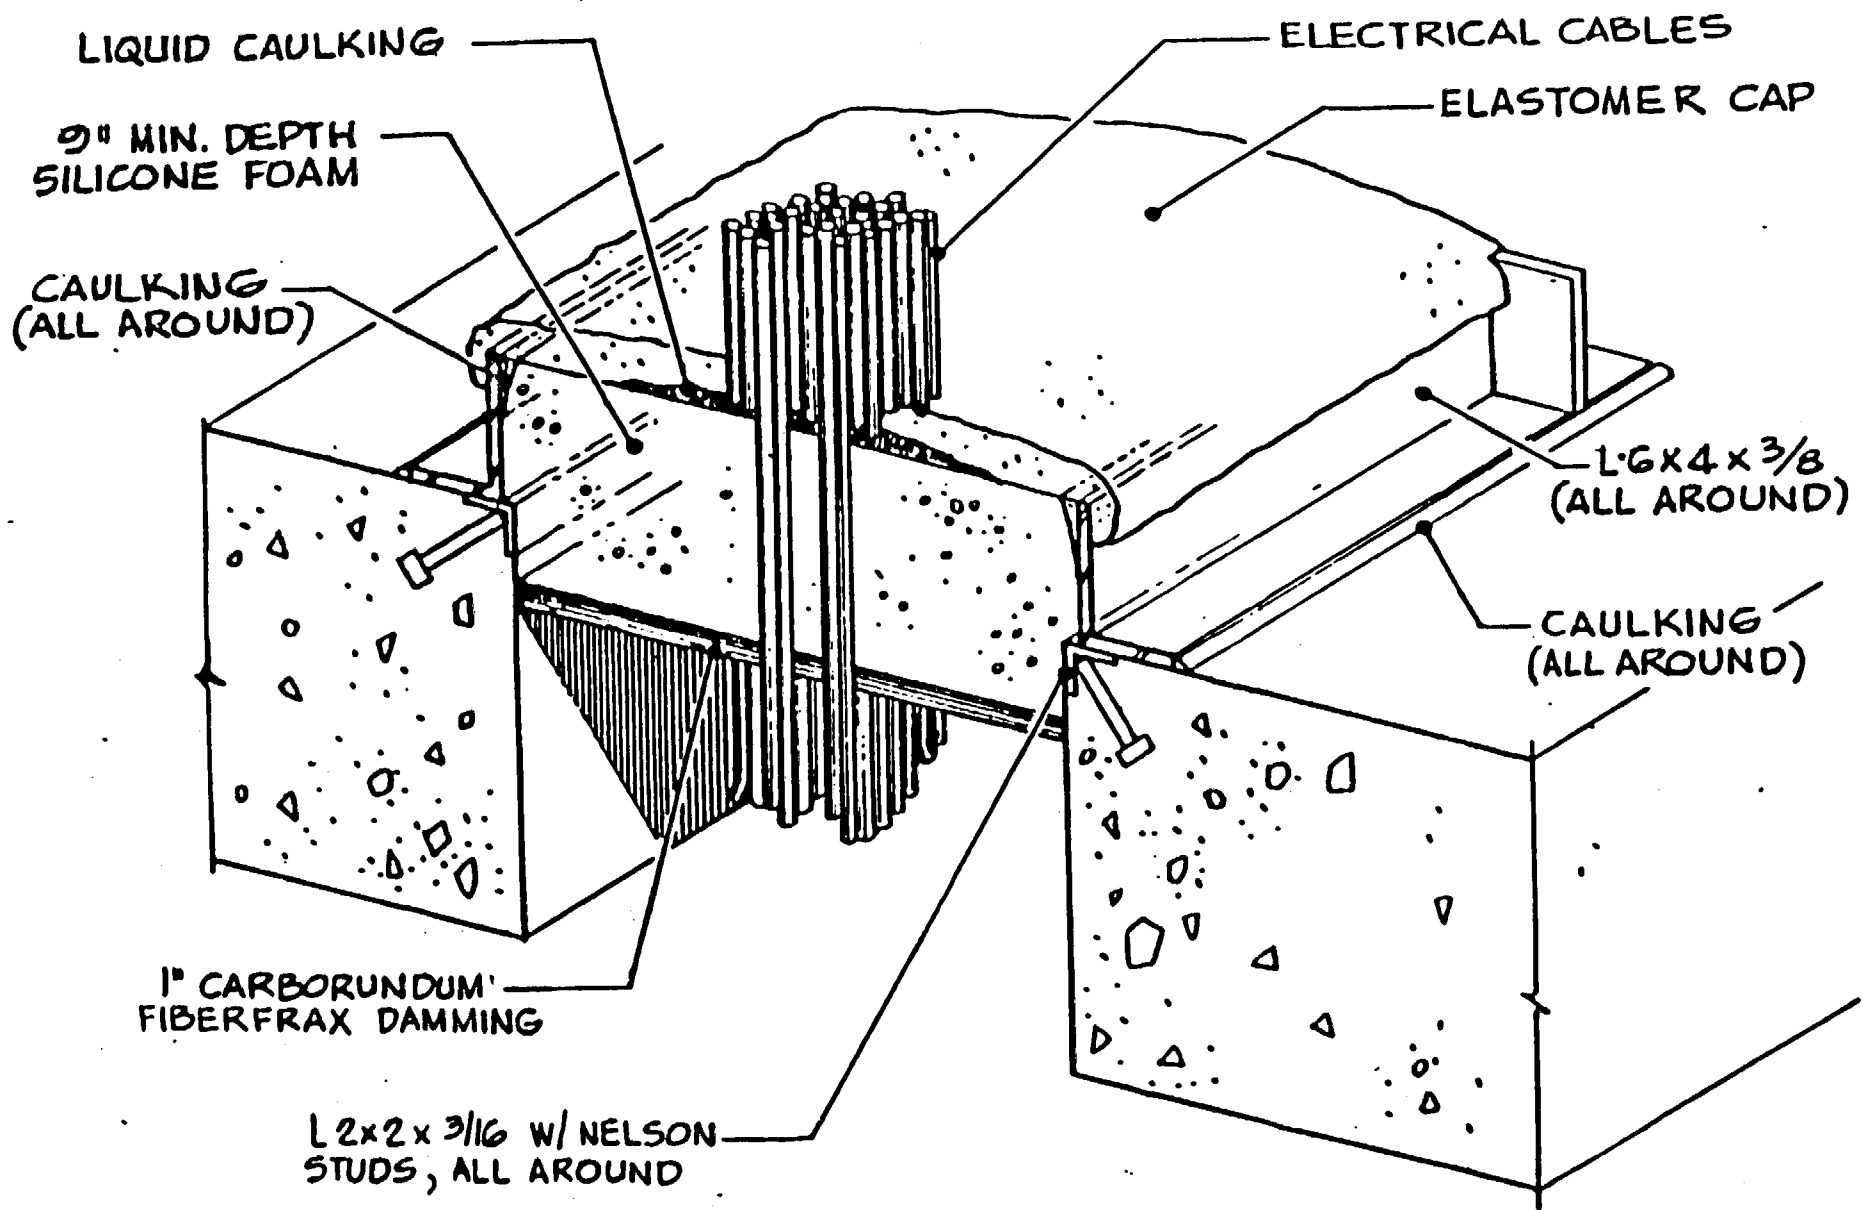
**FIGURE 2**

The licensee found through additional testing that there was a second leak path within the cable bundles penetrating the foam sealant material. If a large number of cables are so tightly massed that foam does not completely surround the individual cables, leakage can occur along the cables. The licensee applied sealant around and between individual cables and at the interface of the foam and the steel angle where foam shrinkage can cause a gap.

Through testing, the licensee showed that a penetration seal with limited conductors penetrating the silicone seal material is watertight. As an additional precaution, an elastomer cap was placed over the seal to protect the foam and sealant from damage by water impingement in the event of fire suppression activity (see Figure 2, attached).

PROPOSED TYPICAL SEAL REPAIR  
 (UPPER CABLE SPREADING ROOM)
