UNITED STATES
NUCLEAR REGULATORY COMMISSION
OFFICE OF NUCLEAR REACTOR REGULATION
WASHINGTON, D.C. 20555

August 9, 1988

NRC INFORMATION NOTICE NO. 88-59: MAIN STEAM ISOLATION VALVE GUIDE RAIL
FAILURE AT WATERFORD UNIT 3

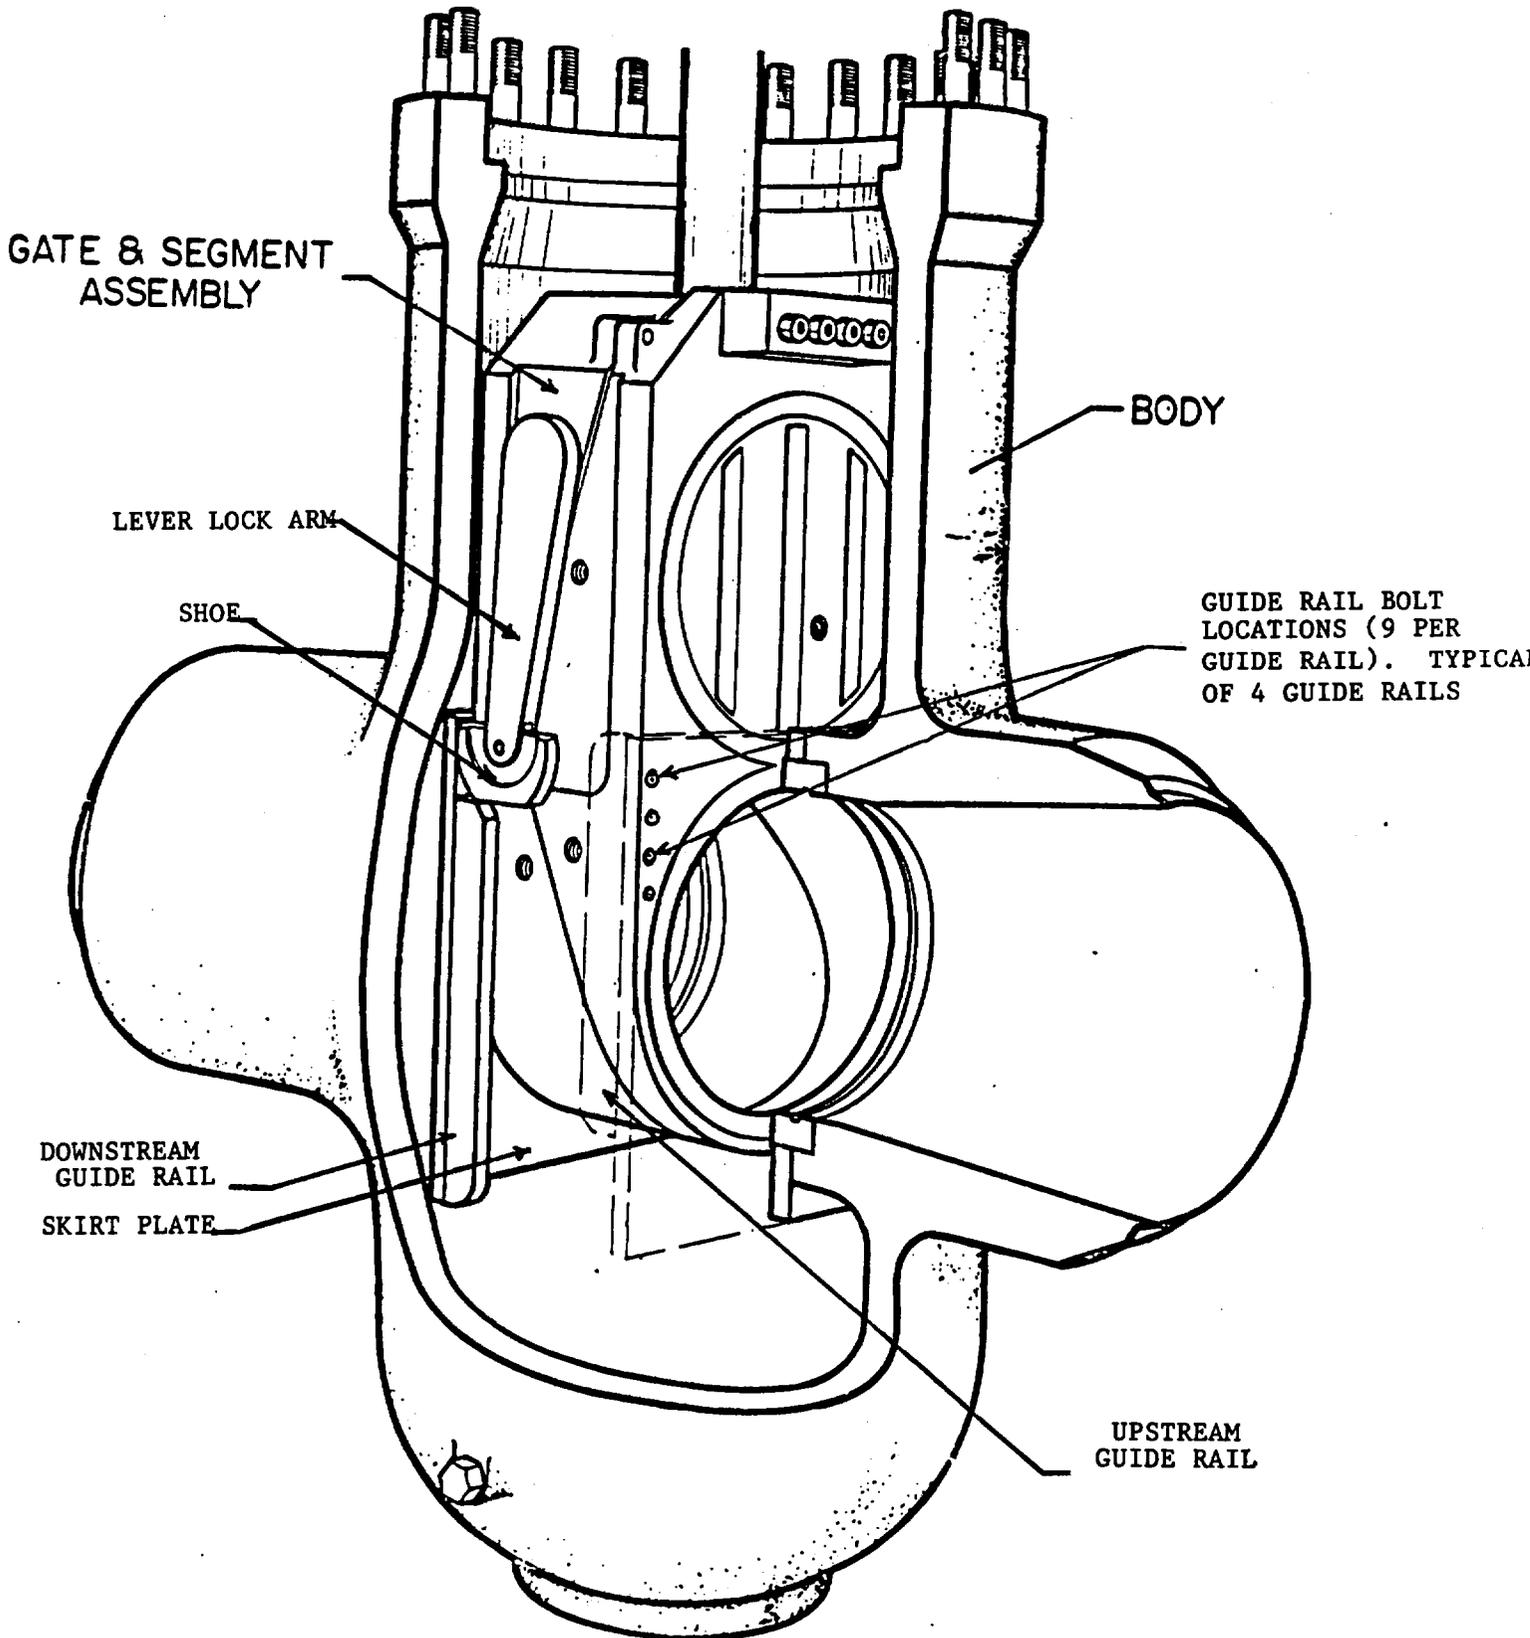
On April 11, 1988, during a routine inspection at Waterford 3, MSIV debris was found in the strainer for the main turbine throttle valve. The disassembly and inspection of the two MSIVs at the plant revealed that the downstream guide rails in one of the valves (see attached drawing) had become completely dislodged, and several bolt heads on the still-attached upstream rails in the same valve had been completely severed. The other MSIV had several separated bolt heads on both upstream and downstream rails, but the guide rails were in place. There were also galling marks on the chamfer of the guide rail and on the shoe attached to the lever lock arm.

An analysis by the licensee indicates that the guide rail failure was caused by the force of the lever lock arm assembly contacting the rail. The valve, however, passed the inservice test requirements. The analysis concludes that even without the rails the valve could still perform its function, albeit at a closure time that is slower by about a second, under the worst-case condition. However, there is a possibility that a detached rail could jam the MSIV in a partially open position. The failure of one MSIV is accounted for in the utility's Safety Analysis Report.

- (1) stelliteing the shoes and the chamfer on the rails
- (2) verifying the bolt alignments
- (3) doing nondestructive examinations of all new bolts
- (4) changing the angles of the rails and of the shoes
- (5) increasing the valve closure time (within system performance constraints)
- (6) periodically making fiberscope examinations of the valve internals to detect excessive galling, severed guide rail bolts, and separated guide rails
