UNITED STATES  
NUCLEAR REGULATORY COMMISSION  
OFFICE OF NUCLEAR REACTOR REGULATION  
WASHINGTON, D.C. 20555

December 14, 1988

NRC INFORMATION NOTICE NO. 88-96: ELECTRICAL SHOCK FATALITIES AT NUCLEAR  
POWER PLANTS

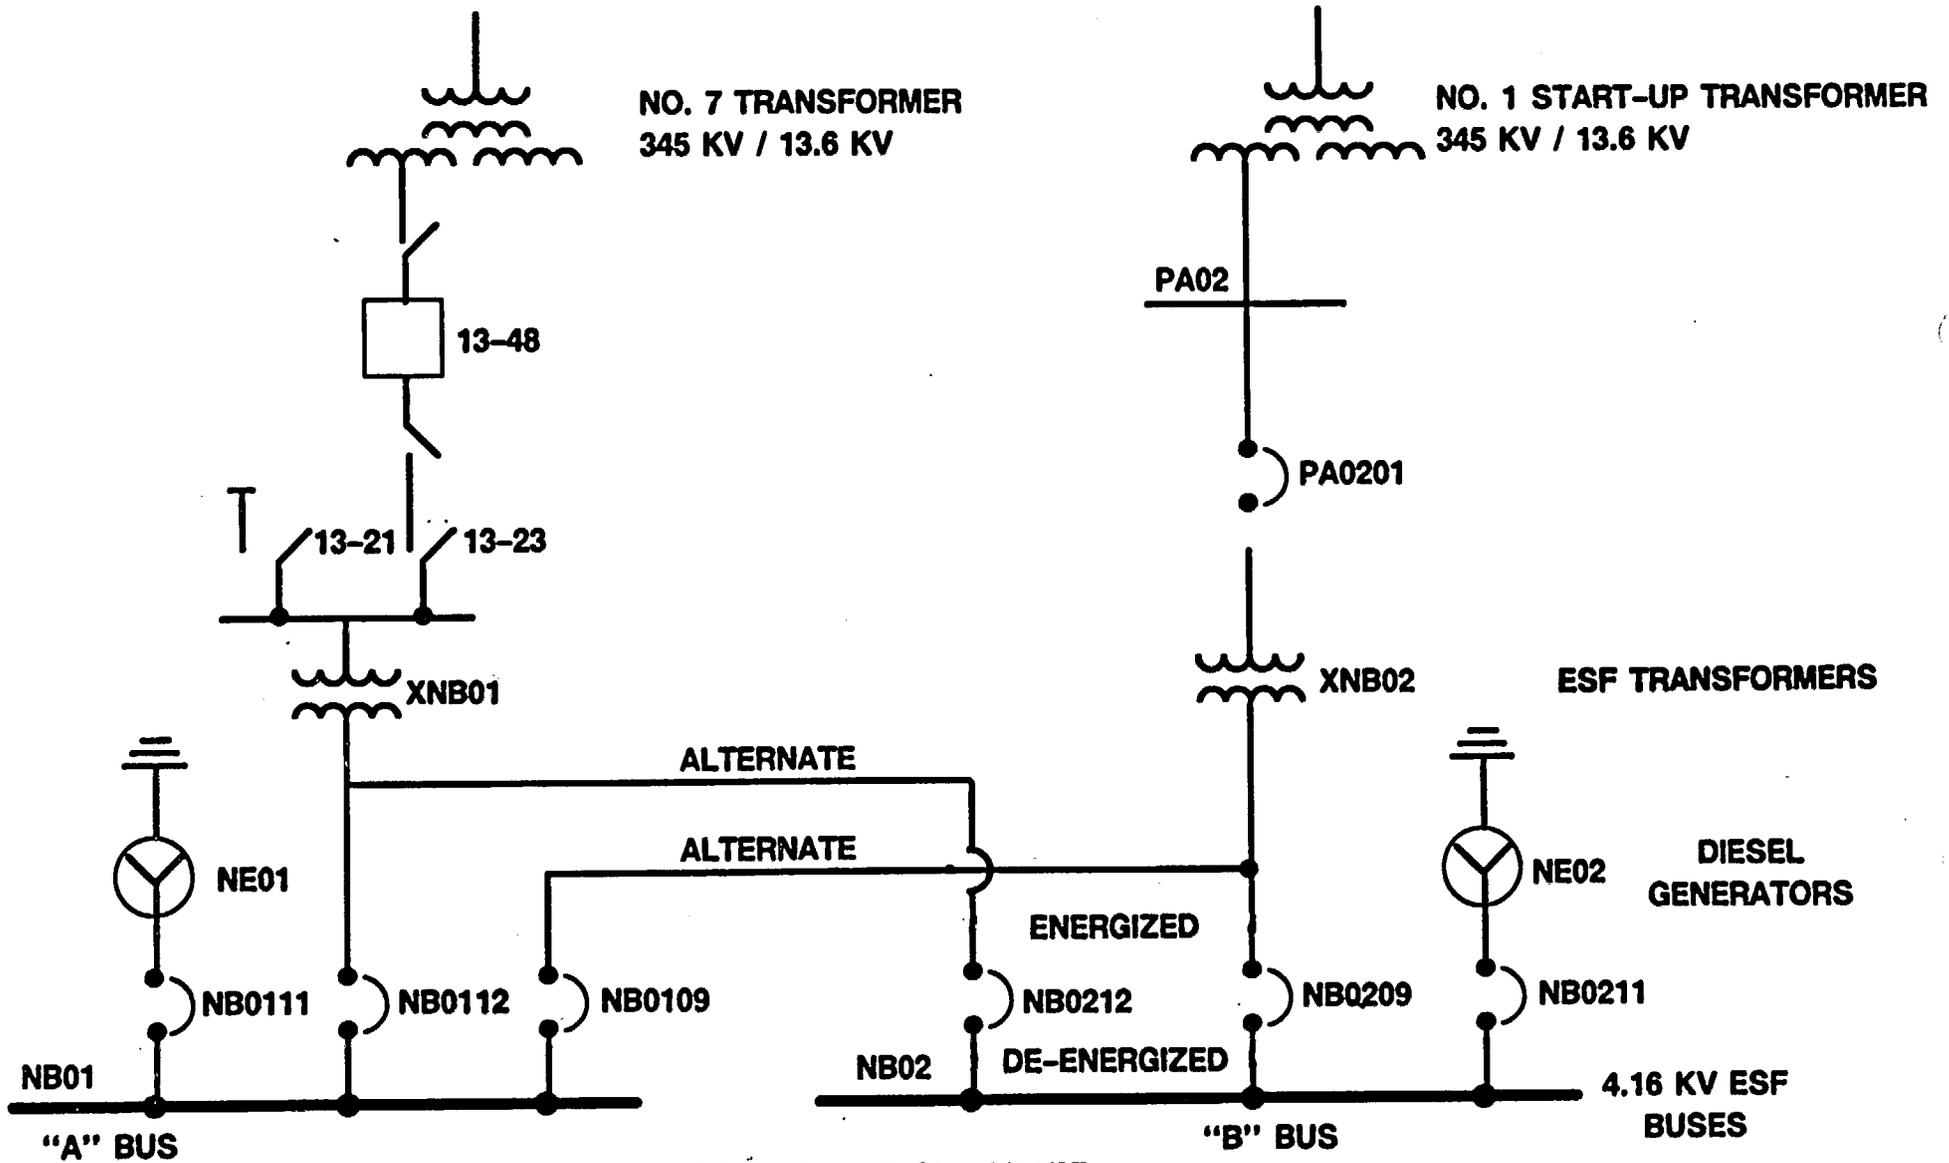
**Figure 1 - Partial Emergency Safety Features Electrical One-Line Diagram**

Wolf Creek has two redundant 4160-volt safety features busses (NB01 and NB02, shown in Figure 1), each fed from separate transformers. Each of these transformers also feeds an alternate crossover line to the other bus to permit powering this opposite bus in case the normal power source for the bus fails. In order to permit the "B" train switchgear to be cleaned, inspected and tested, a shift supervisor prepared a clearance to deenergize the switchgear. In doing this, he left the normal transformer (XNB02) for the "B" train switchgear energized. He reasoned that this transformer should be left energized to provide redundant power to the "A" train via the alternate line, and he believed that he had the concurrence of the Electrical Department for this configuration. The electrical supervisor with whom he discussed this matter, however, believed that the shift supervisor was referring to the fact that the alternate line to the "B" side from the "A" side transformer (XNB01) was to be left energized, as this line could not be deenergized without shutting down the "A" bus also. Thus the incoming lines from both transformers to the "B" train switchgear remained energized, but the electricians believed that the line from the "B" side transformer had been deactivated.

While the electrical technician was working on the potential transformer on the switchgear (NB0209) for the line from the normal "B" train transformer, he came in contact with an energized potential transformer stub and was electrocuted. The breaker (PA0201) in the line feeding the "B" side transformer apparently tripped immediately after the energized stub was contacted. However, the victim was in contact with the cabinet (NB0212) for the energized line from the "A" side transformer. His sleeve, ignited by arcing current, was on fire. This apparently led other electricians in the area who responded to the emergency to believe that the victim was still in contact with energized equipment. Using belts and hoses, the electricians tried unsuccessfully to remove the victim. At this point, the Halon fire protection system in the switchgear room was initiated by the fire, forcing the electricians out of the room temporarily.

The electricians in the switchgear area relayed incorrect information to the control room that a man was hung up on the breaker (NB0212) for the still-energized alternate line from the "A" side transformer. In their haste to free the victim, the operators opened the breaker (NB0112) downstream from the point at which the alternate line to the "B" bus (NB02) leaves the line from the "A" side transformer (XNB01). Consequently, this action deenergized the "A" bus (NB01), but not the alternate line to the "B" bus. This action caused the "A" side diesel generator (NE01) to start, repowering the "A" bus. However, when the control room personnel were informed that the alternate line to the "B" side was still energized, they disconnected all power sources, including the running diesel for both busses by opening breakers 13-48 and NB0111. As a result, all of the emergency safety systems, including the operating residual heat removal system, were deactivated.

After the victim had been removed, the operators tried to repower the "A" bus (NB01) by closing the breaker (NB0111) to the still running diesel but discovered that the diesel generator controls had to be reset in the diesel generator room first. The "A" bus was then repowered from its normal transformer (XNB01). The residual heat removal system was out of service for 17 minutes during this event. However, the core was only partially loaded with fuel at the time, and the reactor coolant temperature rise was negligible. The Wolf Creek staff have since provided a modification to the diesel controls to permit them to be reset from the control room after the diesel power has been interrupted from the control room.

**BREAKER STATUS BEFORE ACCIDENT ON 10/14/87**  
**CLOSED - NB0112, 13-23, 13-48, PA0201**  
**OPEN - NB0109, NB0209, NB0211, NB0212, NB0111**
