UNITED STATES
NUCLEAR REGULATORY COMMISSION
OFFICE OF NUCLEAR REACTOR REGULATION
WASHINGTON, D.C. 20555

August 3, 1988

NRC INFORMATION NOTICE NO. 88-55: POTENTIAL PROBLEMS CAUSED BY SINGLE FAILURE
OF AN ENGINEERED SAFETY FEATURE SWING BUS

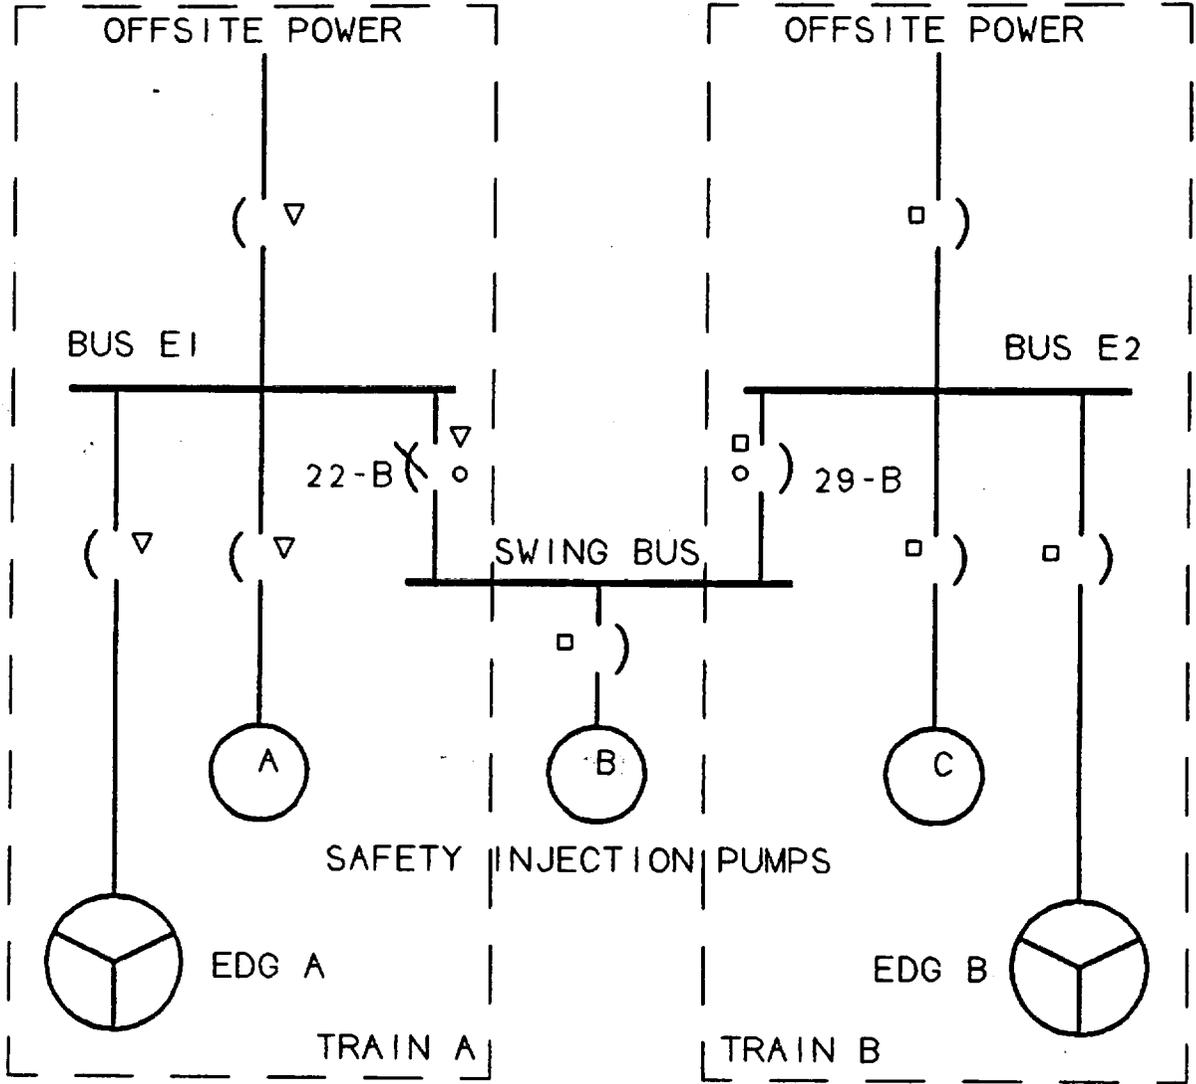
FIGURE 1

As shown in Figure 1, each of two class 1E buses supplies power to a safety injection pump. One of these buses also supplies power to a third safety injection pump via a swing bus. The swing bus is normally supplied with power by bus E1; however, if bus E1 fails to supply power to the swing bus, then the swing bus is automatically transferred to bus E2. An interlock prevents the swing bus from being supplied simultaneously from both of its supply buses. As originally designed, a safety injection signal causes all three safety injection pumps to start automatically.

During the licensee's review of the emergency electrical distribution system, including dc control power, which was done in response to an NRC request, the licensee identified several postulated single failures that could result in loss of two of the three safety injection pumps. For example, loss of dc control power for train B would cause loss of safety injection pumps B and C. However, the analysis of record for the loss-of-coolant accident (LOCA)

assumed that a single failure would cause only one safety injection pump to fail. Pending resolution of this problem, the auto-start capability for the swing pump was defeated, the plant was derated to 60 percent of full power, and the allowable power-peaking factor was reduced from 2.32 to 2.26.

ROBINSON 2
POWER SUPPLY FOR SAFETY INJECTION PUMPS

Subsequently, the licensee performed a new LOCA analysis assuming that only one safety injection pump operates to mitigate the consequences of a LOCA. Calculation of emergency core coolant flow was based on system test performance degraded by 5 percent. Using acceptable models, the licensee found that peak cladding temperature, local metal-water reaction, and total metal-water reaction would be within the acceptance criteria of 10 CFR 50.46 with the reactor operating at 100 percent power with the power peaking factor at 2.32 before the accident. On the basis of these results, NRC permitted the licensee to resume full power operation after removing the auto-start capability of the swing pump and after the limiting conditions for operation were changed to require that two safety injection pumps be operable, each capable of automatic initiation from a separate emergency bus.
