UNITED STATES
NUCLEAR REGULATORY COMMISSION
OFFICE OF NUCLEAR REACTOR REGULATION
WASHINGTON, D.C. 20555

October 14, 1988

NRC INFORMATION NOTICE NO. 88-85: BROKEN RETAINING BLOCK STUDS ON
ANCHOR DARLING CHECK VALVES

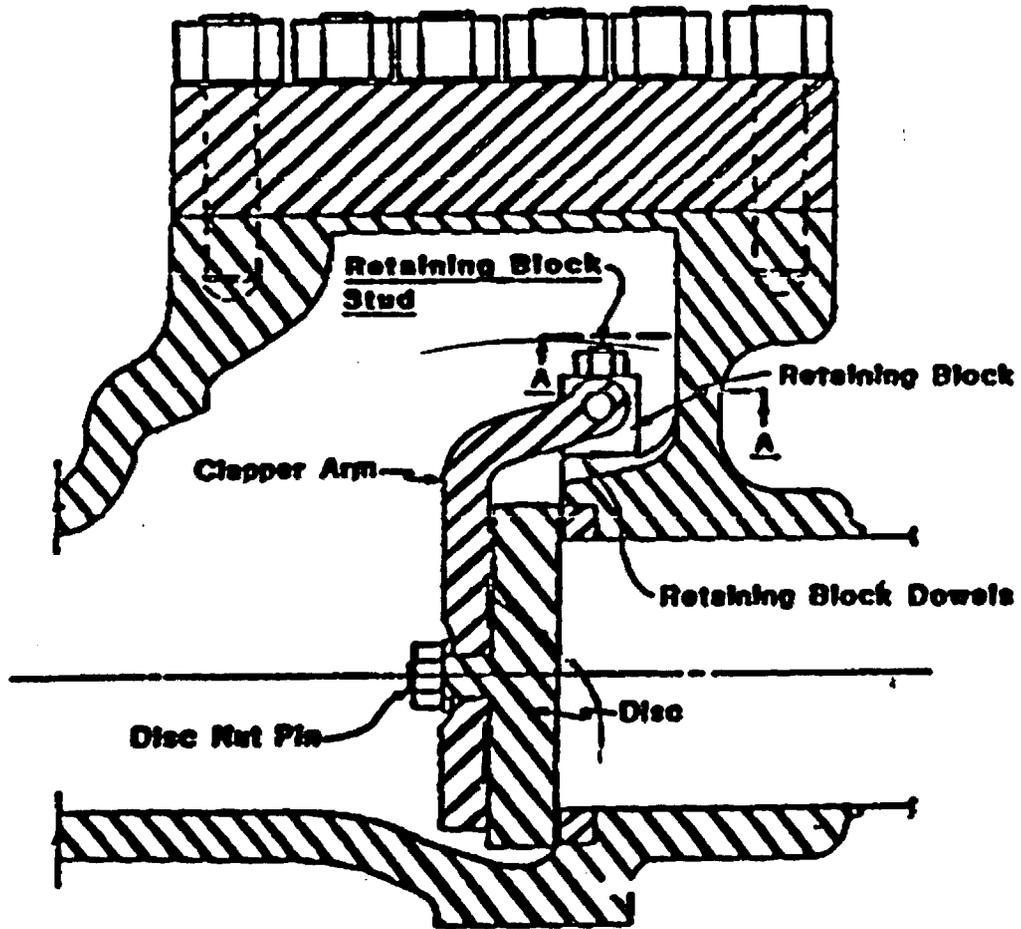
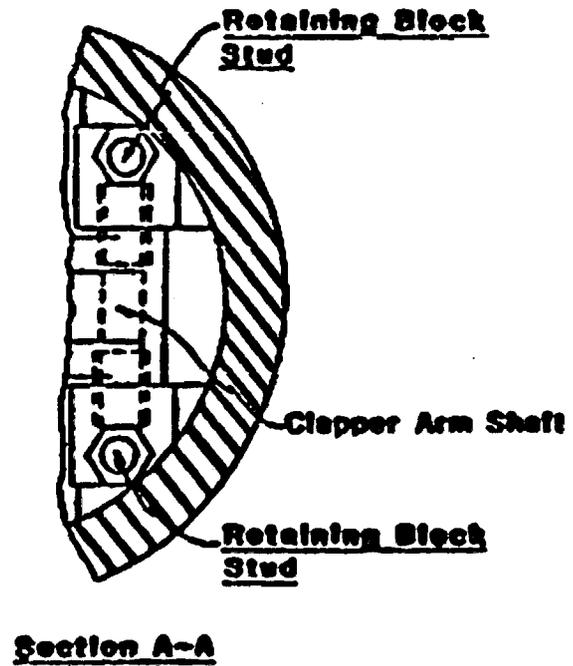
In October 1988 at Diablo Canyon, Unit 2, a scheduled preventative maintenance performed on a check valve in the Residual Heat Removal (RHR) System revealed that two retaining block studs (see drawing) were completely broken. This valve had been successfully stroked by hand several times before the mechanic detected slight movement of the retaining block. Upon further investigation the mechanic discovered that the studs were actually broken. The valve is an 8-inch pressure isolation valve in piping attached to the Reactor Coolant System hot leg. One stud was sheared at the block to valve body interface and the other stud was broken off inside the retaining block. There were signs of significant corrosion product build-up on the failed studs. The valve was manufactured by Anchor Darling.

At D.C. Cook, Unit 1, the two RHR injection check valves were inspected and each was found to have one broken stud. Two SI accumulator injection check valves were also inspected and found to be acceptable. Metallurgical evaluation of the failed studs is ongoing with the preliminary analysis indicating that the failures are due to intergranular stress corrosion cracking.

The NRC staff believes that with seriously degraded studs, the retaining blocks could be dislodged if these valves are called upon to open rapidly during accident conditions. This could lead to blockage of the flow path, and the valves would be incapable of reseating.

Based upon discussions with the valve vendor, the NRC has learned that the affected valves at the plants discussed above are Anchor Darling Model Number S350WSC, Drawing Number 94-12892. The vendor also indicated that based primarily on experience with pressure boundary bolting, they have been using Type 17-4PH stainless steel for bolts and studs in borated water service. They no longer manufacture the S350WSC valve, and they recommend replacement studs be made of Type 17-4PH stainless steel rather than Type 410.
