UNITED STATES  
NUCLEAR REGULATORY COMMISSION  
OFFICE OF NUCLEAR REACTOR REGULATION  
WASHINGTON, D.C. 20555

NRC INFORMATION NOTICE NO. 88-67: PWR AUXILIARY FEEDWATER PUMP TURBINE  
OVERSPEED TRIP FAILURE

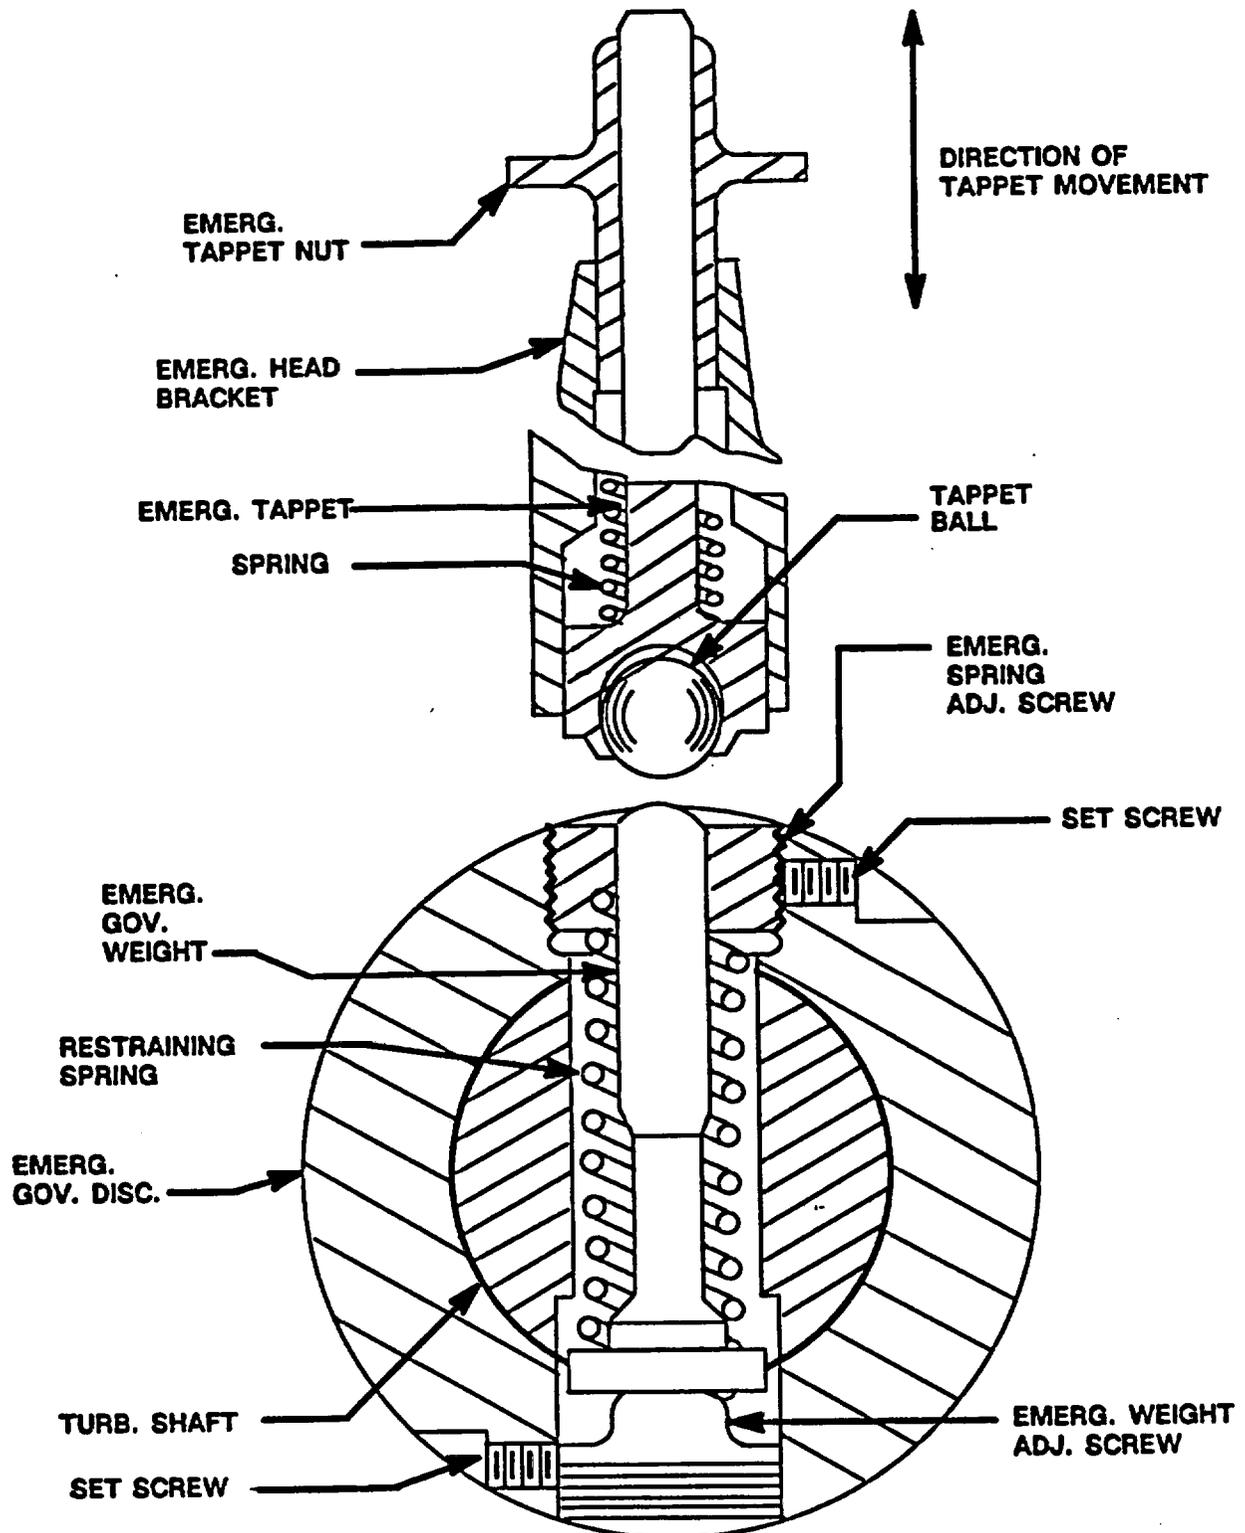
# TERRY TURBINE MECHANICAL TRIP DEVICE TAPPET AND BALL LINKAGE

The licensee's investigation into this event identified the root cause to be failure of the mechanical overspeed trip device because of damage to the tappet ball located in the mechanical trip linkage. The licensee made visual inspections for damage from overpressurization of piping, valves, and instrumentation. There was no evidence of cracks, leaks, or deformation of the overpressurized piping. Analysis performed after the event revealed that piping code stresses were not exceeded.

The mechanical overspeed trip linkage consists of an emergency governor weight (located in the shaft of the turbine), an emergency tappet (see attachment 1), and linkage (not shown in attachment 1) to the trip (steam inlet) valve. During an overspeed condition, centrifugal force causes the emergency governor weight to overcome a restraining spring located in the shaft. The weight then strikes the emergency tappet, which, in turn, rises against a spring allowing the trip linkage to release the stop valve spring closure mechanism closing the steam inlet valve. Initial inspection and test results failed to duplicate the overspeed event. Upon disassembly of the mechanical trip device, visual inspection showed excessive wear on the polyurethane tappet ball. The tappet ball fits into the emergency tappet as shown in attachment 1, with the ball free to rotate. Approximately half the polyurethane was missing from the tappet ball so that the emergency governor weight could not contact the tappet ball with sufficient force to actuate the trip mechanism. The ball was also covered with a gummy substance of unknown origin.

The licensee implemented several corrective actions and plans to upgrade the mechanical trip linkage to the current vendor design (the new design has no tappet ball arrangement). The vendor recommended overspeed testing every refueling outage. Licensees may wish to consider a visual examination of the tappet ball arrangement during the refueling outage.
