UNITED STATES
NUCLEAR REGULATORY COMMISSION
OFFICE OF NUCLEAR REACTOR REGULATION
WASHINGTON, D.C. 20555

August 15, 1988

NRC INFORMATION NOTICE NO. 88-63: HIGH RADIATION HAZARDS FROM IRRADIATED
INORE DETECTORS AND CABLES

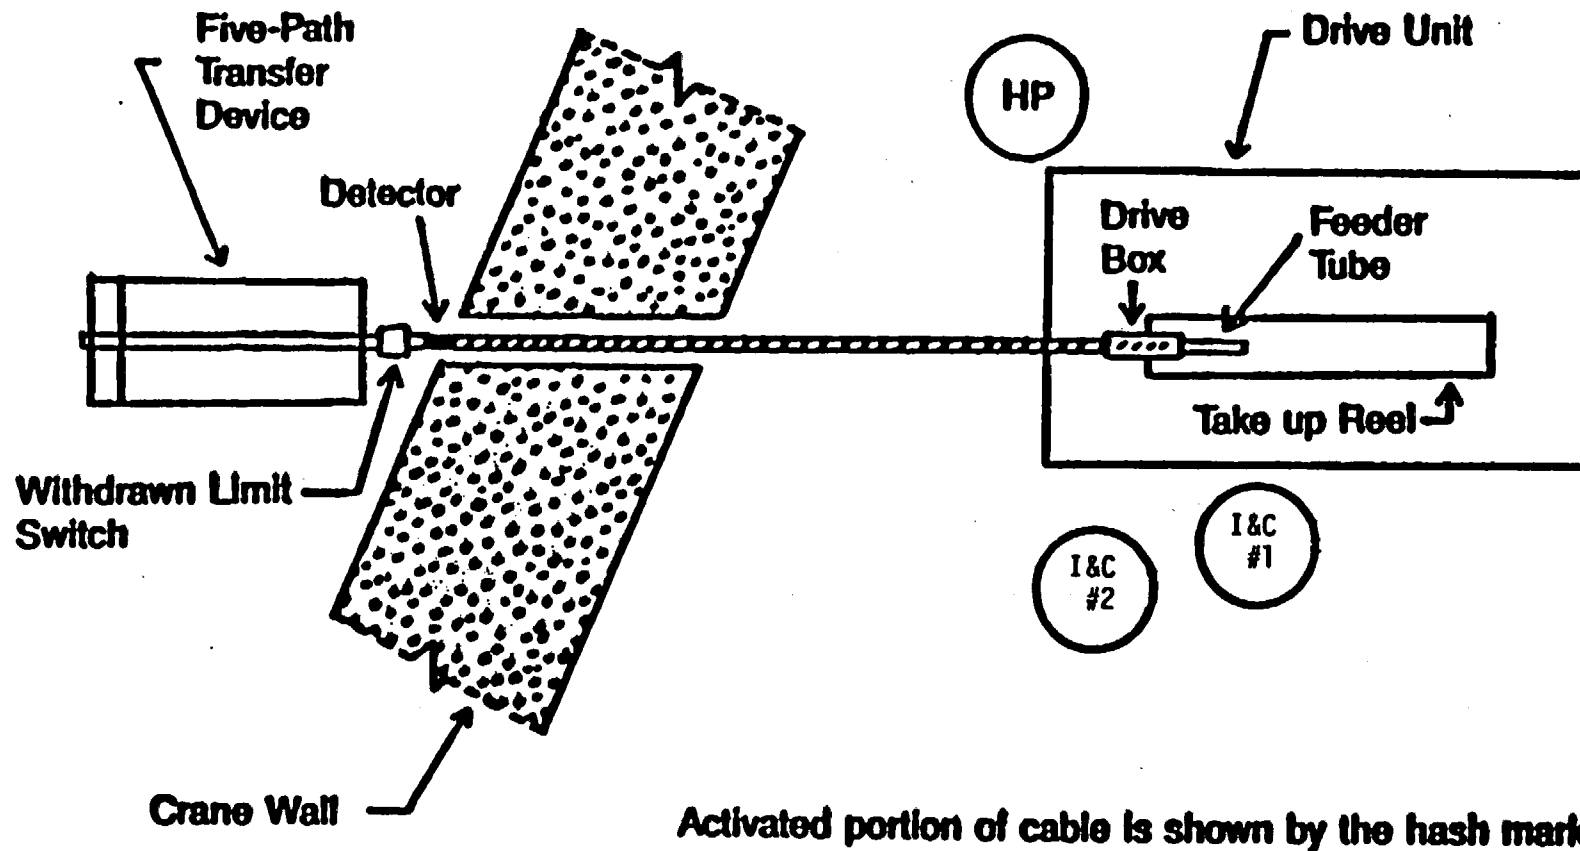
FIGURE 2

the crane wall (see Figure 2), the HP technician noted rapidly increasing radiation levels near the transfer tube which soon exceeded the maximum onscale reading of his survey meter (1000 R/hr). He then ordered the work stopped and the work platform evacuated. Dose estimates performed by the licensee show that whole body doses for the three workers ranged from approximately 700-1000 mrem. The worker who held and pulled the cable received a dose of 800 mrem to his hand. The beta dose contribution to the workers was small because the stainless steel tube casing through which the activated drive cable was inserted effectively attenuated the beta radiation.

Relative Positions of Individuals During Incident
