UNITED STATES
NUCLEAR REGULATORY COMMISSION
OFFICE OF NUCLEAR REACTOR REGULATION
WASHINGTON, D.C. 20555

August 15, 1988

NRC INFORMATION NOTICE NO. 88-63: HIGH RADIATION HAZARDS FROM IRRADIATED
INCORE DETECTORS AND CABLES

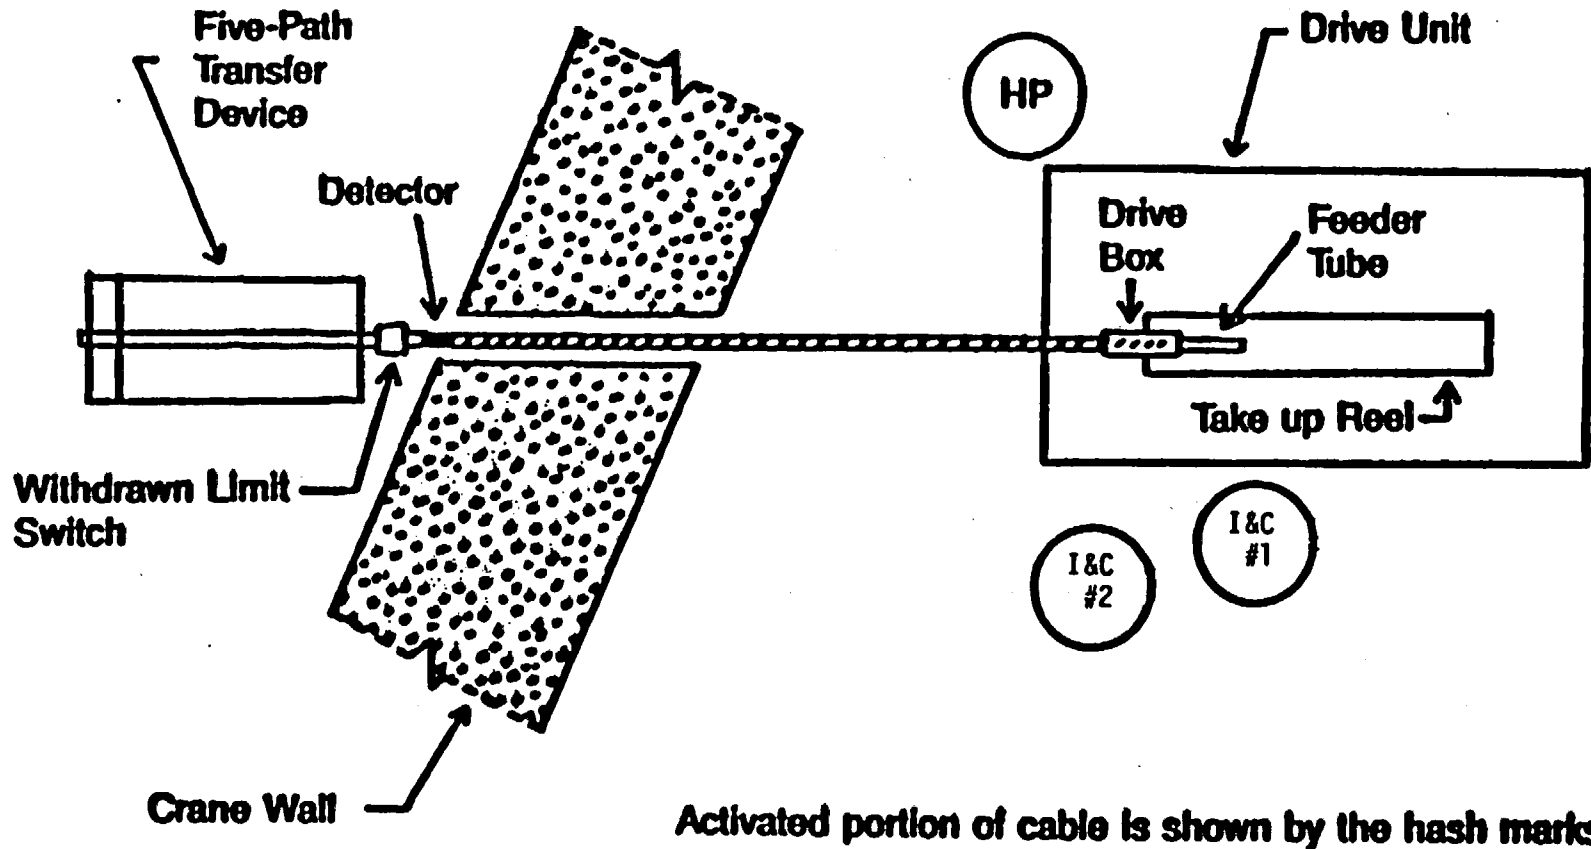
FIGURE 2

During efforts to dislodge the detector, about 100 feet of the cable attached to the detector were manually pulled into the Seal Table Room, through the polar crane wall, and taken up on the "A"-drive-unit reel assembly in the outer annulus area. As the incore detector was pulled up to the penetration through

the crane wall (see Figure 2), the HP technician noted rapidly increasing radiation levels near the transfer tube which soon exceeded the maximum onscale reading of his survey meter (1000 R/hr). He then ordered the work stopped and the work platform evacuated. Dose estimates performed by the licensee show that whole body doses for the three workers ranged from approximately 700-1000 mrem. The worker who held and pulled the cable received a dose of 800 mrem to his hand. The beta dose contribution to the workers was small because the stainless steel tube casing through which the activated drive cable was inserted effectively attenuated the beta radiation.

Licensee personnel had freed stuck detectors several times in the past. Radiation levels associated with the detector typically ranged between 5 and 35 R/hr; the drive cable had never exhibited significant induced activity. The principal radionuclide of concern in the drive cables used at Surry is manganese-56, which has a half-life of 2.56 hours and which accounts for 99 percent of the dose rate once it has reached equilibrium in the core. (NOTE: the principal radionuclide of concern may vary depending on drive cable composition and core irradiation/decay time.) The reason for the typically low activity levels of the drive cable in the past at Surry is that either the cable had resided in the core for only a short time or that it was allowed to decay to background levels between the time it was removed from the core and the time it was withdrawn into the Seal Table Room. However, in this event, the drive cable (which had been in the core at 100-percent power for 26 days) had decayed for only 15 minutes before being withdrawn through the Seal Table Room into the outer annulus area and, therefore, was highly radioactive. The licensee failed to evaluate the radiation hazards from the drive cable and several feet of activated cable were manually pulled into the outer annulus area before the HP technician halted work and ordered all personnel out of the area. Survey meter readings of more than 1000 R/hr were measured 12 inches from the cable.

- (a) Revision of the procedure to replace incore detectors to include steps to free stuck detectors. Performance of this procedure will require the approval of the HP Shift Supervisor, the use of a Special RWP, limitations on manual withdrawal of the detector drive cable, and an evaluation of radiological hazards and detector location.
- (b) Revision of appropriate training programs and procedures to incorporate the lessons learned from this event.
- (c) Informing appropriate station personnel of the key points and lessons learned from this event.
