UNITED STATES
NUCLEAR REGULATORY COMMISSION
OFFICE OF NUCLEAR REACTOR REGULATION
WASHINGTON, D.C. 20555

August 11, 1988

NRC INFORMATION NOTICE NO. 88-61: CONTROL ROOM HABITABILITY - RECENT REVIEWS
OF OPERATING EXPERIENCE

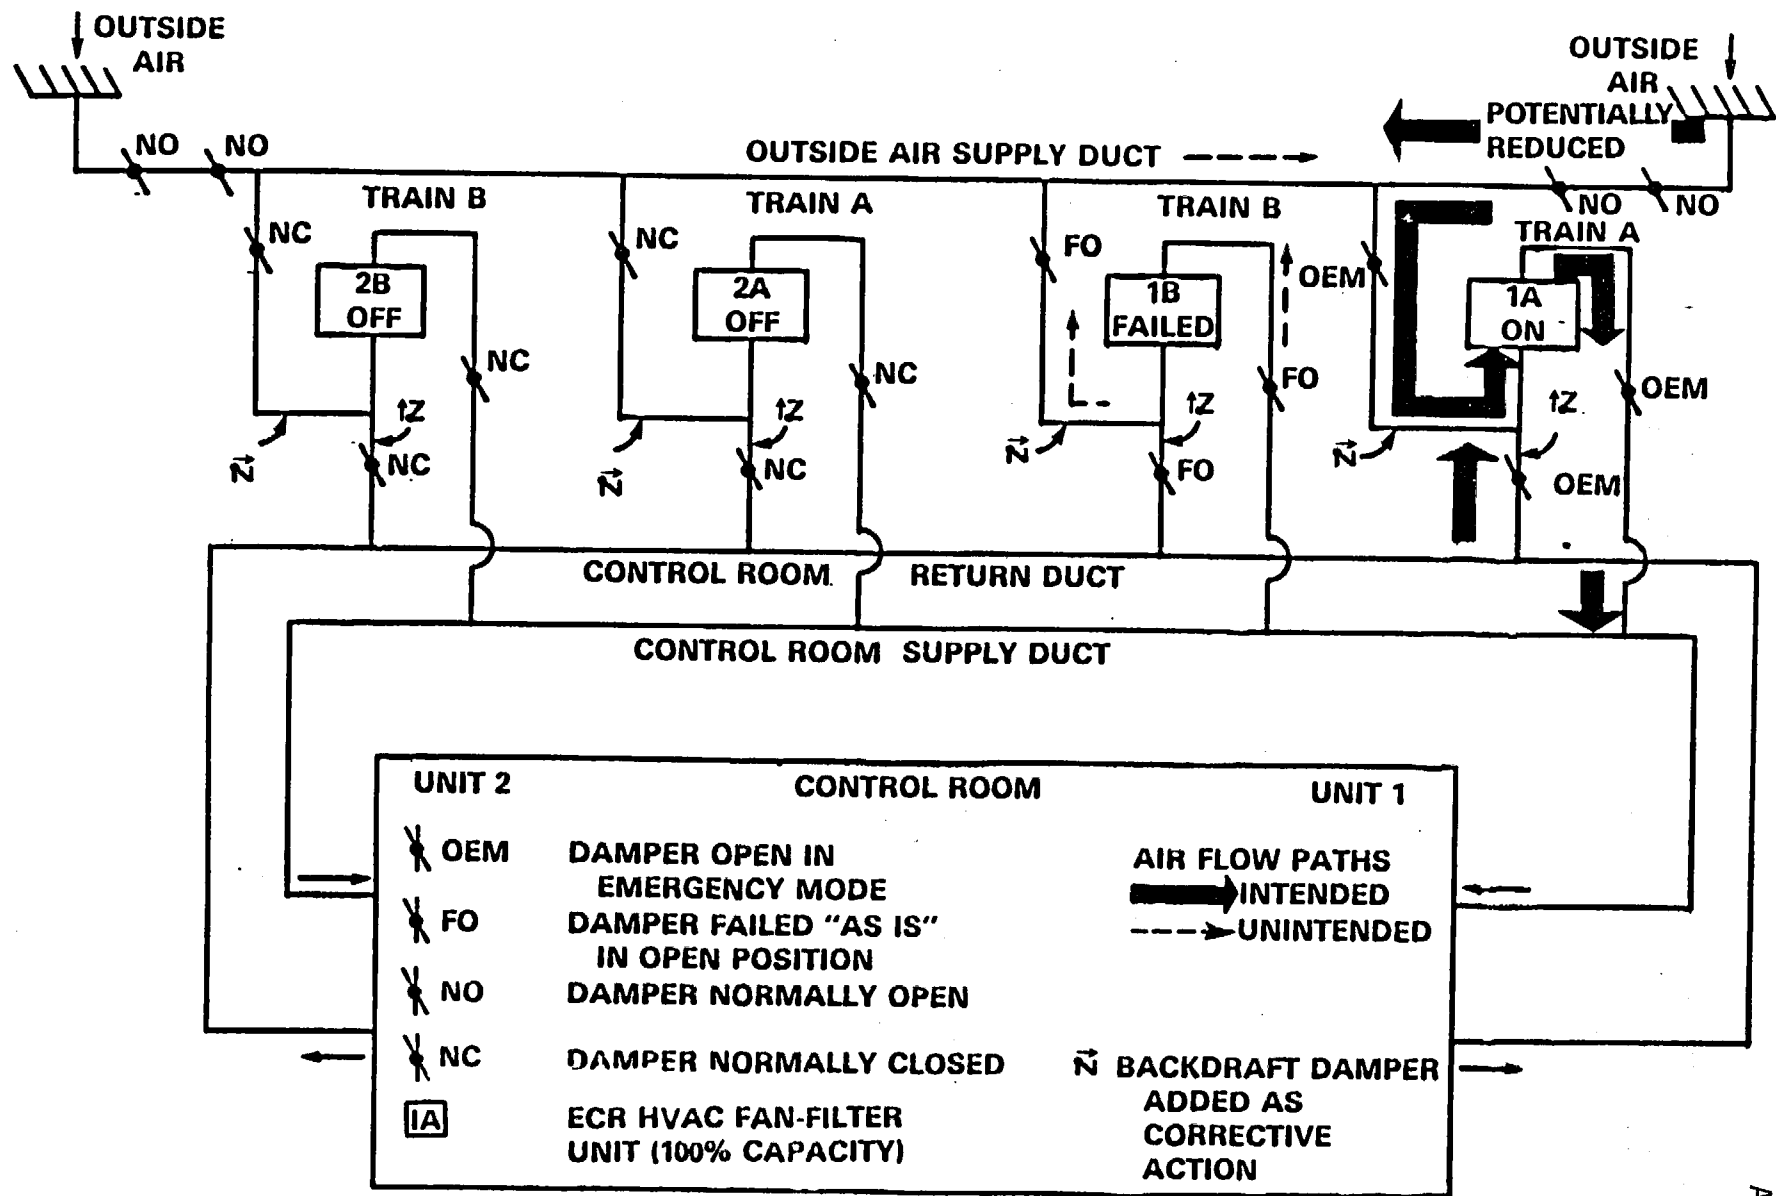
FIGURE 1. SCHEMATIC AIR FLOW PATH DIAGRAM OF ESSENTIAL CONTROL ROOM HEATING, VENTILATING, AND AIR CONDITIONING SYSTEM (ECR HVAC) AT VOGTLE. ASSUMED CONTAINMENT ISOLATION SIGNAL FOR UNIT 1 WITH TRAIN B FAILED.

On July 2, 1987, plant engineering personnel identified an inadequacy in the dose analysis for control room operators. On receipt of a safety injection signal or a control room outside air intake high radiation signal, the control room heating, ventilating, and air conditioning (HVAC) system is automatically transferred from the normal system units to the essential control room (ECR) fan-filter units in the emergency mode of operation. The ECR system consists of two redundant and physically separated 100 percent capacity fan-filter units for each side of the control room, associated with the corresponding reactor unit (four for the combined Unit 1 and Unit 2 control room (Figure 1)). Each of the ECR units belongs to a different safety train, but portions of the outside air intake ductwork and control room supply and return ductwork are common to each of the units. On initiation of the ECR system, the associated motor-operated dampers for the essential units are automatically opened and those for the normal units are automatically closed.

When both of the ECR fan-filter units are operating, loss of power to one of these units can reduce the amount of outside air available to pressurize the control room. This can happen because the dampers losing power fail in the "as-is" position. At the time of the identification of the problem, no back-draft dampers were installed. This degrades the ECR HVAC system by establishing flowpaths through the common ductwork and the ductwork of the failed unit back to the suction of the operating unit, which could potentially reduce the outside air flow to the control room and reduce the control room pressure below the design value. Maintenance of the design control room pressure is required to minimize unfiltered inleakage.

On July 4, 1987, an additional condition was discovered that could have caused an insufficient control room pressure. All ECR systems share common outside air supply ductwork. The common air supply ductwork has intakes from the outside atmosphere associated with both Units 1 and 2. Redundant isolation dampers in series are provided for both Unit 1 and Unit 2 duct openings from the outside atmosphere. During construction, the Unit 2 duct opening had been isolated by locking the dampers closed. If one of the outside air isolation dampers for Unit 1 had closed as the assumed single failure of an active component, no source of outside air would be available to the control room (shared by both Units) and the required pressure would not be maintained. Because the licensee had removed chlorine gas sources from the site, the capability to isolate toxic gases was no longer needed. Thus, the licensee deactivated and tagged open the outside air isolation dampers.

The licensee concluded that the actual effect on control room pressure could not be calculated in the absence of test data and decided to modify the system by installing backdraft dampers, as noted on Figure 1, for the ECR HVAC systems of both Units 1 and 2.
