UNITED STATES
NUCLEAR REGULATORY COMMISSION
OFFICE OF NUCLEAR MATERIAL SAFETY AND SAFEGUARDS
WASHINGTON, D.C. 20555

April 25, 1988

INFORMATION NOTICE NO. 88-18: MALFUNCTION OF LOCKBOX ON RADIOGRAPHY DEVICE

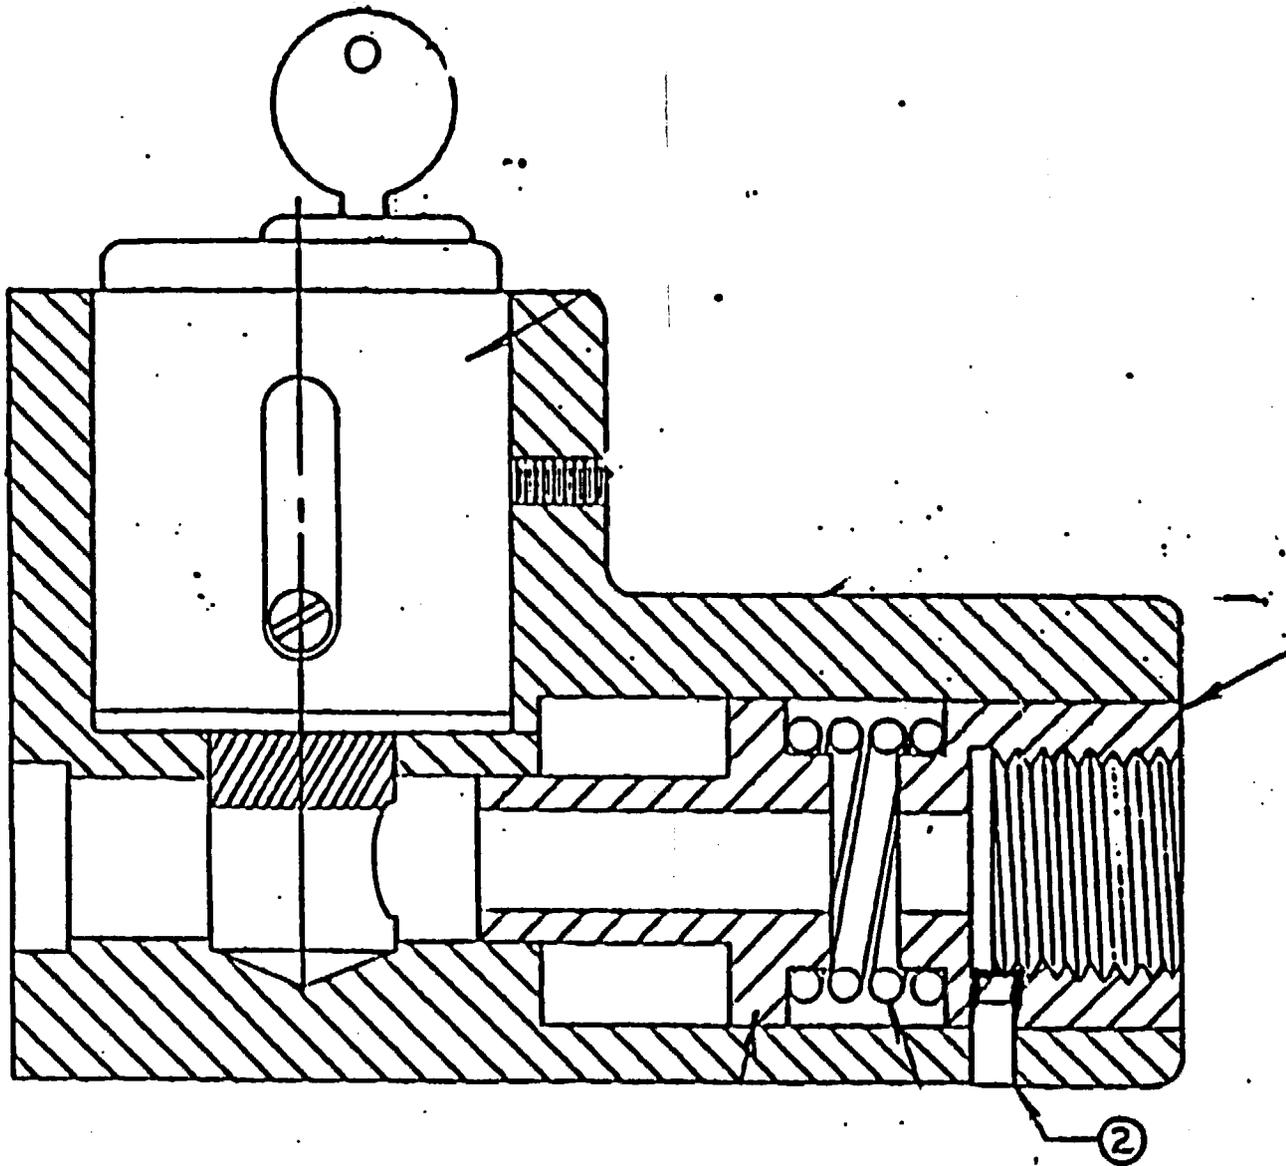
DIAGRAM OF AFFECTED LOCKBOX

When the device was examined by the manufacturer, two of the roll pins that hold the fixed insert in the lockbox were missing. The third roll pin had partially come out, thus allowing the insert and the source assembly to come out of the lockbox. Since two of the pins were missing, it is believed that the other pin could have worked free due to the pivot action that might occur when cranking the source assembly in and out of the device. No explanation is offered for why two of the roll pins were missing.

Item number 2 of the attached diagram (Figure 1) shows the location of the bottom roll pin. The two other roll pins, one on each side, were located at a 45° angle from the bottom pin. The missing pins may have been identified and replaced, if this item had been added to the daily equipment checks.

Figure 1 Device, Showing Location of Bottom Roll Pin (No. 2)

Section 34.28 of 10 CFR Part 34 requires daily radiographic equipment checks for defects. Licensees should verify that they have appropriate programs in place to promptly identify equipment problems and correct them immediately. Also note that potential generic defects must be reported to the NRC in accordance with 10 CFR Part 21. Licensees may also wish to review their emergency procedures to assure that their radiographers will respond properly and safely in any event such as the one described involving an unshielded source.
