UNITED STATES  
NUCLEAR REGULATORY COMMISSION  
OFFICE OF NUCLEAR REACTOR REGULATION  
WASHINGTON, D.C. 20555

**NRC INFORMATION NOTICE NO. 88-01: SAFETY INJECTION PIPE FAILURE**

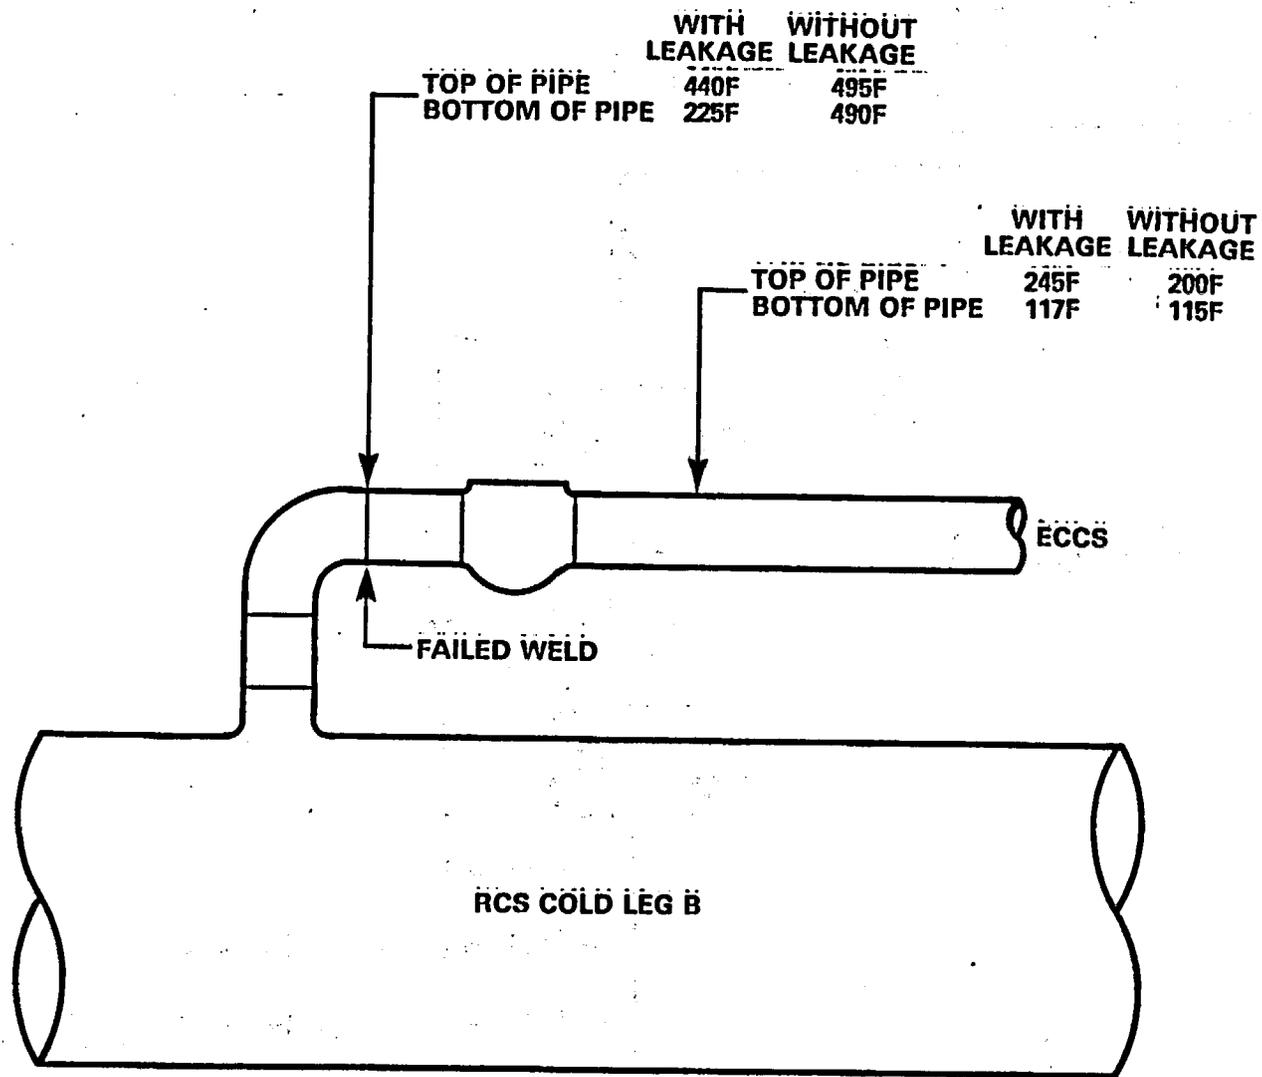
FARLEY 2 TEMPERATURE DATA

By ultrasonic testing, the licensee found an indication of a crack on the interior surface of the 6-inch ECCS piping connected to the cold leg of RCS Loop B. The indication was located at a weld connecting an elbow and a horizontal spool, as shown in Attachment 1. Further, the indication was on the underside of the pipe and extended circumferentially 60 degrees in both directions from the bottom of the pipe. The crack extended through the wall for approximately 1 inch at the center of the indication. Visual and metallographic examinations showed that the weld had failed as a result of fatigue after roughly one million stress cycles. The licensee examined the operating records and determined that the number of stress cycles imposed by starting up and shutting down and by safety injections was significantly less than the relevant design criteria.

Data from the sensors demonstrated that there was an adverse temperature distribution in the Loop B ECCS piping as shown in Attachment 1. The circumferential temperature difference at the location of the failed weld was 215° F. Further, the temperature at the bottom of the pipe fluctuated as much as 30° F in 30 seconds. This spatial and temporal distribution was caused by failure of the valve in the bypass pipe around the boron injection tank (BIT) to seat properly. The valve, which is shown in Attachment 2, is believed to be the cause of failure of the weld. Leakage through the valve apparently caused the check valves in the Loop B ECCS pipe to partially open, or chatter, admitting relatively cold coolant to the unisolable portion of the pipe between the nozzle and the first check valve. Temporarily redirecting the valve leakage away from the ECCS manifold changed the temperature distribution, as shown in Attachment 1. It should be noted that there may be other safety-related piping in both PWRs and BWRs which could experience similar fatigue due to thermal cycling.

Corrective action for this common-mode failure would include redesigning the piping, instrumenting unisolable and adjacent portions of the piping to detect cyclic or abnormal thermal stresses, instrumenting the ECCS manifold to detect pressure resulting from valve leakage, or providing additional surveillance.

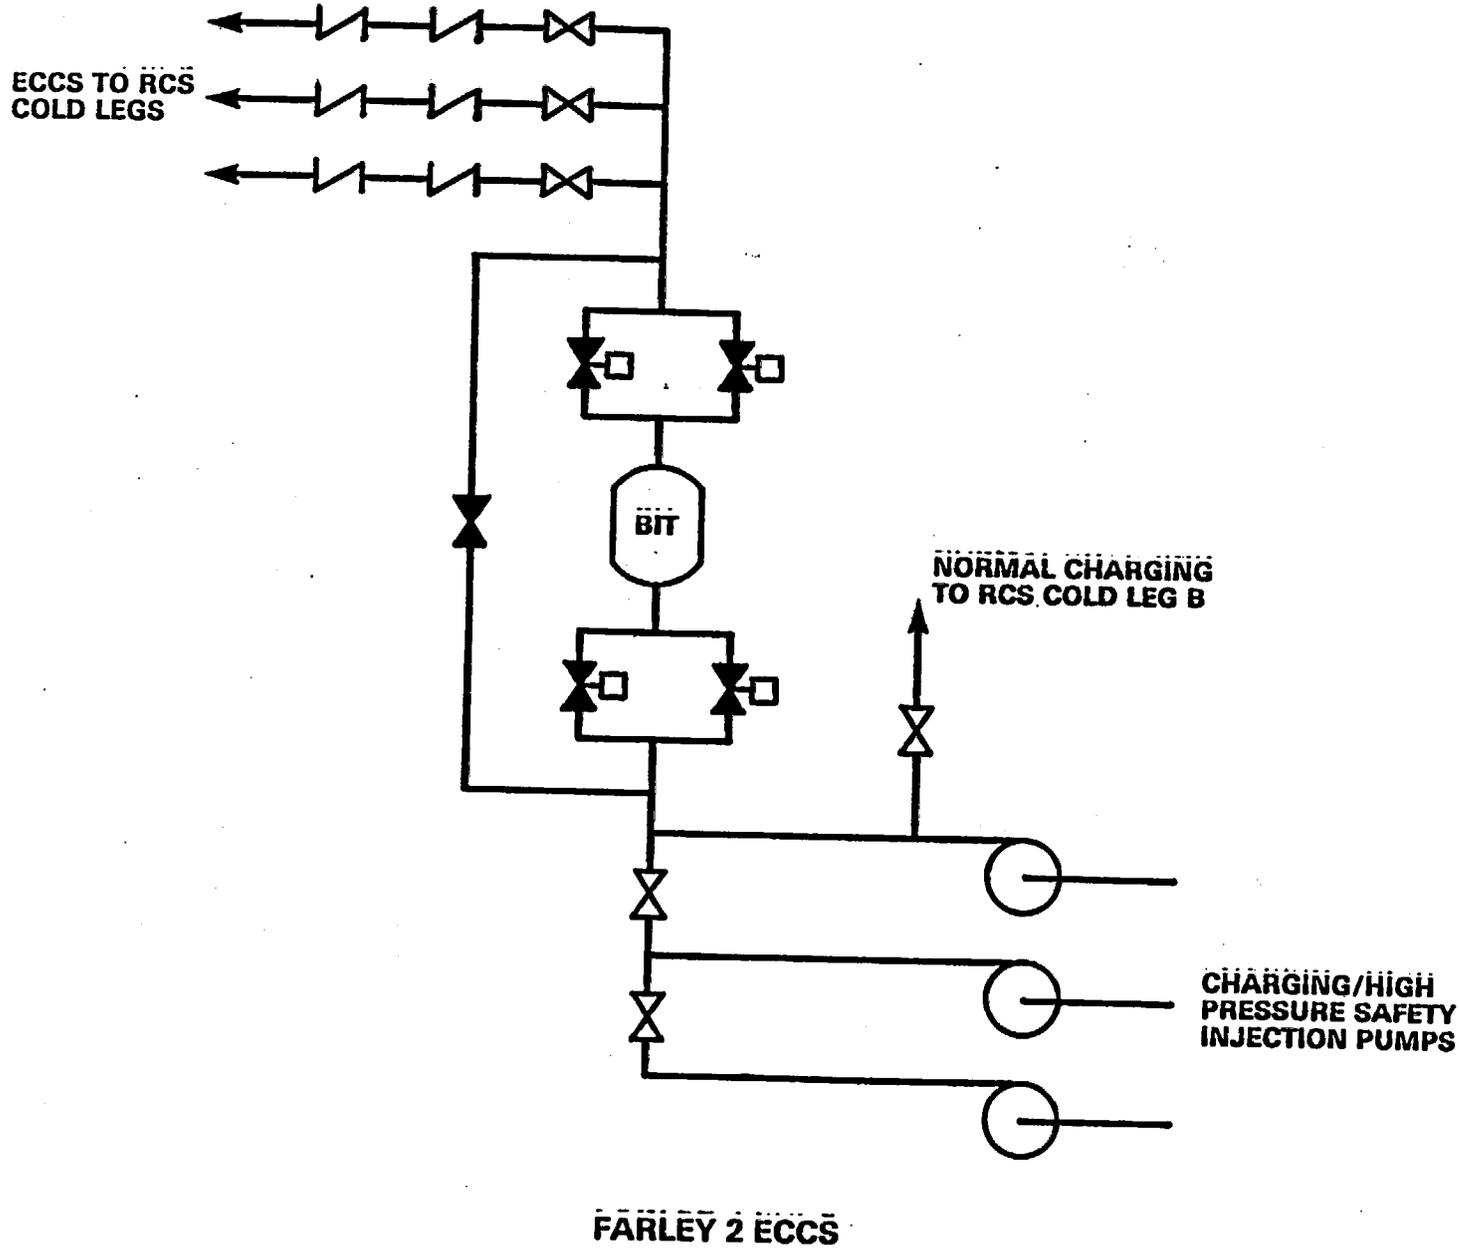
A generic safety question may exist for those plants having dual purpose pumps that are used for charging the RCS with coolant during normal operation and injecting emergency core coolant at high pressure following an accident. During normal operation, with one of the pumps providing charging flow to the RCS via the normal charging piping and with a leaking valve allowing coolant to flow to the ECCS manifold, pressure in the manifold will exceed RCS pressure and check valves in the ECCS piping will open admitting relatively cold coolant to the RCS. The flow rate via this additional path or paths is determined by the throttling that occurs in the leaking valve. If the check valves in more than one ECCS pipe open, then more than one unisolable ECCS failure may occur. Subjecting the flawed piping to excessive stresses induced by a seismic event, water hammer, or some other cause conceivably could result in simultaneous double-ended failure of more than one ECCS pipe.
