UNITED STATES
NUCLEAR REGULATORY COMMISSION
OFFICE OF INSPECTION AND ENFORCEMENT
WASHINGTON, D.C. 20555

February 16, 1979

IE Information Notice No. 79-04

DEGRADATION OF ENGINEERED SAFETY FEATURES

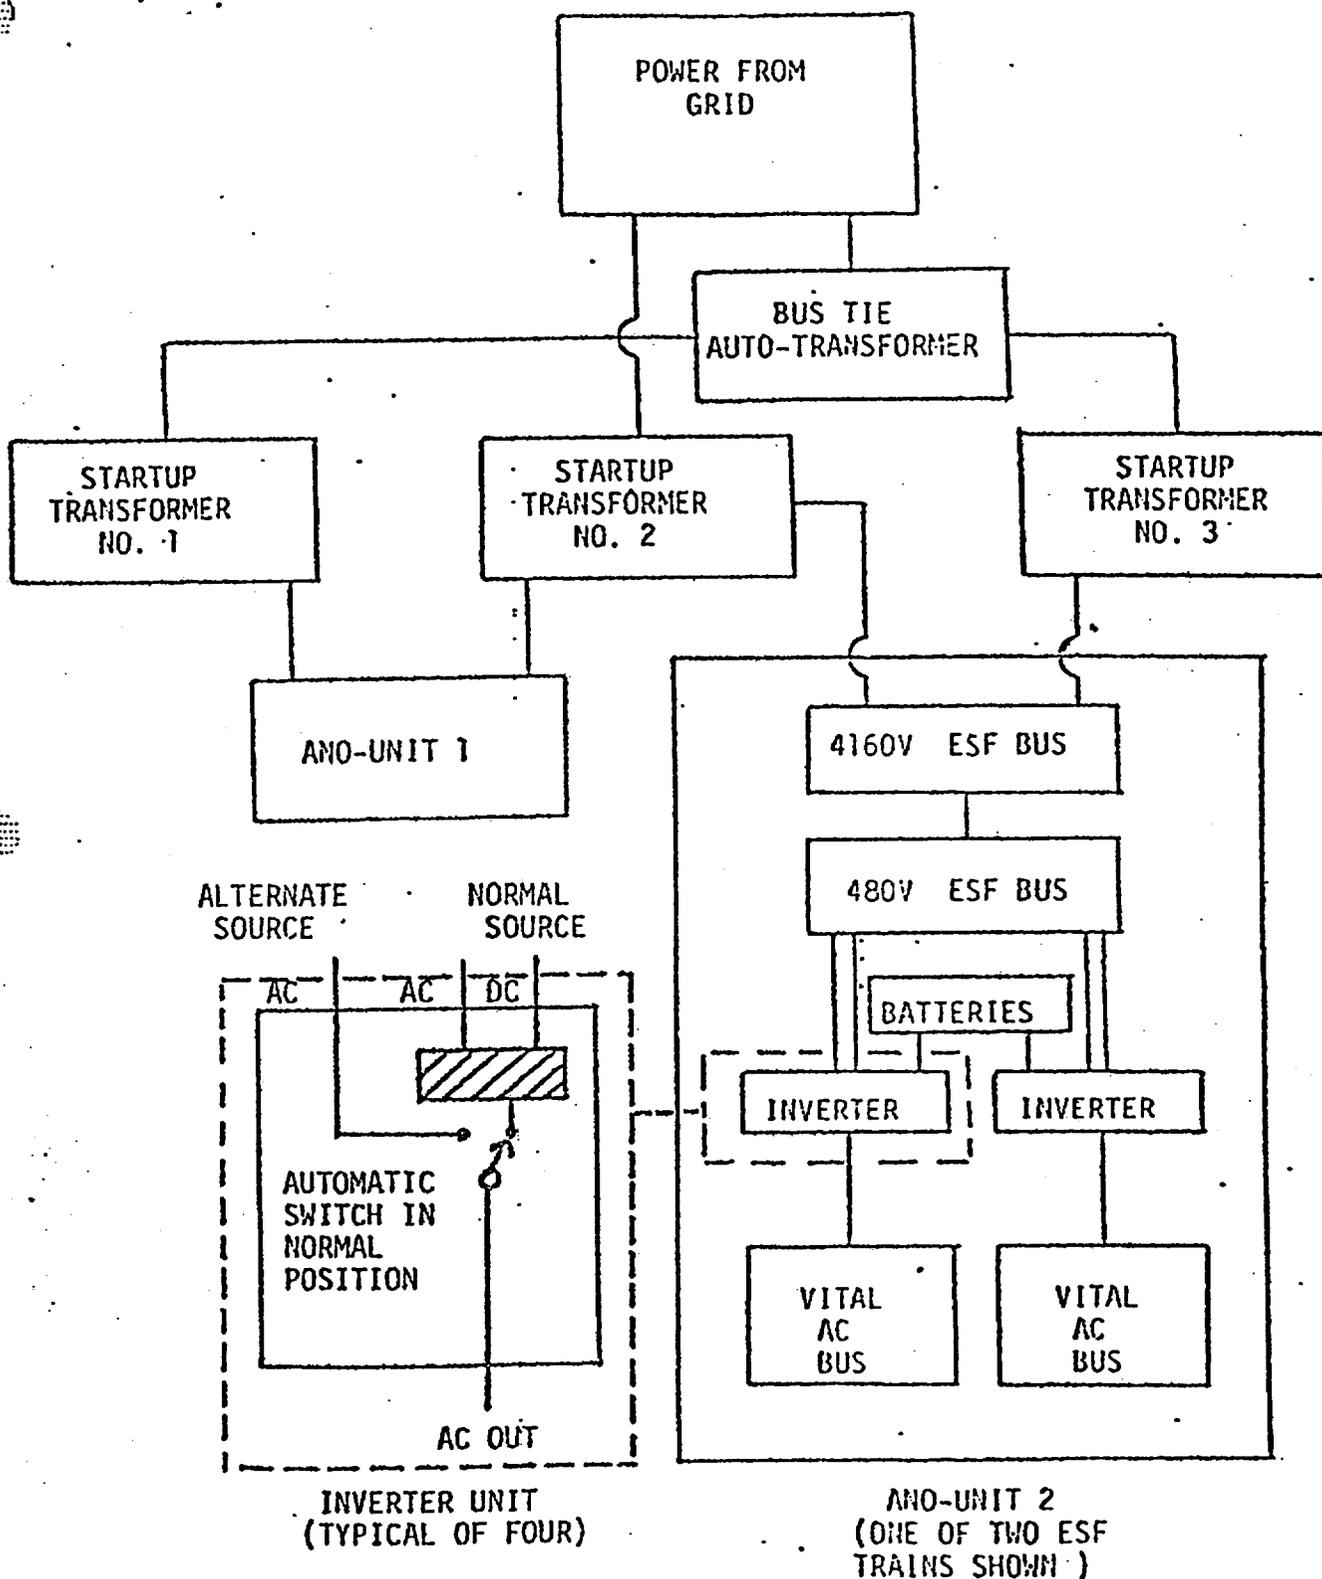
FIGURE 1

The power to Startup Transformer No. 3, which was feeding Unit 2, and to Startup Transformer No. 1, now feeding Unit 1, normally passes through a single piece of equipment, the Bus Tie Auto-Transformer. (Figure 1 shows a simplified block diagram of the principal electrical equipment involved.) The Auto-Transformer has the capacity to provide power for both units, but due to an error, the protective relays were still adjusted for the operation of Unit 1 only. As a result, when both units concurrently drew power from the Auto-Transformer these protection relays tripped and cut off power to Startup Transformer Nos. 1 and 3.

Startup Transformer No. 2, also shown in Figure 1, thus became the only source of offsite power for both Units 1 and 2. The onsite switching equipment automatically transferred the full auxiliary loads for both units to this transformer. However, this transformer is not designed to carry full auxiliary loads for both units. For this reason, Startup Transformer No. 2 became overloaded and the voltage dropped on the station distribution system for offsite power. At this time and during most of the incident, operating personnel at both units were unaware of the degraded voltage⁽²⁾ condition due to the overloaded Startup Transformer No. 2.⁽³⁾

The loss of the Bus Tie Auto-Transformer was caused by inappropriate setpoints for its protective relays. The Bus Tie Auto-Transformer loss had not been adequately reviewed prior to this event in that the overloading of the shared Startup Transformer No. 2 had not been identified during the design and review process.
