UNITED STATES
NUCLEAR REGULATORY COMMISSION
OFFICE OF INSPECTION AND ENFORCEMENT
WASHINGTON, D.C. 20555

IE Information Notice No. 80-08

THE STATES COMPANY SLIDING LINK ELECTRICAL TERMINAL BLOCK

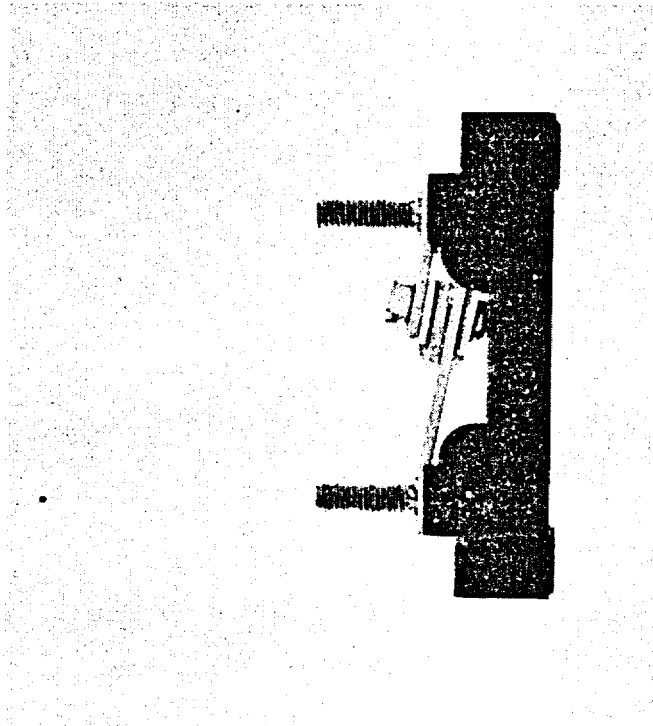
**Side View of States Company
Terminal Block in Assembled Position**

The connection between the two slotted bars on the terminal block is made by a U-shaped sliding link and spacer located between the two bars. The top of the U-shaped link and the spacer are drilled and the bottom of the link is threaded to accept a 8-32 screw. When the screw is tightened it binds the link, spacer and bar together to make electrical connection. Loosening the screw and sliding the link from between the bars breaks the connection. The purpose of the link is to provide easy insertion of test instruments, etc. into the circuit.

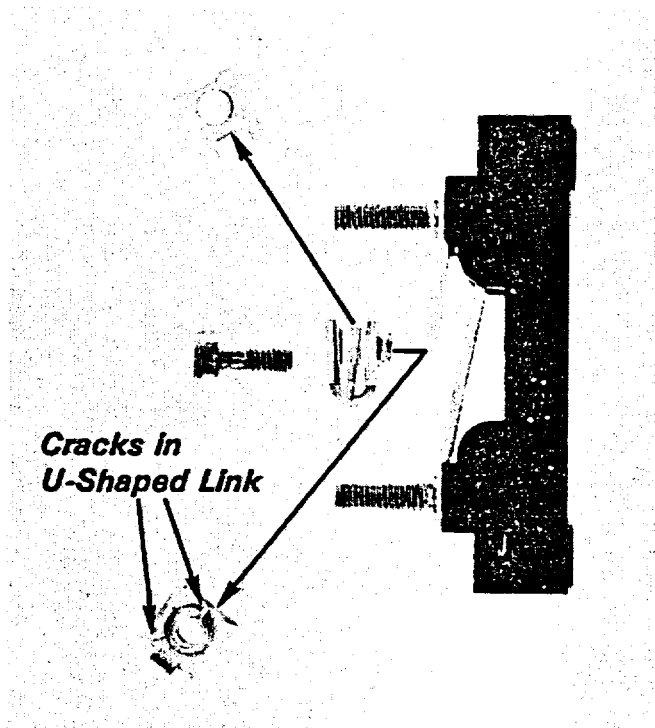
**Exploded View of
States Company Terminal Block**

The defect, which has been identified in 5% of the terminal blocks checked, occurs in the form of a crack between the threaded screw hole and the side of the U-shaped link. When the screw is tightened the crack widens and a poor or intermittent electrical connection can result. A defective link is impossible to cinch tightly in place and is difficult to detect visually.

Enclosure 1 shows the States Company terminal block. The defect, a crack in the bottom portion of the metal U-shaped link, is displayed in the exploded view of the terminal block assembly. These terminal blocks are widely used in the nuclear industry and may be used as permanent installations in safety related systems. The defective mechanical connection can cause an electrical circuit malfunction.
