UNITED STATES
NUCLEAR REGULATORY COMMISSION
OFFICE OF INSPECTION AND ENFORCEMENT
WASHINGTON, D.C. 20555

IE INFORMATION NOTICE NO. 85-60: DEFECTIVE NEGATIVE-PRESSURE, AIR-PURIFYING,
FULL FACEPIECE RESPIRATORS

POTENTIAL: SMALL HOLES IN FULL FACE RESPIRATOR

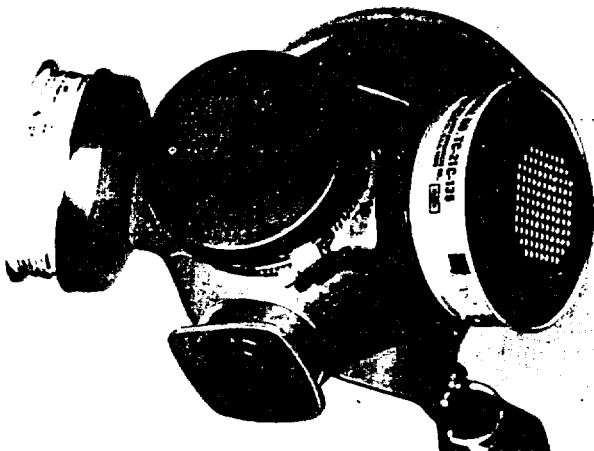
Ultra-Twin Respirator
Mine Safety Appliance Company (MSA)

Small holes or cuts were found in the black rubber facepiece near the metal edge of the clamp holding the speaking diaphragm cover. Most of the respirators involved were four years old or older and in many cases the holes did not completely penetrate the facepiece. None of the cuts started from the inside of the mask.

The cause is abrasion from twisting the mask which occurs if the cartridges are over-tightened and if the wearer pulls the masks off by pulling the filter cartridges.

- Inspect for deterioration by bending or flexing the mask inward.
- Install and remove cartridges by holding the cartridge receptacle in one hand and snugging it with the other.
