IE INFORMATION NOTICE NO. 85-60: DEFECTIVE NEGATIVE-PRESSURE, AIR-PURIFYING,
FULL FACEPIECE RESPIRATORS

POTENTIAL: SMALL HOLES IN FULL FACE RESPIRATOR

Ultra-Twin Respirator
Mine Safety Appliance Company (MSA)

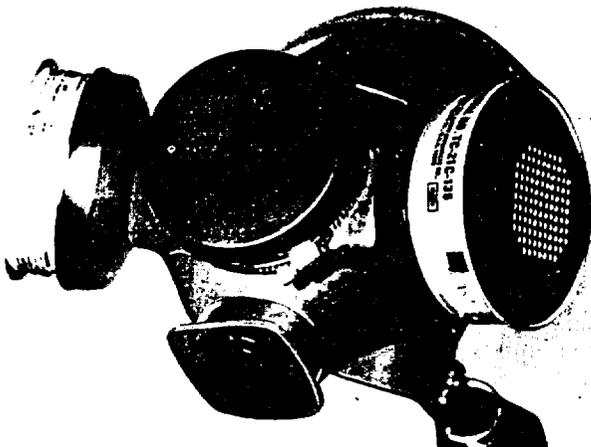
Small holes or cuts were found in the black rubber facepiece near the metal edge of the clamp holding the speaking diaphragm cover. Most of the respirators involved were four years old or older and in many cases the holes did not completely penetrate the facepiece. None of the cuts started from the inside of the mask.

The cause is abrasion from twisting the mask which occurs if the cartridges are over-tightened and if the wearer pulls the masks off by pulling the filter cartridges.

- Inspect for deterioration by bending or flexing the mask inward.
- Install and remove cartridges by holding the cartridge receptacle in one hand and snugging it with the other.
