UNITED STATES
NUCLEAR REGULATORY COMMISSION
OFFICE OF INSPECTION AND ENFORCEMENT
WASHINGTON, D.C. 20555

July 8, 1985

IE INFORMATION NOTICE NO. 85-50: COMPLETE LOSS OF MAIN AND AUXILIARY FEEDWATER
AT A PWR DESIGNED BY BABCOCK & WILCOX

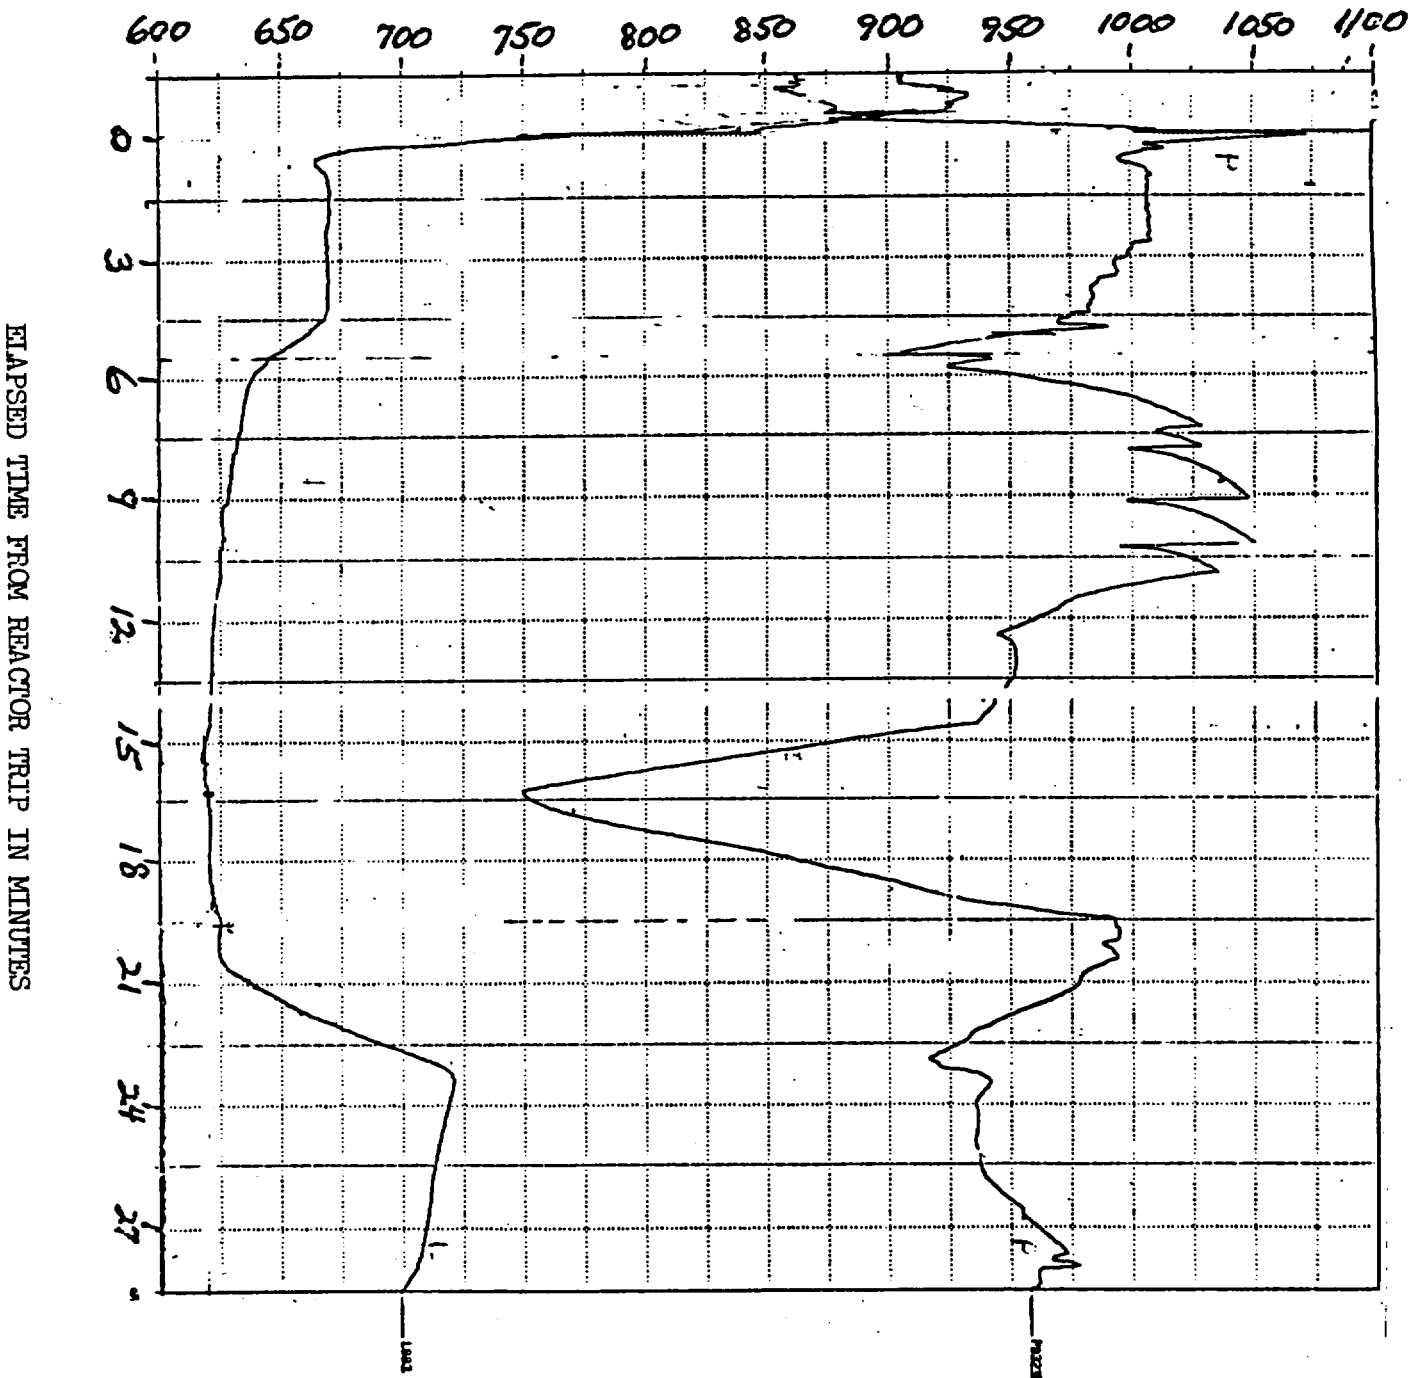
FIGURE 1: STEAM GENERATOR 1 LEVEL AND PRESSURE

Four and a half minutes after reactor trip, water level in the steam generators began to fall from the normal post-trip level which is 35 inches. After MSIV closure, steam release to atmosphere continued to remove decay heat. One minute later, Channel 1 of SFRCS actuated when the water level in Steam Generator 1 actually reached the SFRCS setpoint at 27 inches (See Figure 1). SFRCS started Auxiliary Feedwater Pump 1 and initiated alignment of it to Steam Generator 1.
