UNITED STATES  
NUCLEAR REGULATORY COMMISSION  
OFFICE OF INSPECTION AND ENFORCEMENT  
WASHINGTON, D.C. 20555

July 8, 1985

IE INFORMATION NOTICE NO. 85-50: COMPLETE LOSS OF MAIN AND AUXILIARY FEEDWATER  
AT A PWR DESIGNED BY BABCOCK & WILCOX

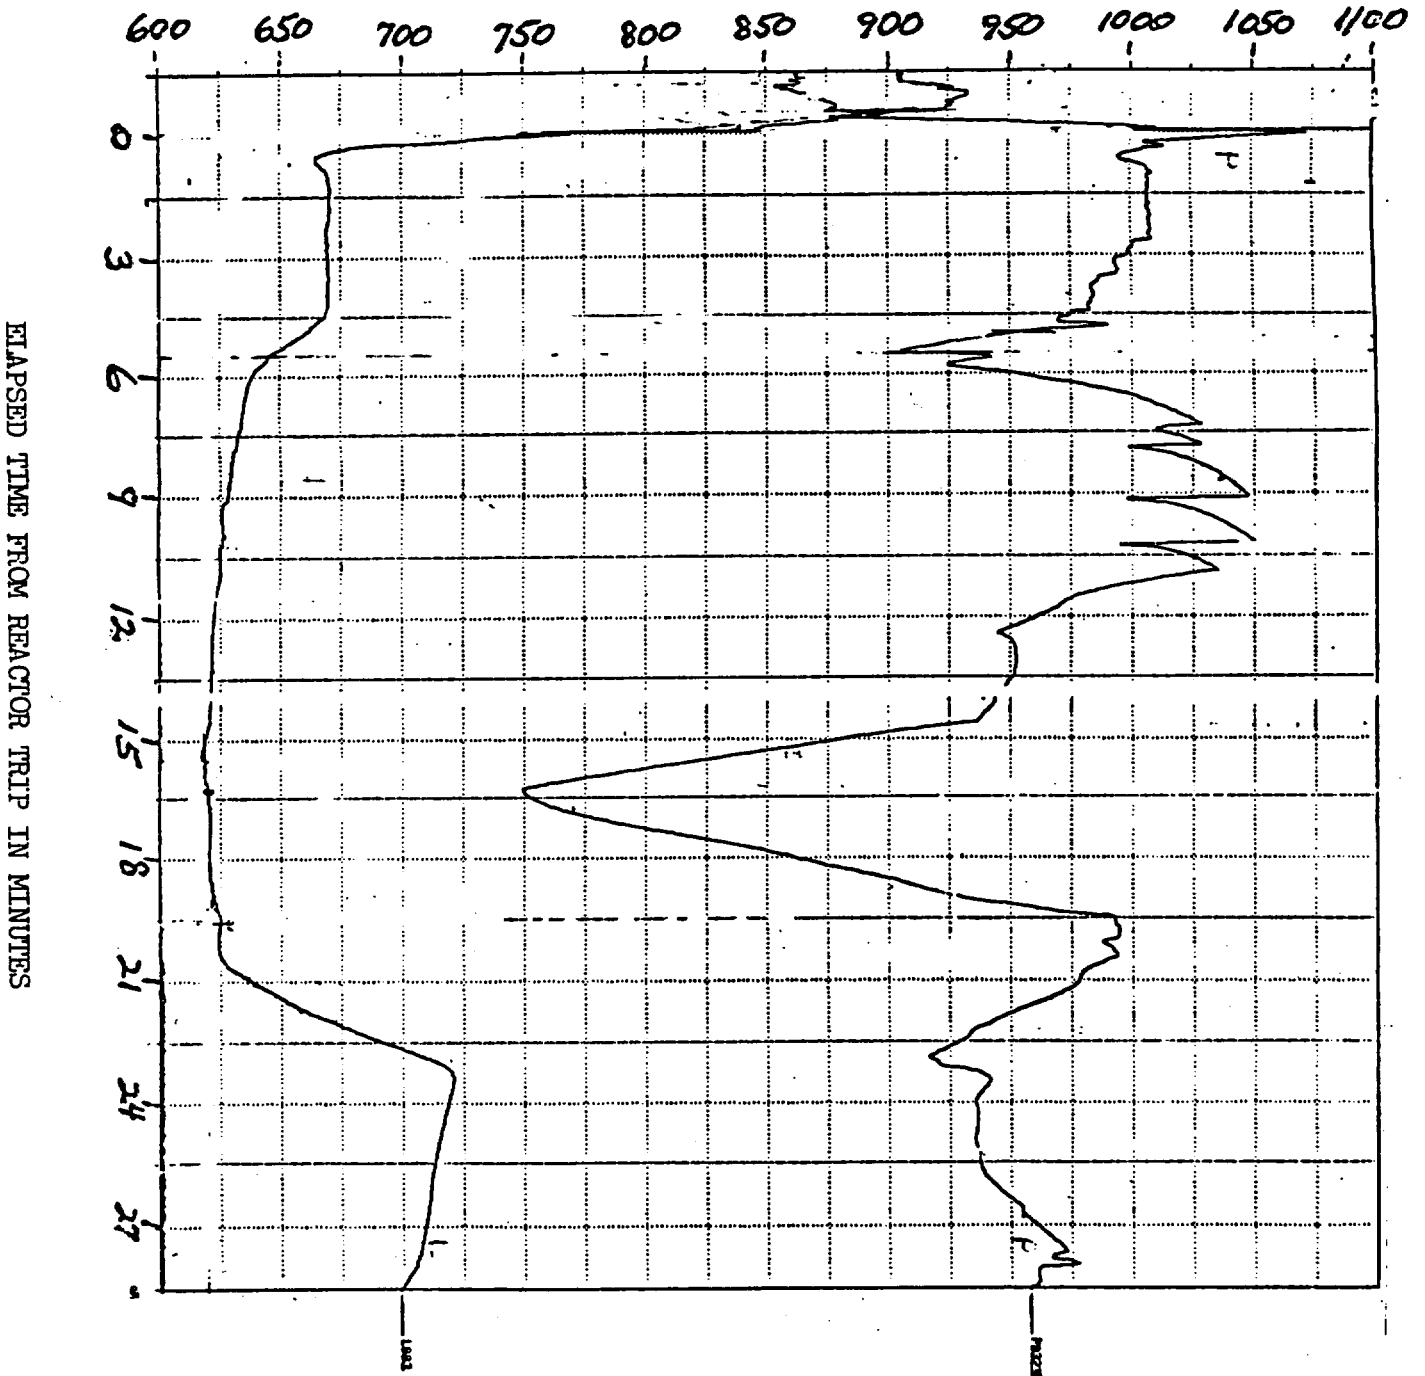
FIGURE 1: STEAM GENERATOR 1 LEVEL AND PRESSURE

Four and a half minutes after reactor trip, water level in the steam generators began to fall from the normal post-trip level which is 35 inches. After MSIV closure, steam release to atmosphere continued to remove decay heat. One minute later, Channel 1 of SFRCS actuated when the water level in Steam Generator 1 actually reached the SFRCS setpoint at 27 inches (See Figure 1). SFRCS started Auxiliary Feedwater Pump 1 and initiated alignment of it to Steam Generator 1.

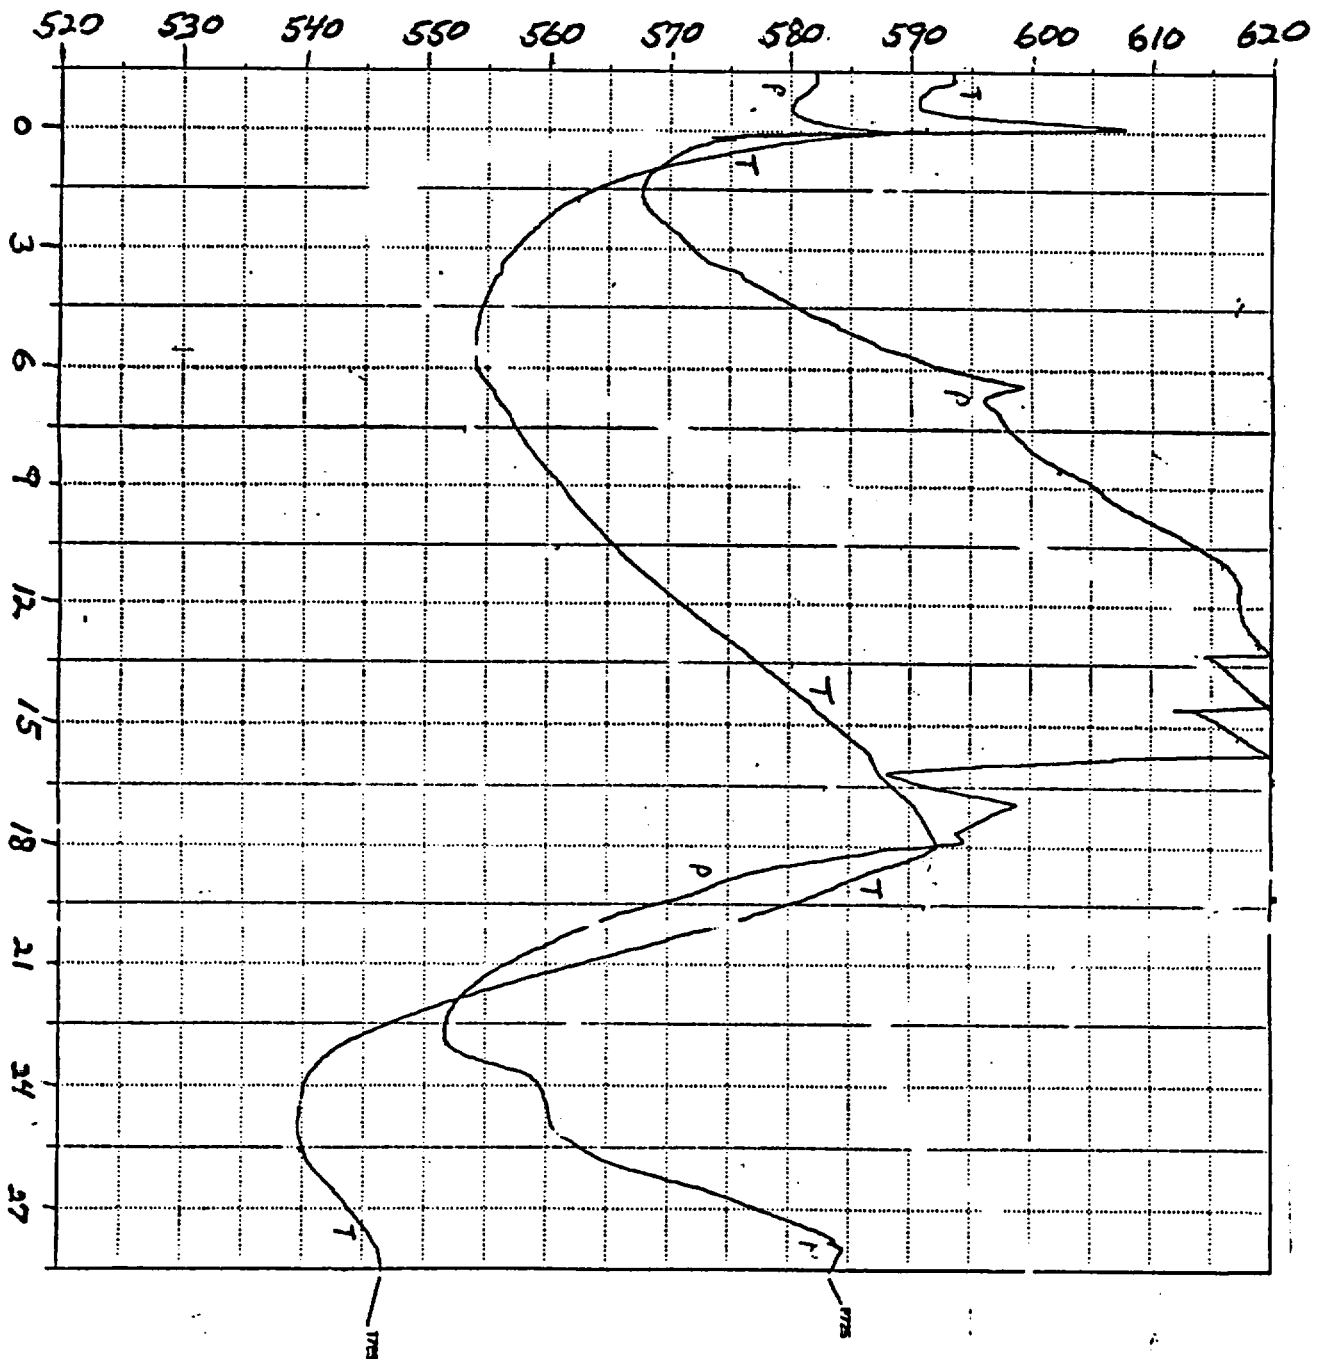
FIGURE 2: RCS TEMPERATURE AND PRESSURE

Approximately 16 to 18 minutes after reactor trip, the operators had the startup and auxiliary feedwater pumps running and the valves aligned. Water levels were beginning to rise in the steam generators. Reactor coolant temperature reached a maximum of 594° F and then started to decrease to normal. Refilling of the steam generators caused the reactor coolant system to fall to 1716 psig and about 540°F before returning to normal (See Figure 2).
