UNITED STATES
NUCLEAR REGULATORY COMMISSION
OFFICE OF INSPECTION AND ENFORCEMENT
WASHINGTON, D.C. 20555

April 30, 1985

IE INFORMATION NOTICE NO. 85-35: FAILURE OF AIR CHECK VALVES TO SEAT

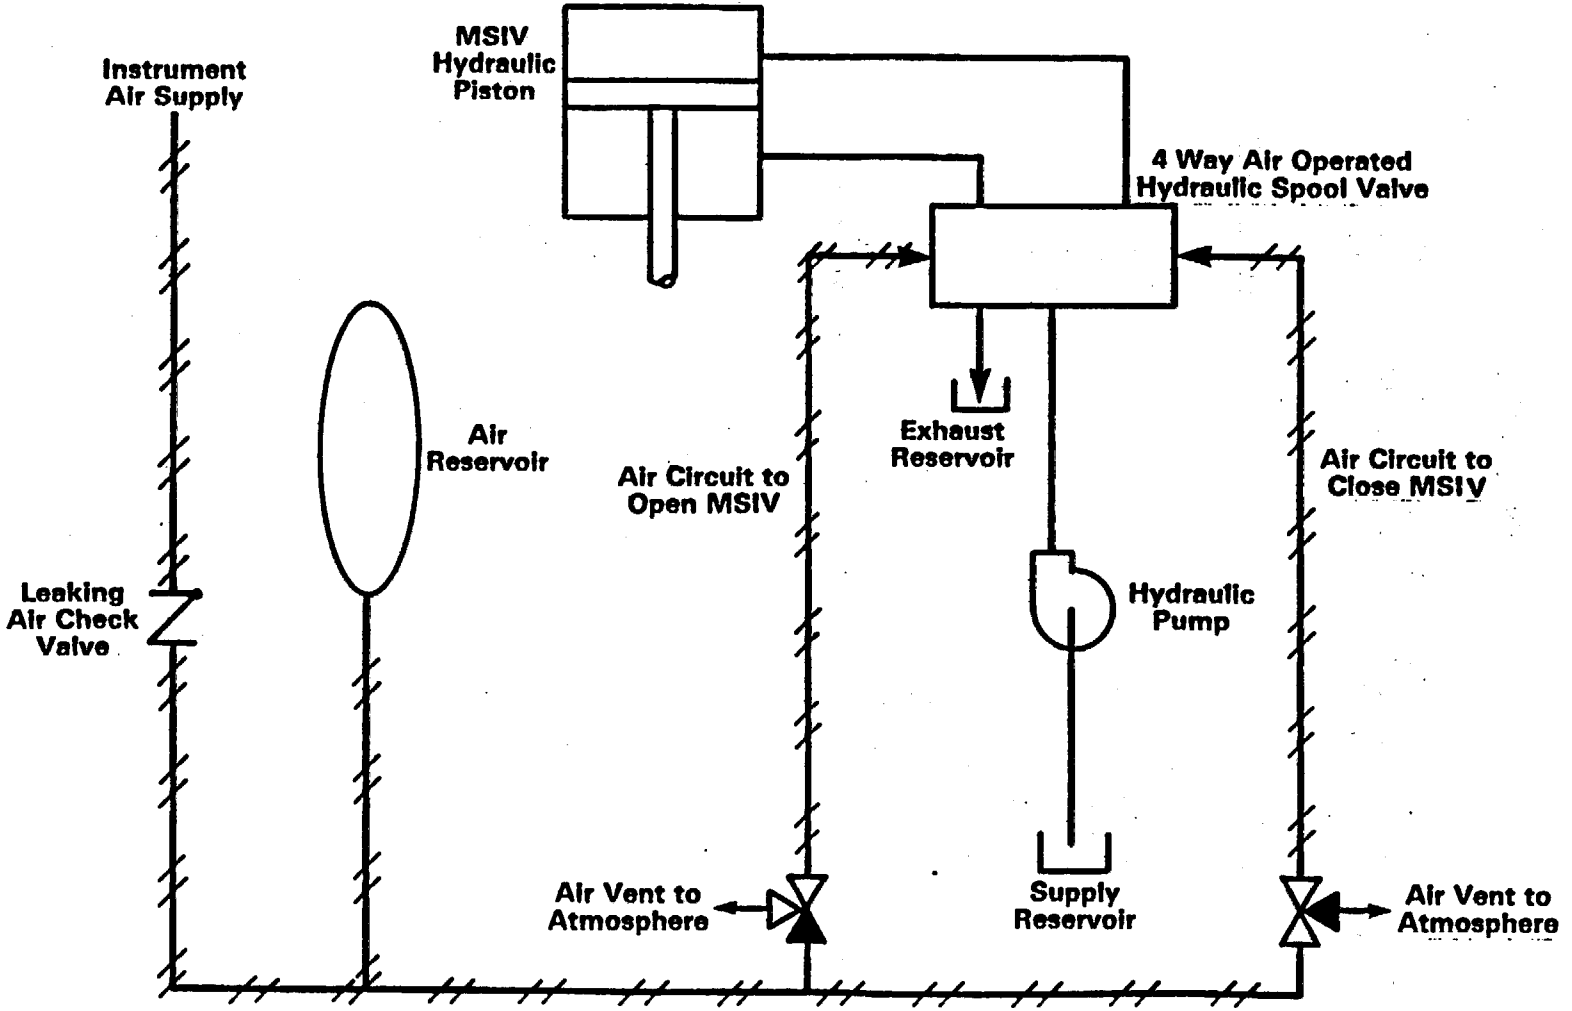
Figure 1 MSIV Control System

On March 14, 1985, at Byron Unit 1, two MSIVs failed to close on a main steam line isolation signal as required. The cause was determined to be failure of instrument air check valves to seat in response to gradually decreasing air pressure.

At the time of the isolation signal, the unit was cooling down following the startup test for loss of offsite power. The removal of offsite power had deenergized the station air compressors, allowing the instrument air pressure to decrease. The leaking instrument air check valves had allowed air accumulators to bleed down, removing the air pressure needed to shift hydraulic spool valves so that the hydraulic circuits could close the MSIV (see Figure 1). As a result, one of the four MSIVs did not close and one MSIV only partially closed.
